1200 Architectural Engineers PLLC

EHT Traceries Historic Preservation

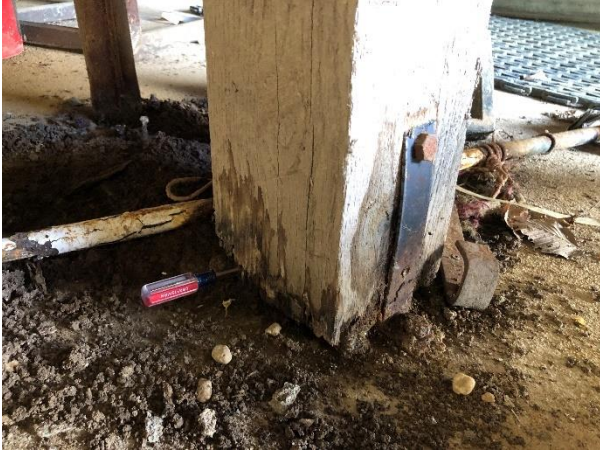
| OBSERVATIONS | IMAGES |
|---|---|
| <p><u>Photo #1</u><br/>This image shows the deterioration of existing wood columns that bear at slab on grade. The screwdriver is embedded at the base of the column in material weakened by moisture exposure.</p> <p><i>Recommendation:</i><br/><i>Repairs include replacing the column and installing a new pre-cast or cast-in-place concrete plinth at its base. Alternatively, the post can be retained by removing the damaged base and replacing with a new concrete plinth. Include connection between wood and new base and anchorage between new base and existing slab on grade. Temporary shoring will be required during repair work.</i></p> | <p>Photo #1:</p> |

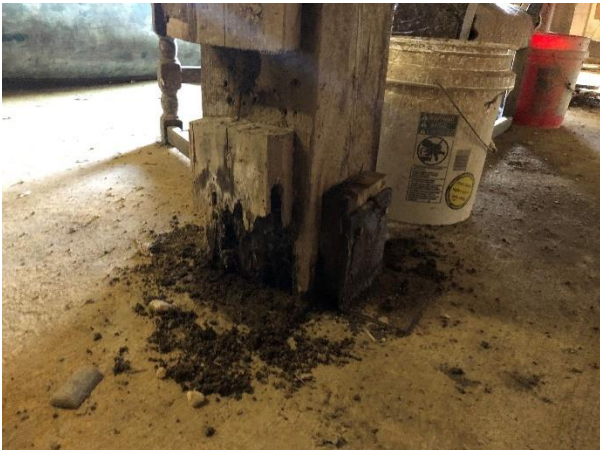
| OBSERVATIONS | IMAGES |
|---|---|
| <p><u>Photo #2:</u><br/>Severe moisture and termite damage at wood columns bearing at slab on grade.</p> <p><i>Recommendation:</i><br/><i>See Photo #1</i></p> | <p>Photo #2:</p> |

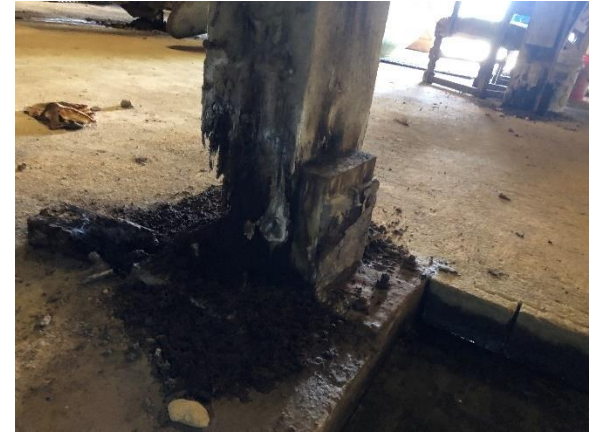
| OBSERVATIONS | IMAGES |
|---|---|
| <p><u>Photo #3:</u><br/>Severe moisture and termite damage at wood columns bearing at slab on grade. Significant section loss at the base of the column is apparent.</p> <p><i>Recommendation:</i><br/><i>Full replacement is recommended where damage extends more than 8 inches above the floor level. Final determination of repair versus replacement may be decided based upon architectural and construction cost parameters.</i></p> | <p>Photo #3:</p> |

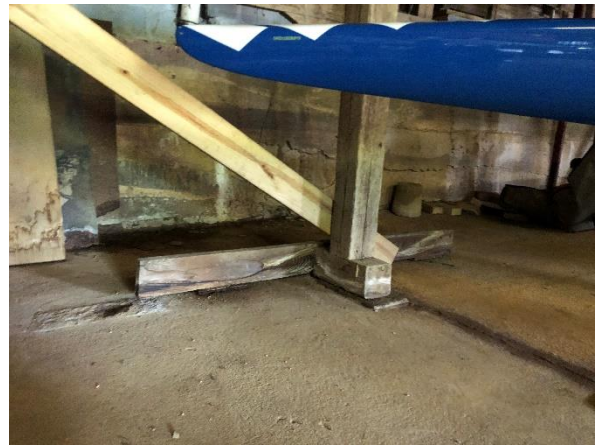
*Replacement or repair by encasement of the post base in a new cast-in-place concrete plinth is recommended. New reinforcement in the plinth should engage the existing post base and the plinth should be anchored into the slab on grade.*

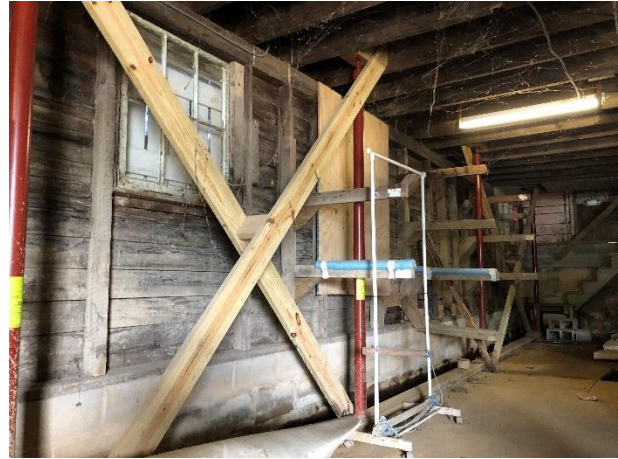
*Continue solid wood blocking between tops of braces in the joist bays to provide a better transfer of load from the floor system.*

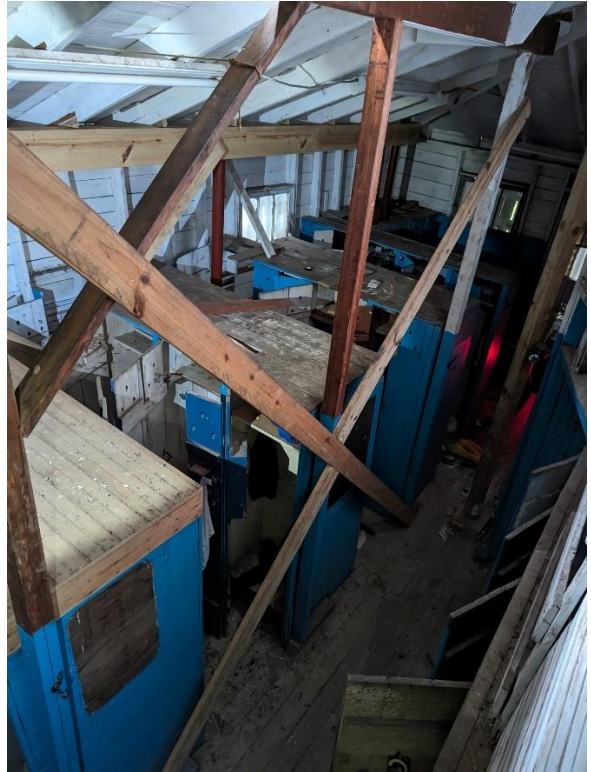
*Recommendation:  
See below*

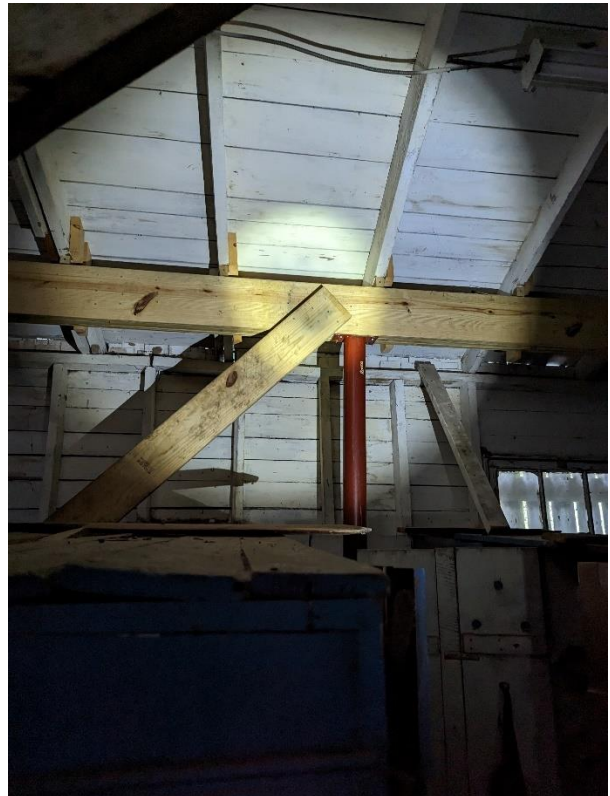
*Recommendation:  
See below*

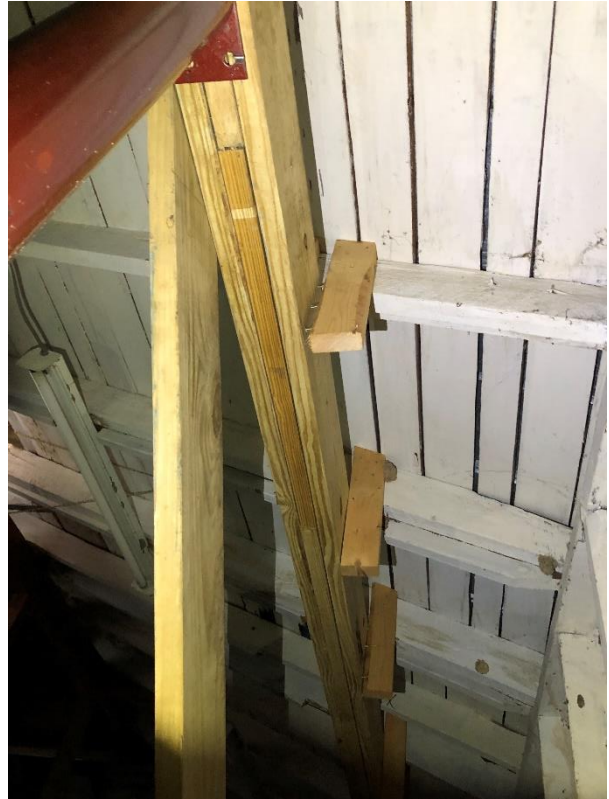
*Add additional blocking and fasteners to reinforce these connections.*

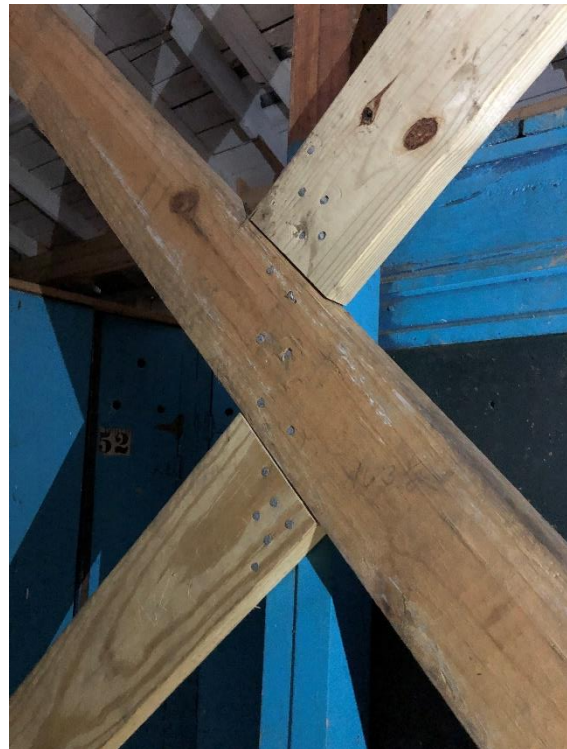
*Augment connections with light gage metal strapping fastened to the wood braces.*

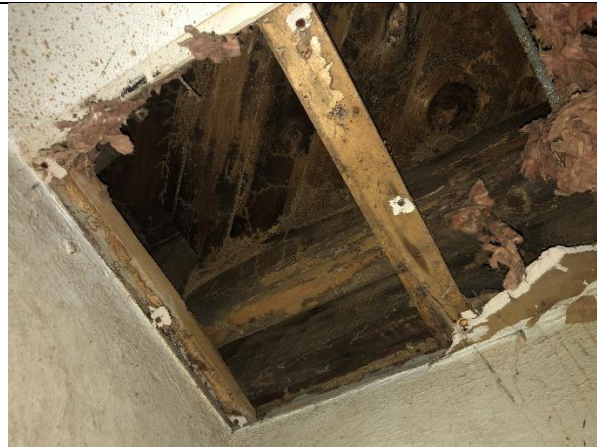
- *Sister new framing to the existing joists wherever the existing members show sectional loss.*
- *Assume some additional floor board replacement with new plywood.*

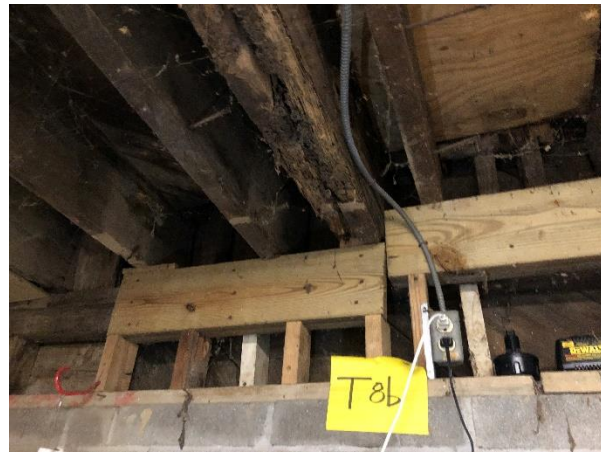
- *Sister new framing to the existing joists wherever the existing members show sectional loss.*
- *Assume some additional floor board replacement with new plywood.*

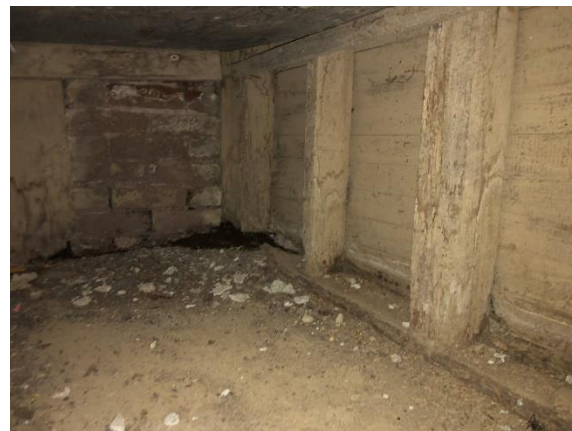
- *Replace the sill plate and sister new studs to the existing studs.*
- *Replacement sill material should be pressure treated wood or of a naturally rot resistant wood species. Anchors into the floor slab should be stainless steel.*
- *Sill replacement will require temporary shoring of floors or wall above area of repair.*

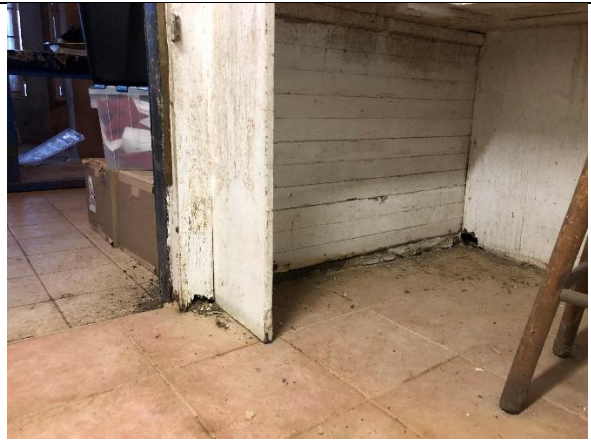
- *Lifting bearing walls. Because the highest settlements tend to be around the perimeter walls, which in turn tend to correspond to bearing walls below, lifting the floor supports in these areas would be similar to lifting the weight of structure from ground level up through the roof level, as we would be lifting a line of bearing wall. This is possible but more along the lines of larger scale lifting of portions of the building, with similar cost implications.*
- *Leveling of the floors at the finish level is*

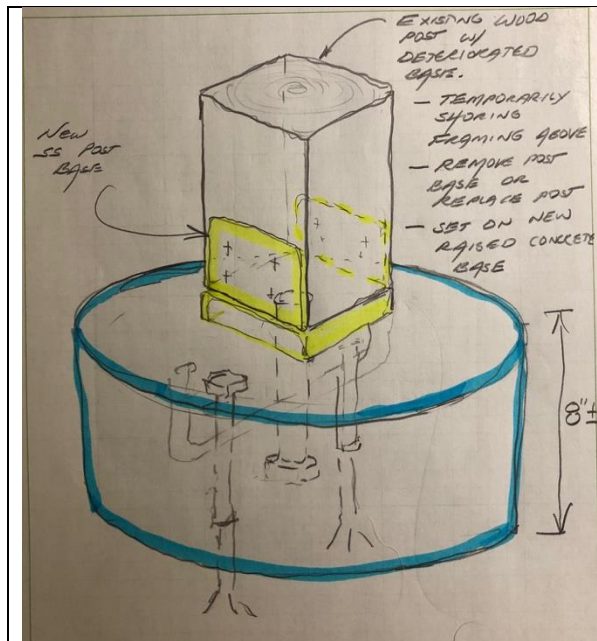
Figure 1: Wood post base repair concept

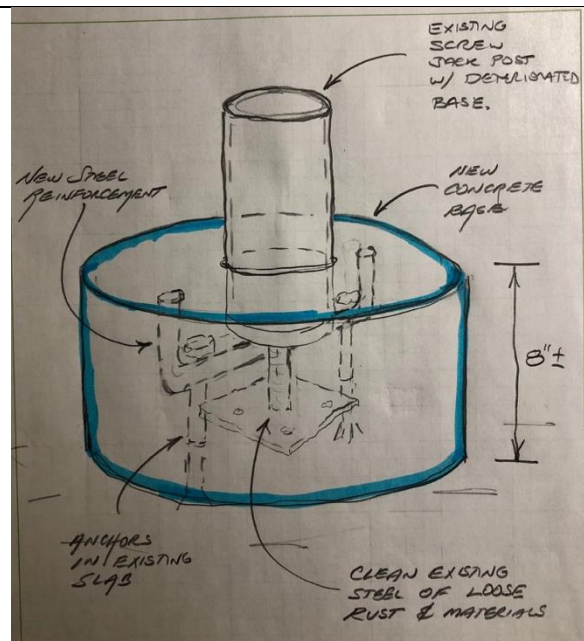
Figure 2: Steel post base repair concept

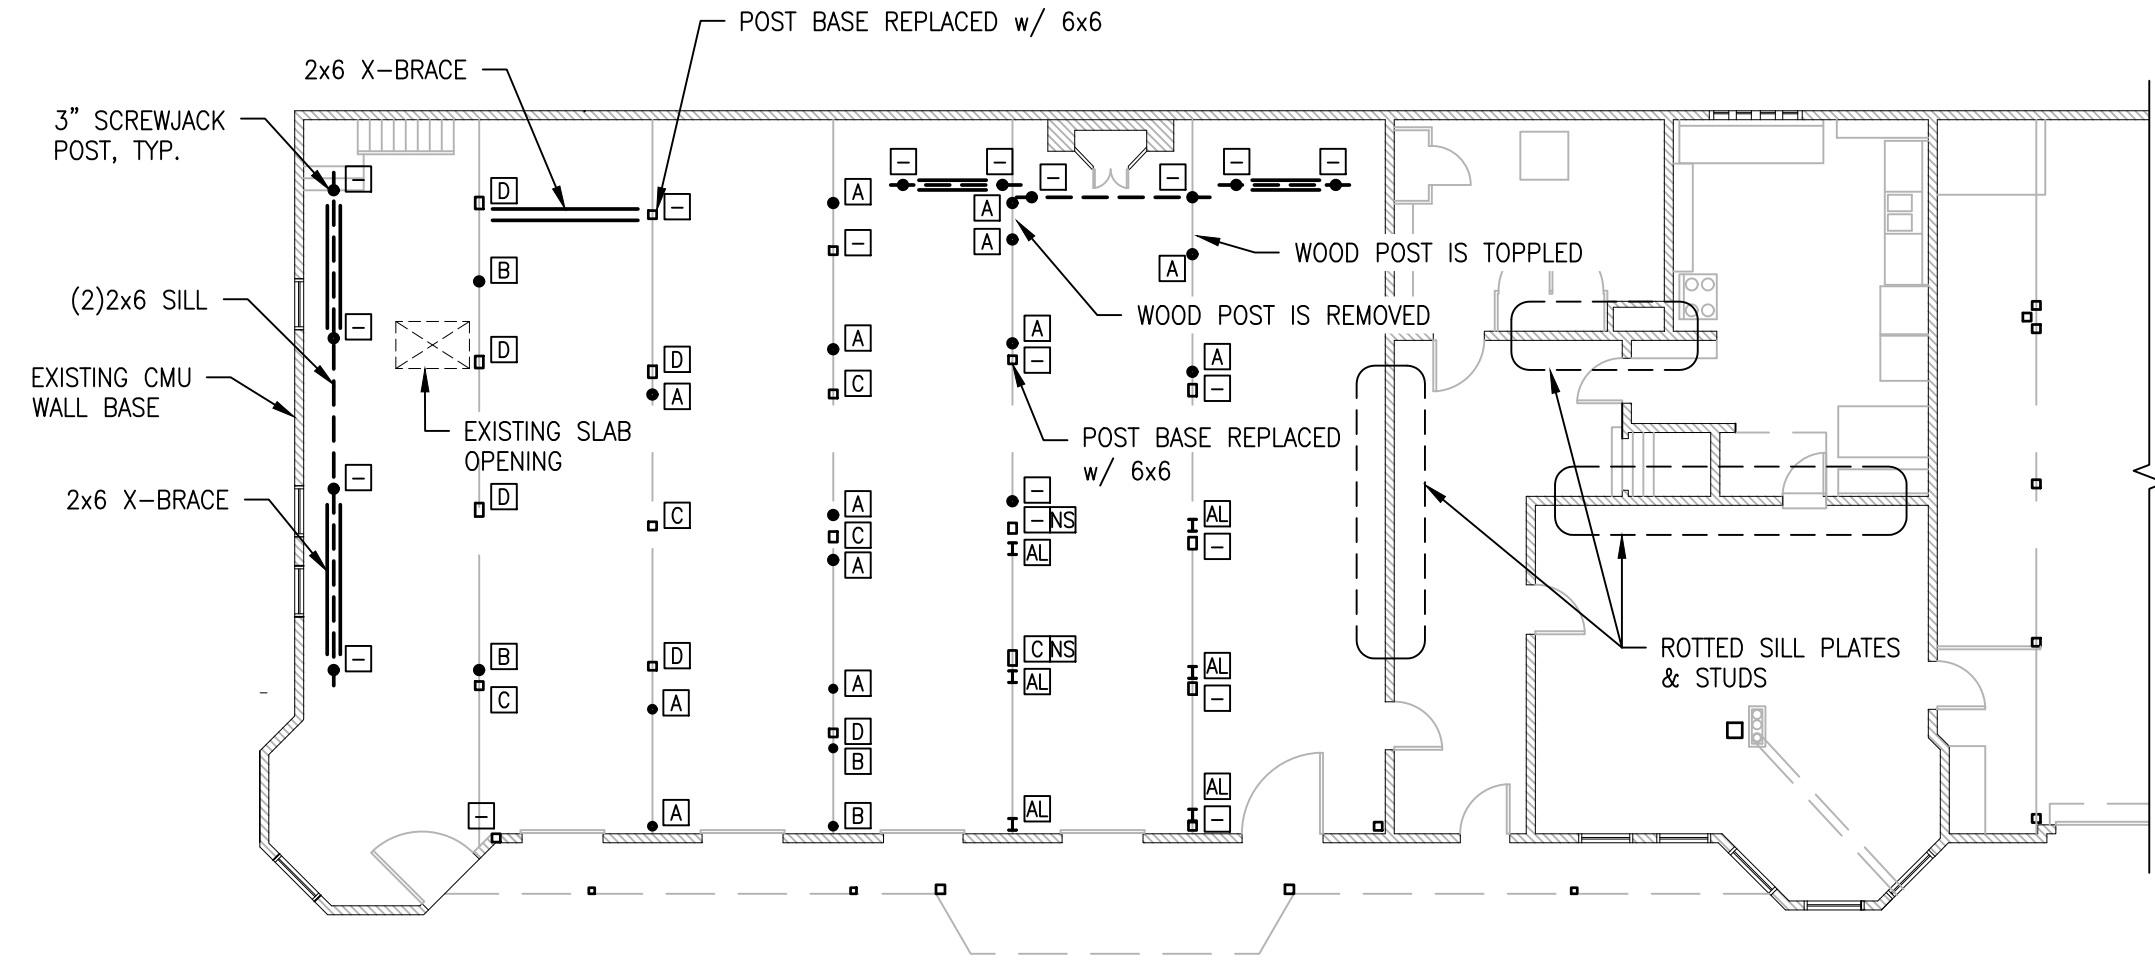
1 EXISTING LOWER LEVEL FOUNDATION PLAN  
 S100 SCALE: 3/32"=1'

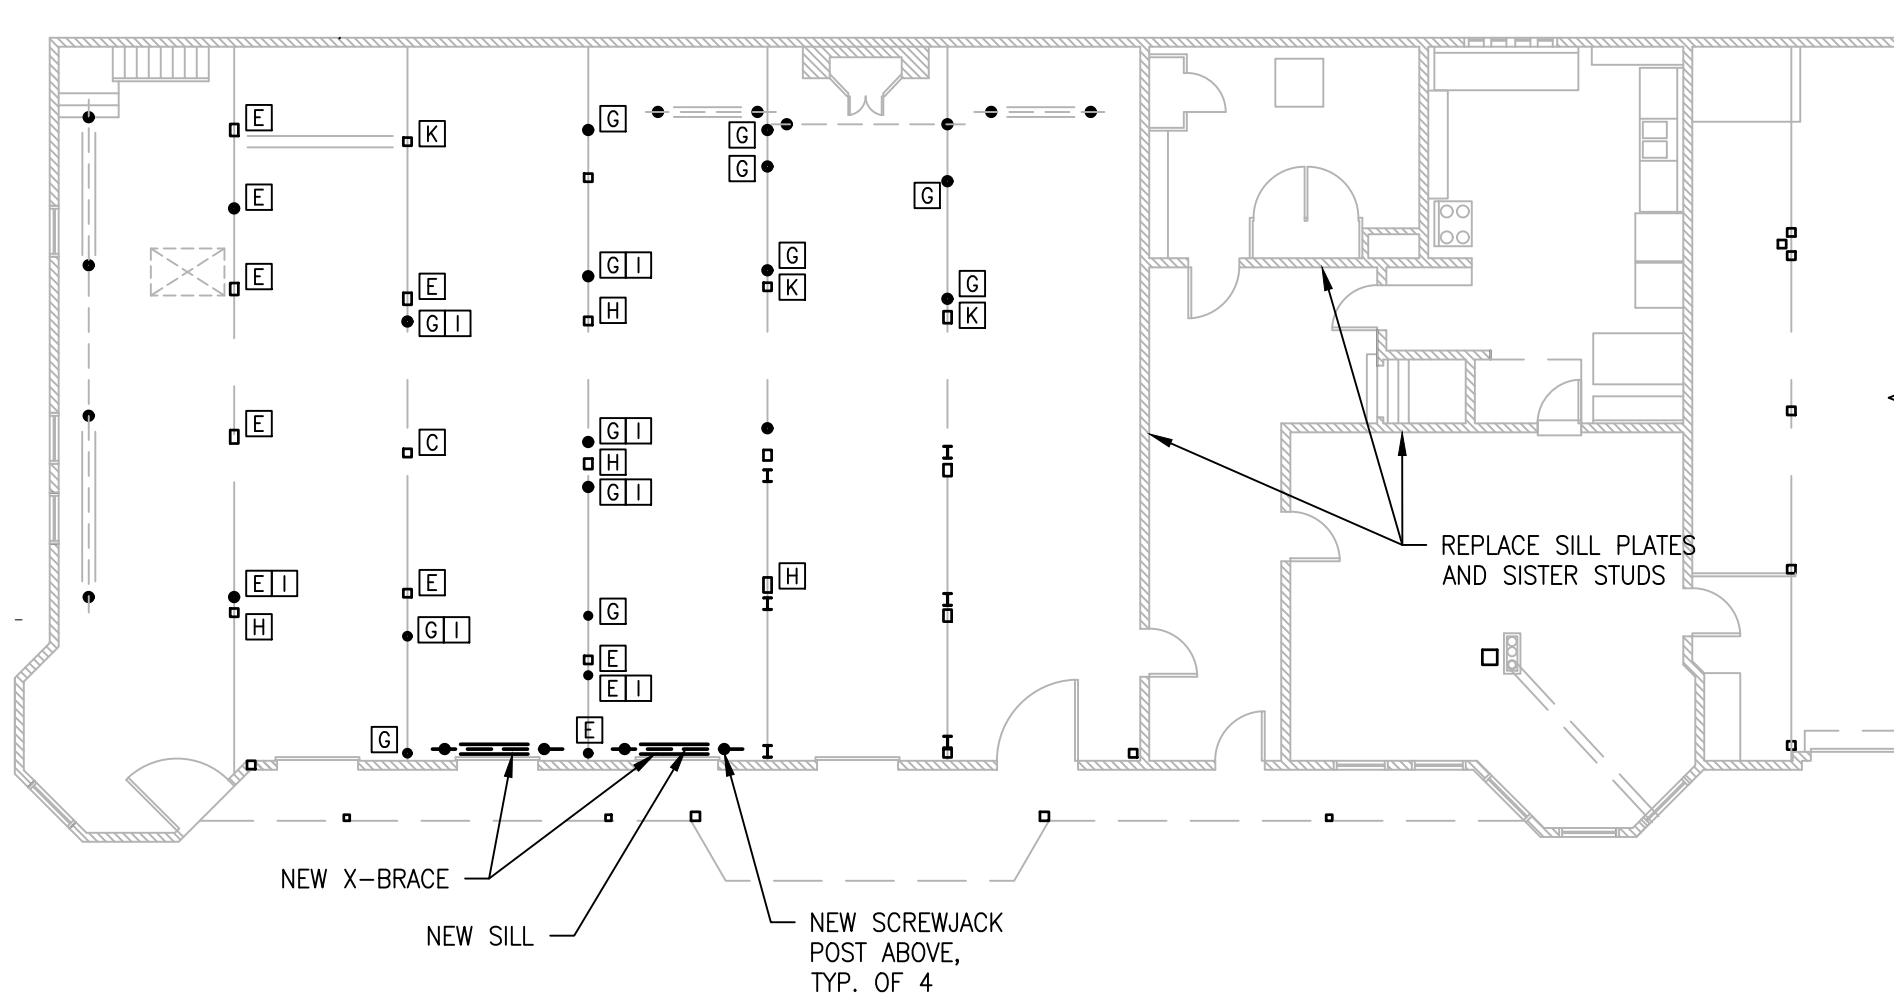
- [E] REPLACE MEMBER COMPLETELY WITH NEW RAISED BASE.
- [G] SCRAPE, PAINT, & ENCASE POST BASE IN CONCRETE, OR REPLACE.
- [H] CUT COLUMN BASE AND REPLACE WITH BEARING BLOCK OR CONCRETE PLINTH.
- [I] STEEL POST IMMEDIATELY ADJACENT TO FAILING WOOD COLUMN MAY BE REMOVED IF COLUMN IS REPLACED.
- [K] ADD ANCHORS TO EXISTING BEARING BLOCK INTO SLAB.

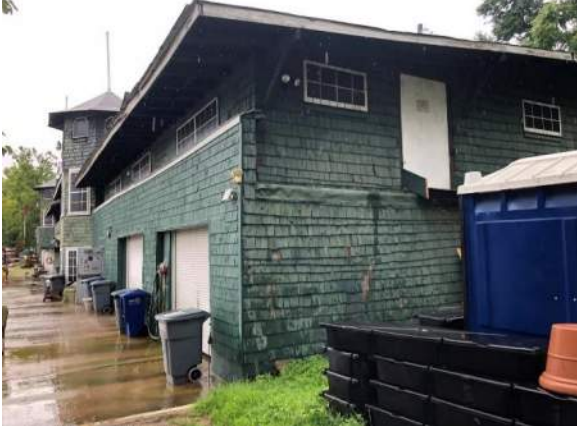
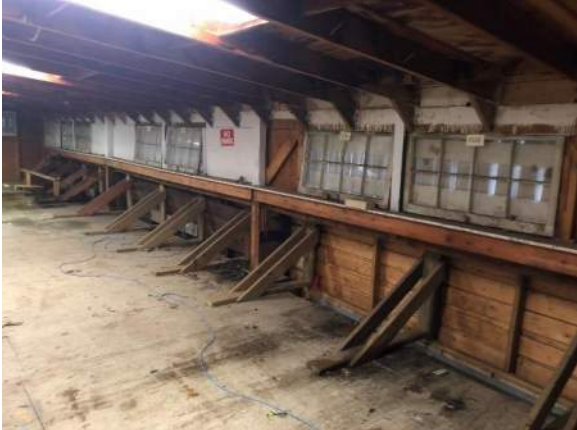
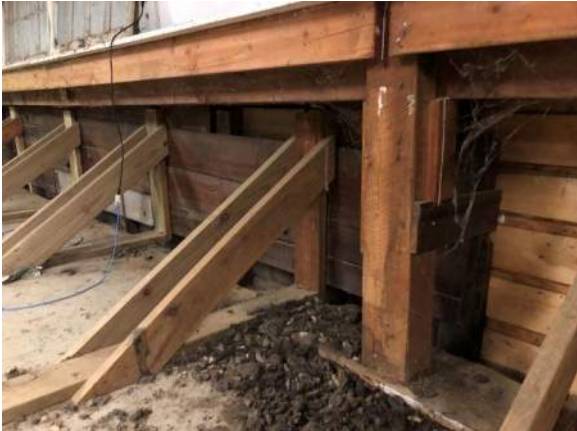
| OBSERVATIONS | IMAGES |

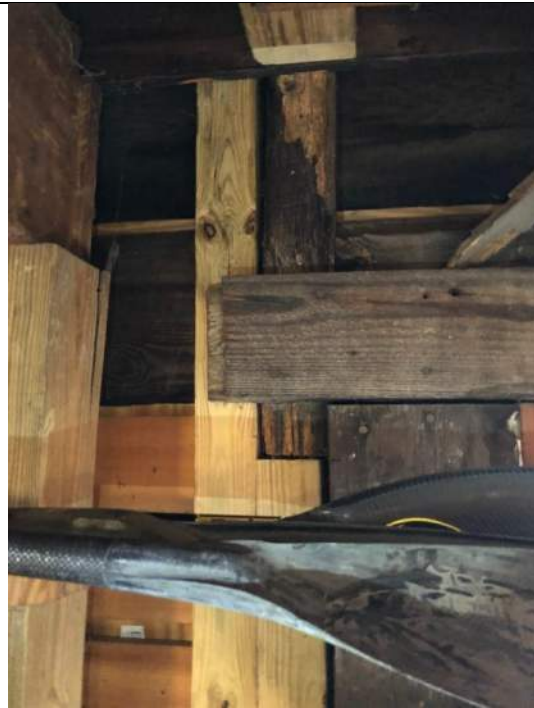
Photo #4: Replacement of historic wall studs of the south wall at 1<sup>st</sup> floor level

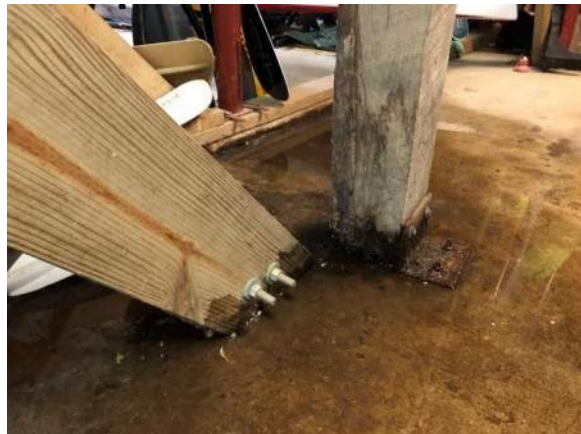
The shoring and bracing added in 2011 and 2012 extends down to the ground floor slab on grade, as depicted in the image. This level has been subjected to repeated moisture collection and the shoring and bracing is suffering from active deterioration at the connections. In general, water on the site migrates from the higher elevations to the north toward the river to the south, and has established pathways for penetration through the north foundation wall over time.

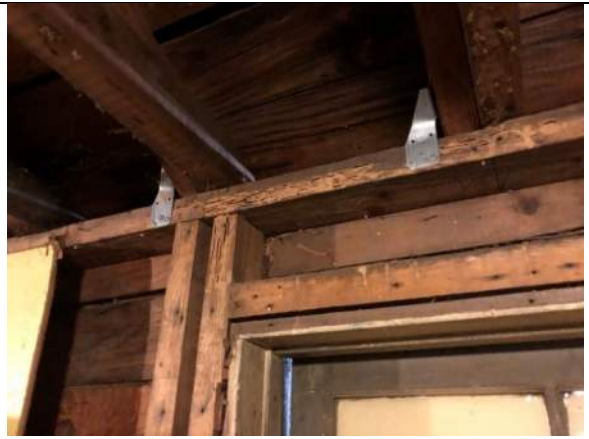
The photo depicts the north side of the 2<sup>nd</sup> floor intermediate wall along its top plate. A history of termite damage is apparent in lengths of the top plate and some studs. Newer hurricane ties have been added at the bearings of the small gabled roof over the Women's Locker Room, however some of these ties undoubtedly have reduced capacity where attached to deteriorated wood.

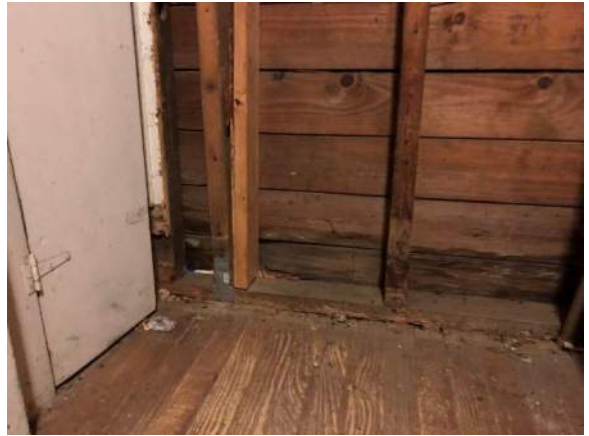
The photo depicts the north side of the 2<sup>nd</sup> floor intermediate wall along its bottom plate. A history of sustained water penetration is apparent in the plate and lower boards that were once exterior siding. Localized termite damage and selective reinforcement was also observed.

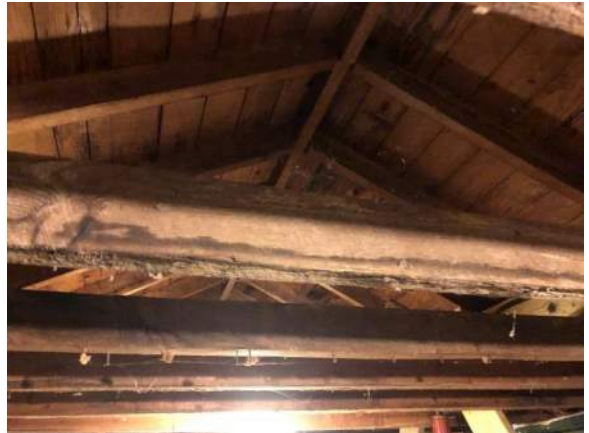
The tie connecting the bearings of the gabled roof rafters has suffered some water damage and material degradation. The roof structure above the Women's Locker Room appeared relatively intact for some portions, however the support conditions were typically heavily compromised structurally.

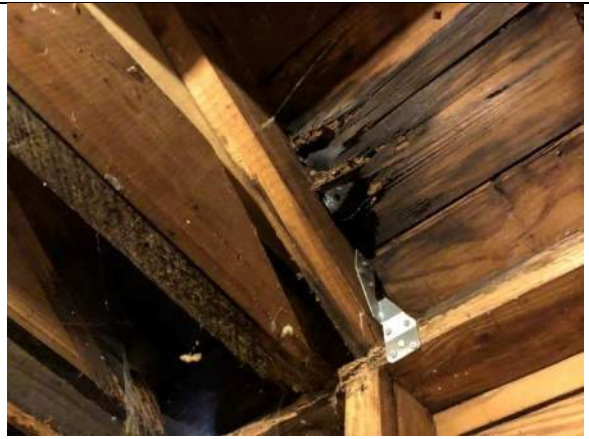
Areas of failed roof boards were noted, as well as some prior repairs of structural members. The modern hurricane tie observed here is fastened into a wood top plate that is now suffering material damage, apparently associated with the sustained water penetration from above.

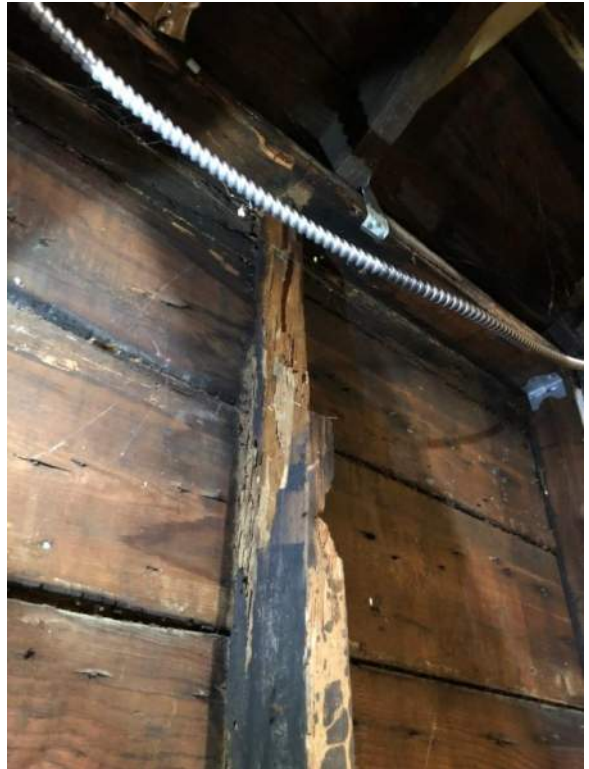
The 2<sup>nd</sup> floor north wall was observed to be severely deteriorated. This image is an example of a historic stud that was left in place that is now almost fully deteriorated from a combination of water penetration and termite damage.

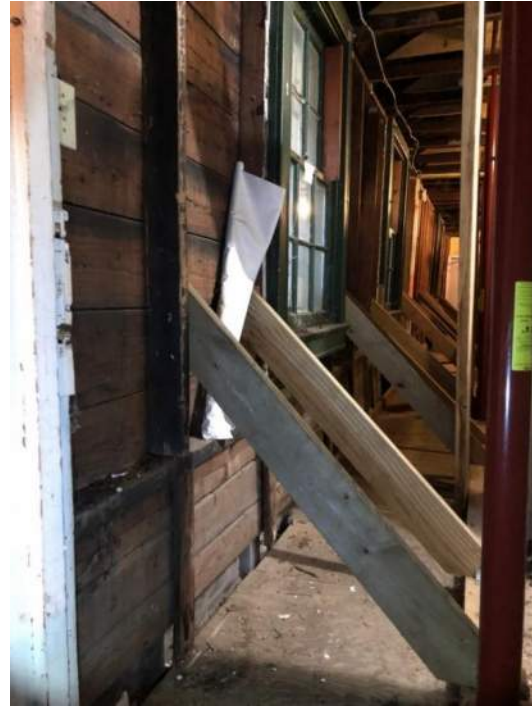
The line of shoring and bracing is offset to the south of the inside face of the north wall by approximately 2 to 3 feet. Similar to that observed at the south wall, diagonal wood kickers extend up the wall and tie into the floor level at the base of the shoring and bracing.

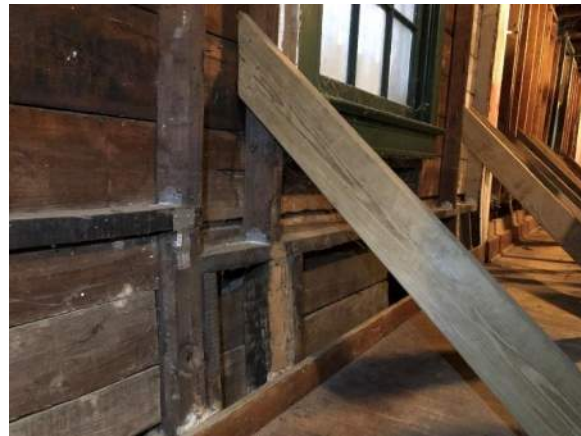
Also similar to the south wall, the extension of the 2<sup>nd</sup> floor wall at the north side was achieved by an additive construction that was inherently susceptible to lateral displacement and even failure because of the discontinuities in the framing. The discontinuity just above the 2<sup>nd</sup> floor level has formed a hinge and has displaced outward to the north. The 2011-2012 shoring and bracing have temporarily addressed this discontinuity and outward buckling with the addition of light-gage metal connection and regularly spaced diagonal bracing struts. In general the framing toward the west end of the Women's Locker Room was observed to be in better condition than that observed to the east, however some water and insect damage was clearly present.

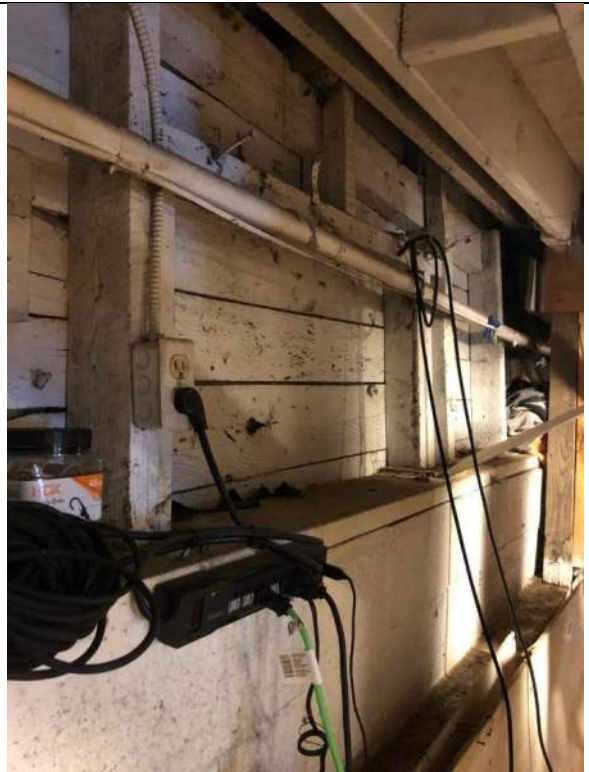
Following this relatively intact wall framing down to the 1<sup>st</sup> floor level, defining the north wall of what now functions as a Weight Room, the historic framing was observed to be relatively intact. However, the framing was typically constructed with a physical discontinuity, or structural hinge, between the top of masonry foundation and the 2<sup>nd</sup> floor framing. The historic studs bear on a modern sill plate and the foundation itself was comprised of modern concrete block for the upper portions, both of which are consistent with the likelihood that the bottom portion of the historic framing had been previously deteriorated and essentially replaced by extending the foundation upward with new cmu.

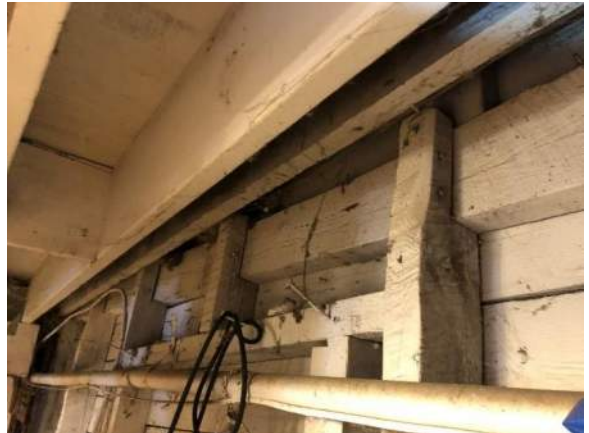
Image shows a discontinuity of the stud framing relative to the 2<sup>nd</sup> floor level, potentially created when the 2<sup>nd</sup> floor framing was fully replaced (note the modern wood framing running parallel to the north wall). A wall section depicting this portion of the north wall is represented in Figure #1 below. The presence of multiple structural hinges within the spanning portions of the walls between the diaphragms present at the roof, 2<sup>nd</sup> and ground levels creates a fundamentally weakened structural system. The wall structure is now comprised of a mix of historic and new material, all of which is very much reliant on the temporary shoring and bracing for support and stability.

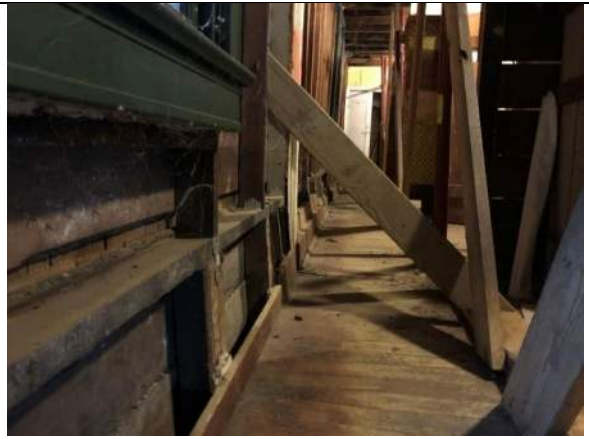
Further east along the north wall at the 2<sup>nd</sup> floor level, wood deterioration and outward buckling of the wall becomes more severe. Added metal fasteners now provide little benefit where connected into heavily deteriorated wood.

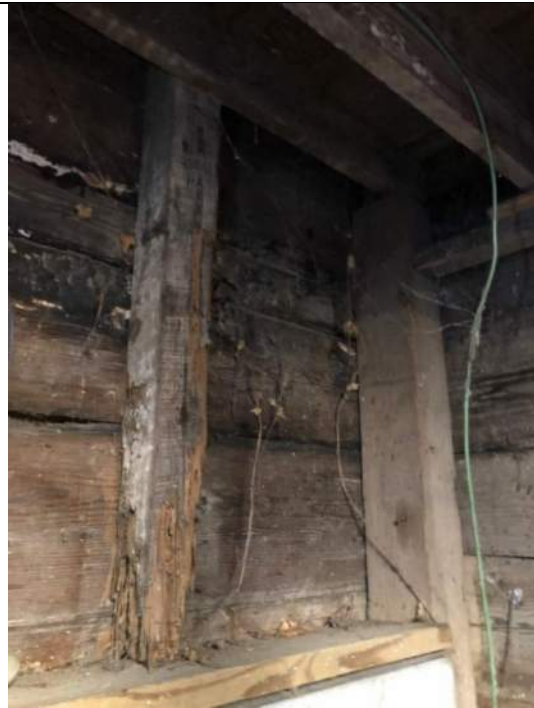
Areas of historic wood wall framing in the eastern portion of the north wall, at the 1<sup>st</sup> floor level, were observed to be significantly deteriorated. Typically, as noted for the western portion of this wall, the lowest level of the studs has been previously replaced with a new wood sill plate and cmu foundation wall set at a higher level. That history of wood deterioration has continued since that time, as both images show severe wood deterioration now extending up into what must have been more intact historic structural fabric when the earlier repairs were implemented.

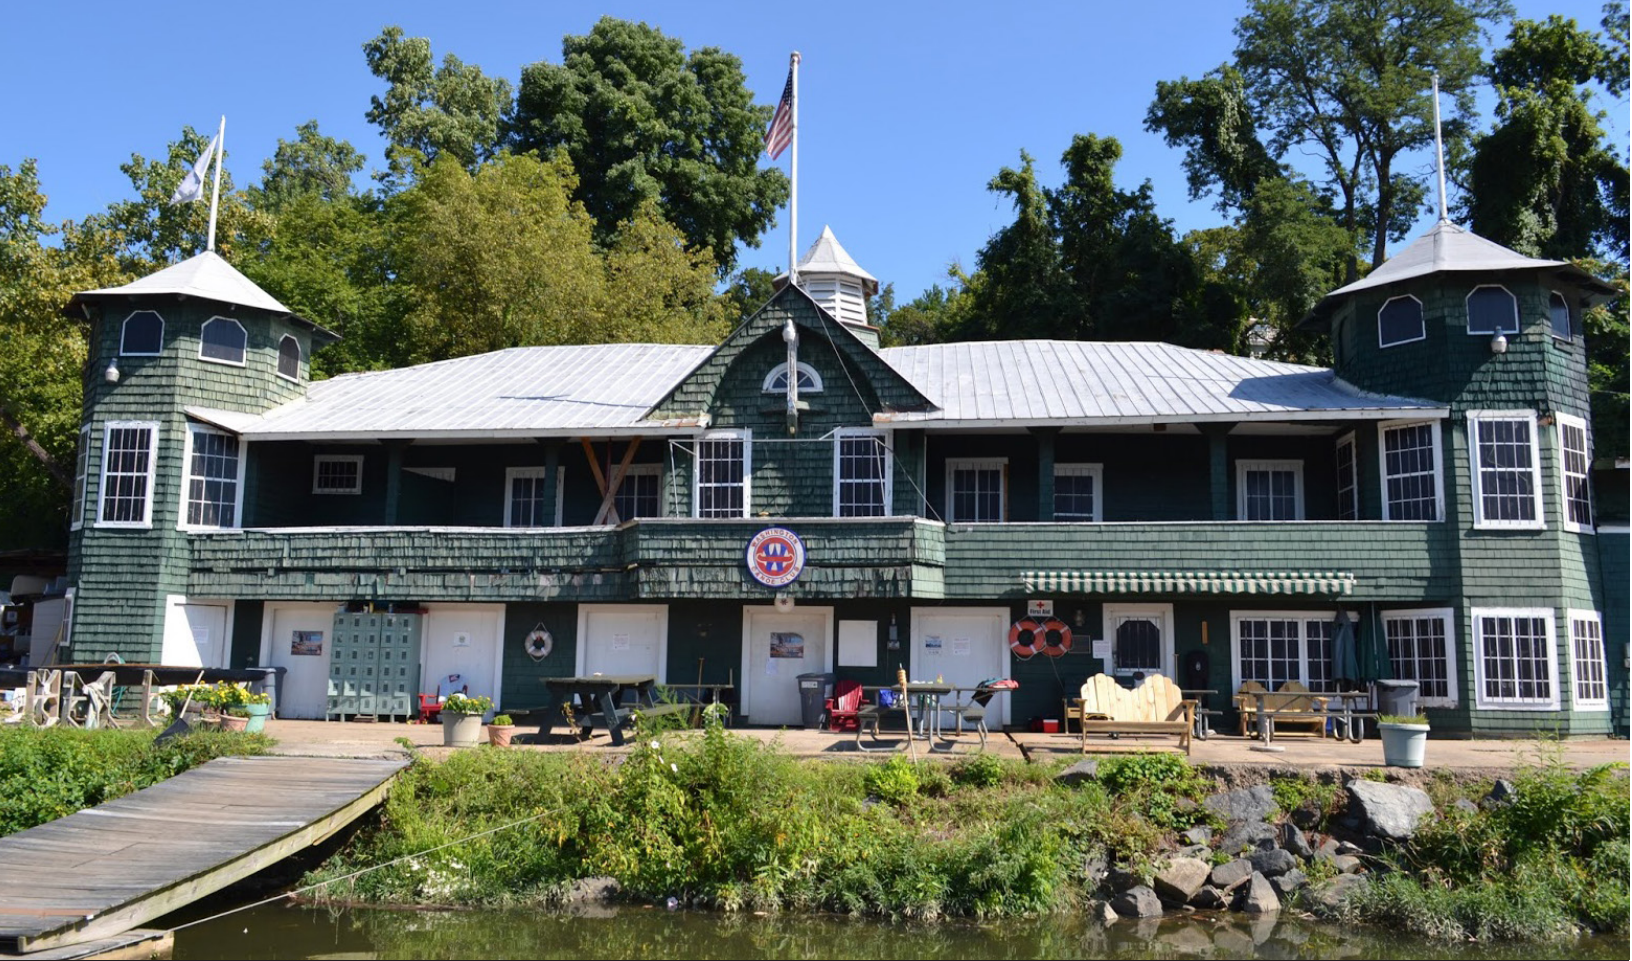
# WASHINGTON CANOE CLUB

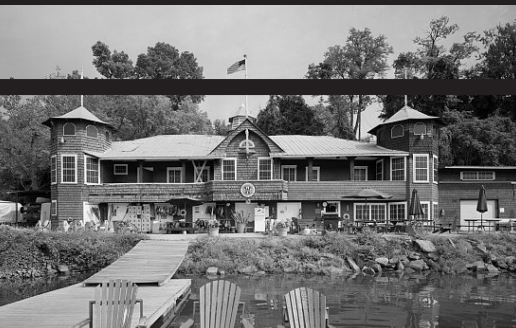
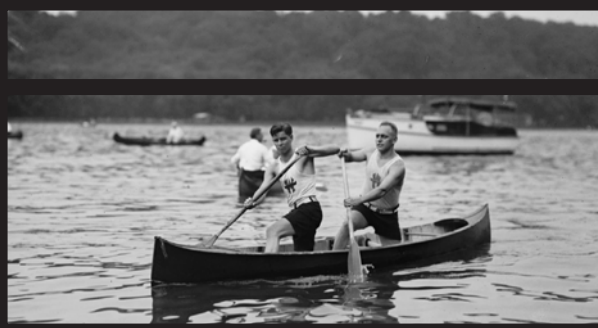
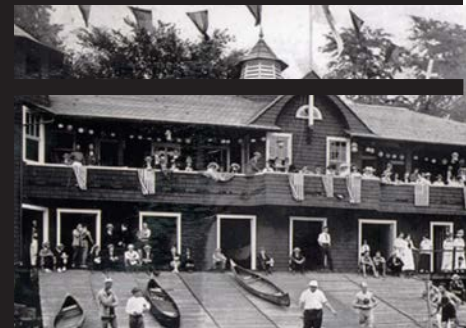
EHT TRACERIES, INC.  
PREPARED FOR WASHINGTON CANOE CLUB

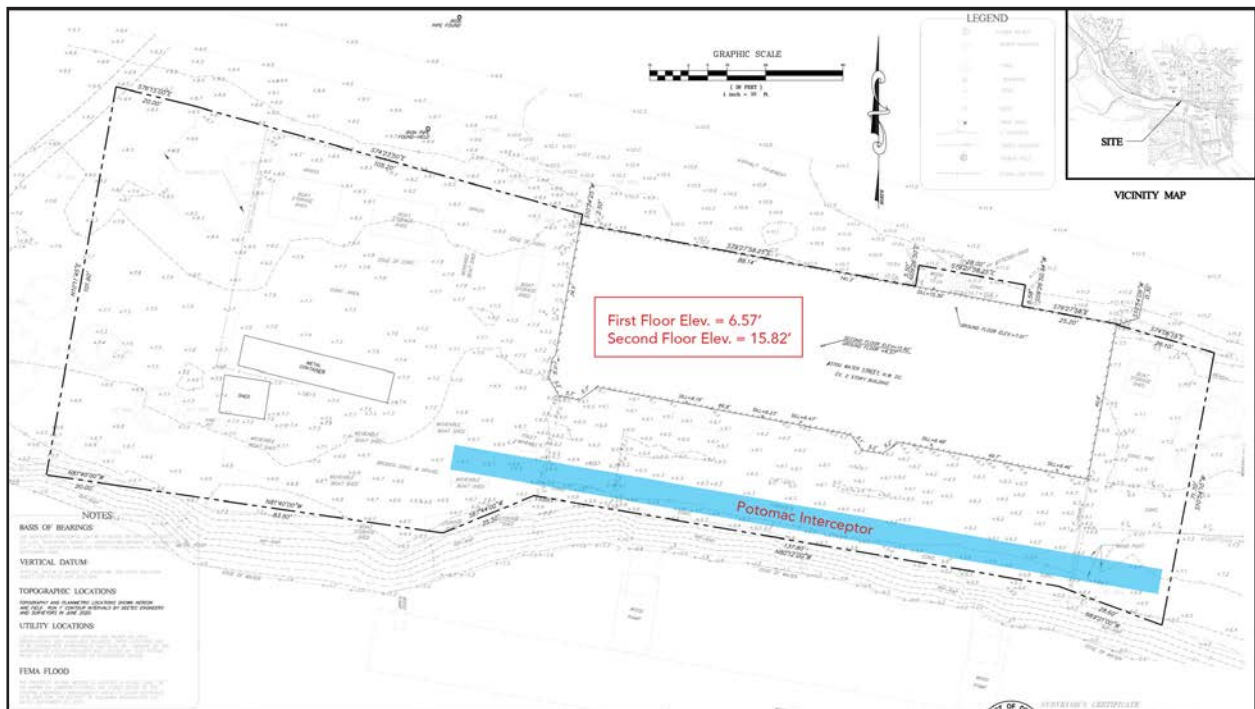
FIGURE 02 Topographic Survey of the Washington Canoe Club. Deetec Engineers and Surveyors, June 2020.

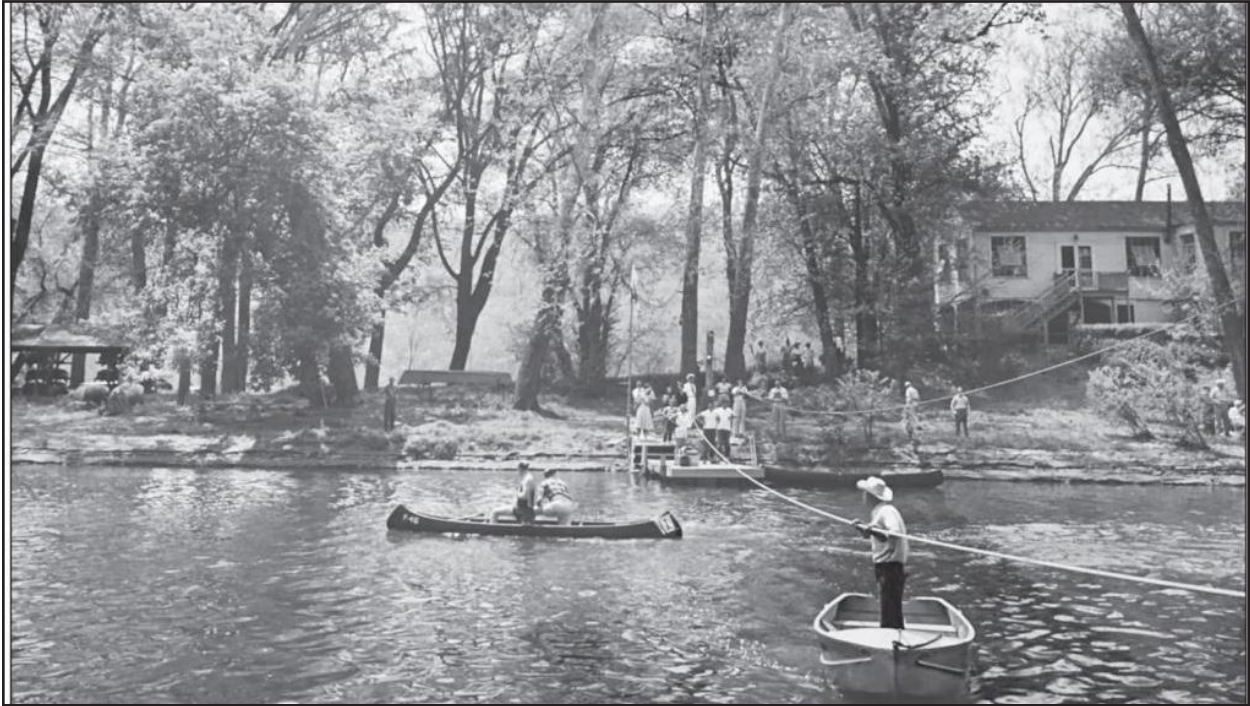
**FIGURE 03** The Sycamore Island Canoe Club as it appeared in the mid-twentieth century. Founded in 1885, the club is located on the Potomac several miles upriver from Washington DC and the Washington Canoe Club. Christopher Brown, *Washington Canoe Club*.

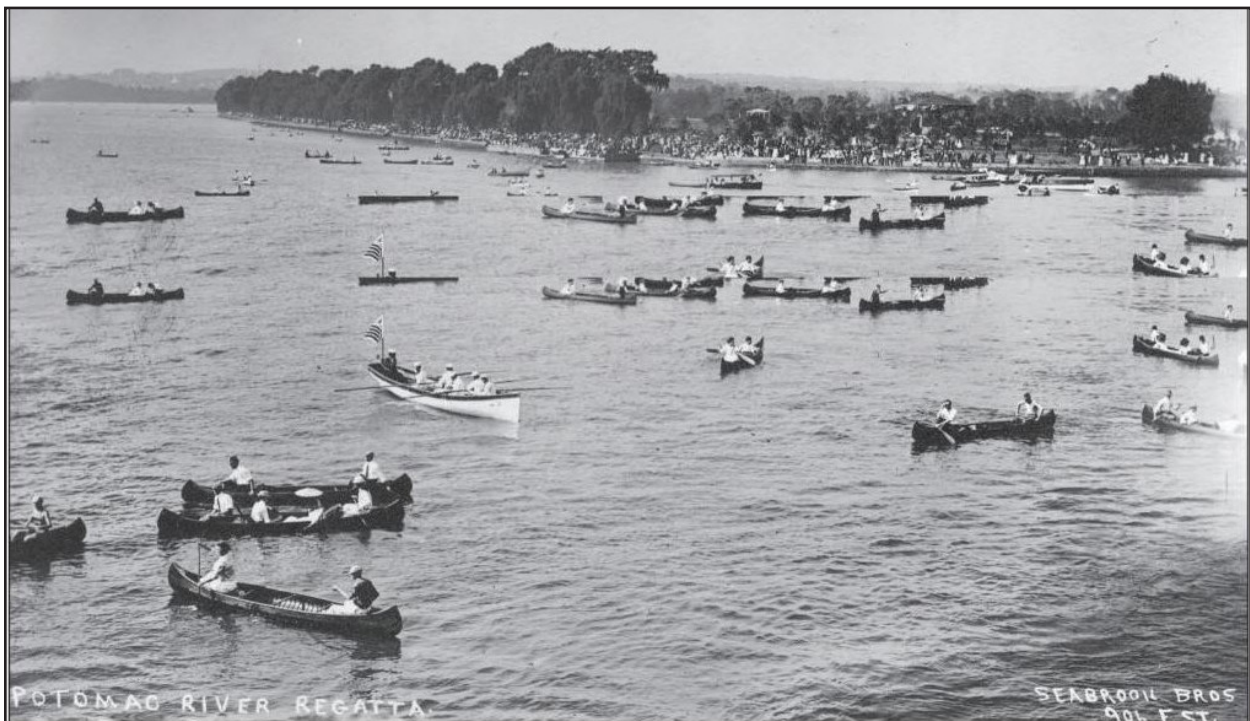
**FIGURE 04** 1900s postcard of the Potomac River near Haines Point showing people in canoes and small boats enjoying the water. Christopher Brown, *Washington Canoe Club*.

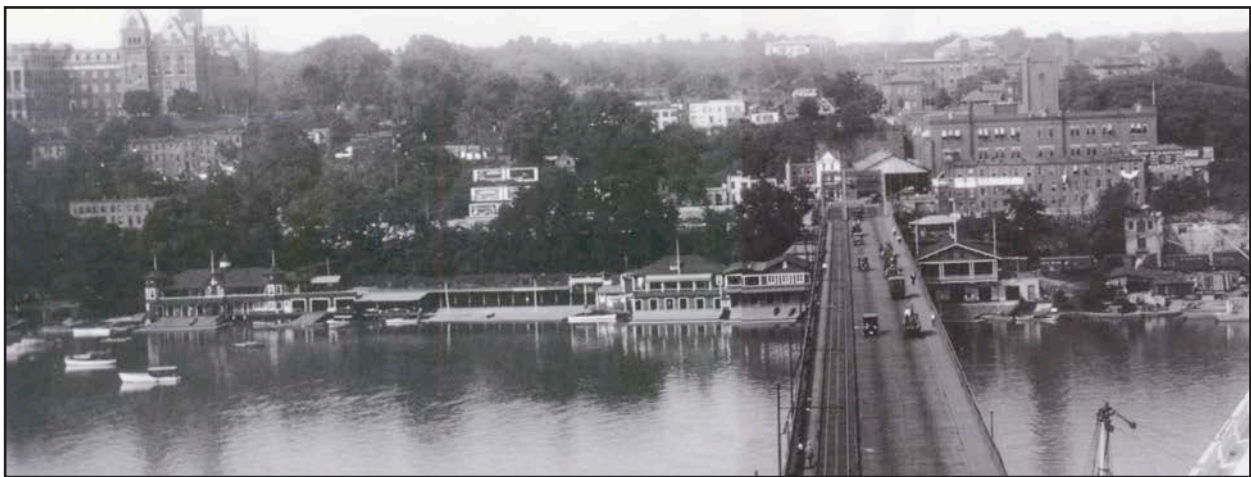
**FIGURE 06** Image taken from Virginia looking north to the western end of the crowded Georgetown waterfront. The Washington Club is located at the left end of this image, seen between the one-story shed belonging to Dempsey's Boathouse to the east and several smaller sheds to the west, 2 September 1922. The Potomac Boat Club is visible directly to the east of Aqueduct Bridge. The People's Archive at the DC Public Library.

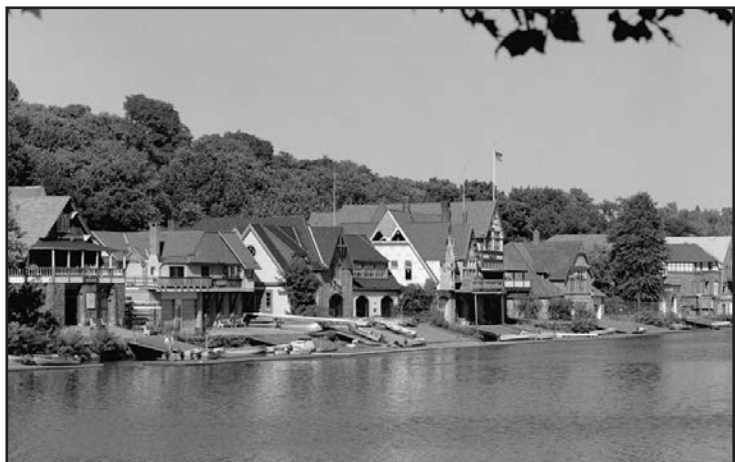
FIGURE 07 Boathouse Row along the west bank of the Schuylkill River in Philadelphia, undated. Library of Congress.

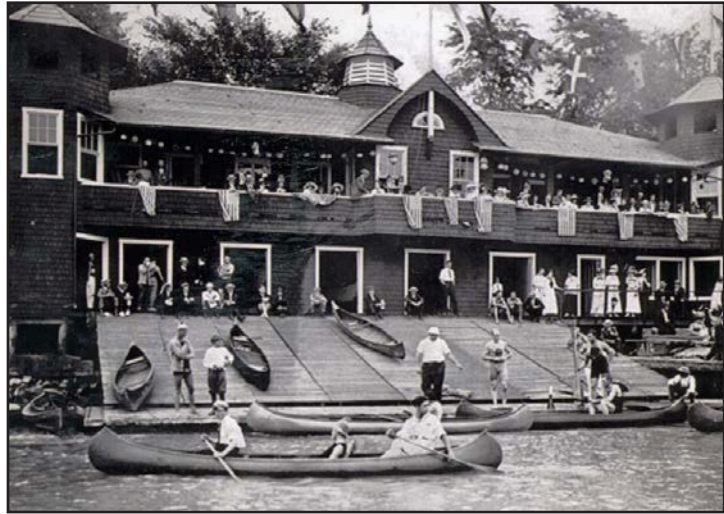
**FIGURE 08** Washington Canoe Club outfitted for a regatta, c. 1920. Brown, *Washington Canoe Club*.
