1200 Architectural Engineers PLLC

EHT Traceries Historic Preservation

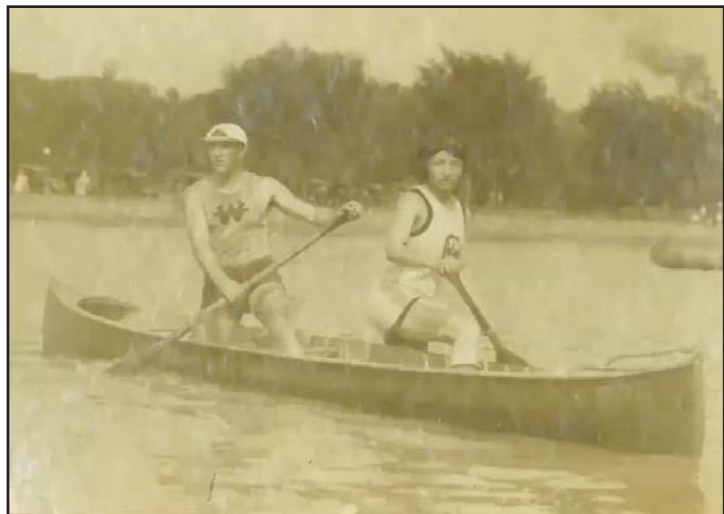
**FIGURE 09** Photograph of Harry Knight, Jr. (future Olympian) and Elizabeth Smith competing in a Mixed Tandem race for the Washington Canoe Club, c. 1921. Washington Canoe Club.

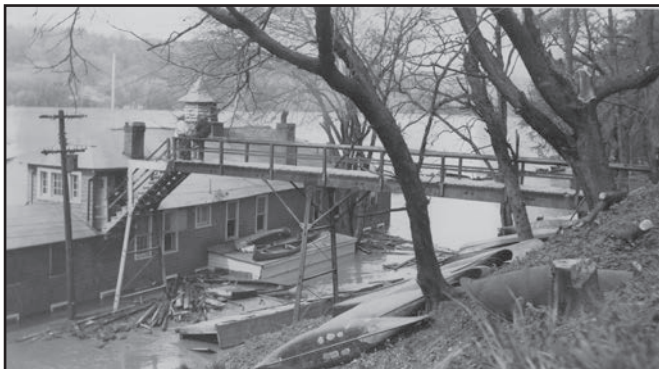
**FIGURE 19** Catwalk bridge leading from C&O Canal towpath to entrance within tower at the north elevation, looking southwest, 1936. The elevated entrance comprised of double wood-panel doors with glazing. Note attached shed off of the northern elevation, as well as the openings at the first story level. Also note that by this time, the roof shingles had been replaced with some sort of composite. William "Dusty" Rhodes family

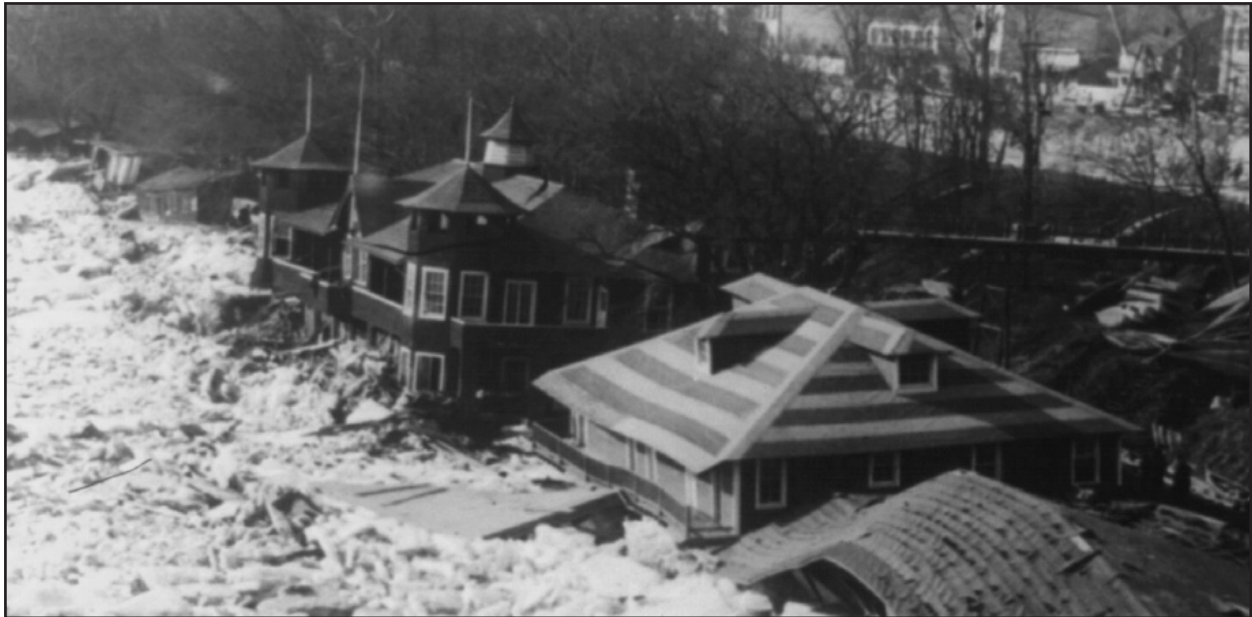
**FIGURE 20** Bird's-eye view of the boathouses along the Potomac River damaged by the ice jam, February 1918. Library of Congress.

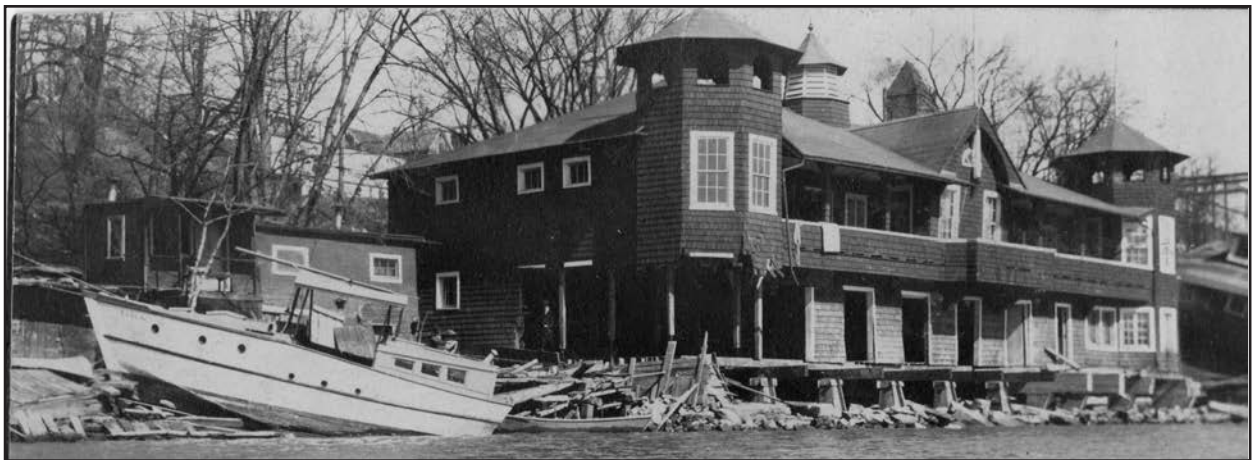
**FIGURE 21** The west boat storage area sustained significant damage after a motor boat drove into the building during a flooding event, n.d. Brown, *Washington Canoe Club*.

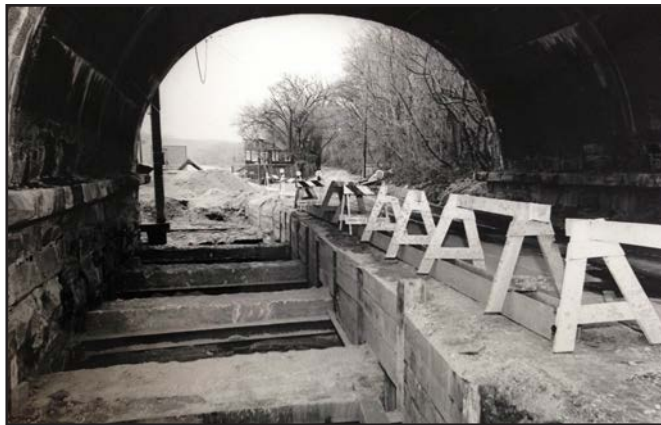
**FIGURE 26** Installation of Potomac Inceptor Sewer Line, looking west, .c. 1965. Washington Canoe Club.

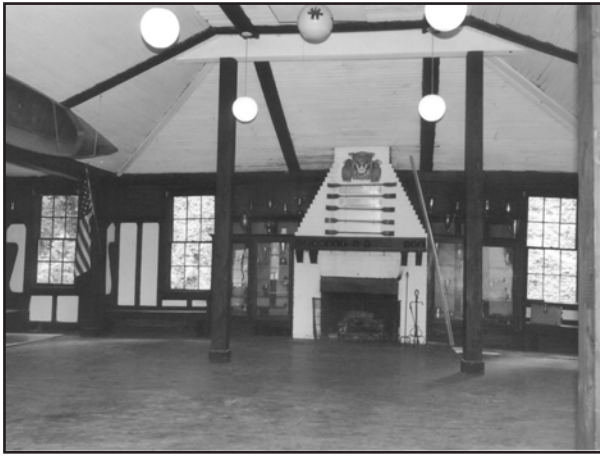
**FIGURE 33** North Wall of Ballroom. NRHP, Office of Betty Bird, August 27, 1989.

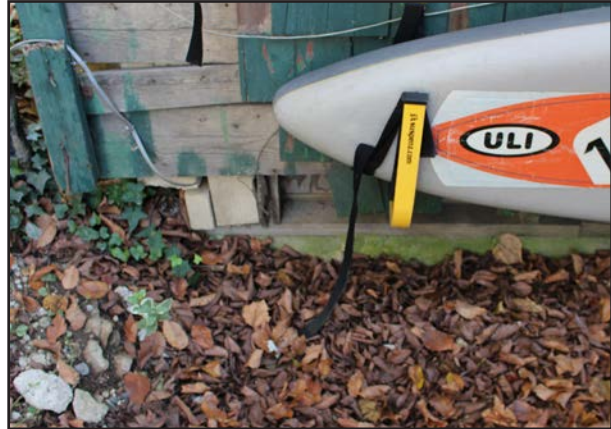
**FIGURE 43** Excavation at northwest corner of the building reveals lack of waterproofing and drainage system at the foundation area.

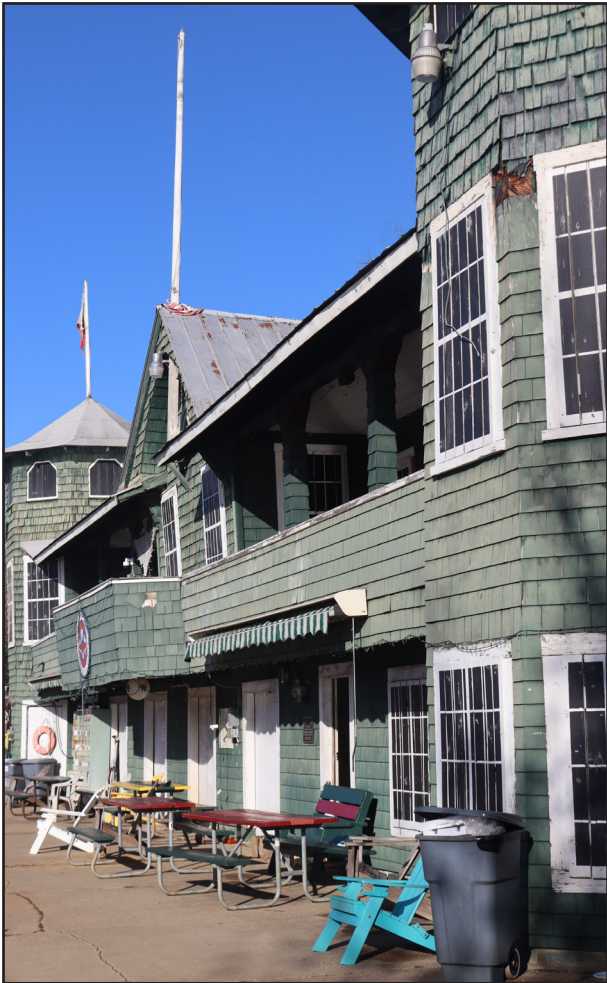
FIGURE 48 Green painted wood shingle siding with white trim on south elevation. Areas of replacement and missing shingle evident. Note that the balcony structure is leaning away from the building.

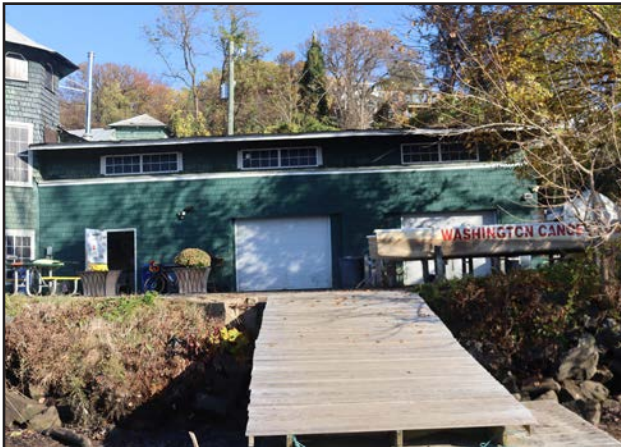
FIGURE 49 Newer shingles on south elevation of east bay.

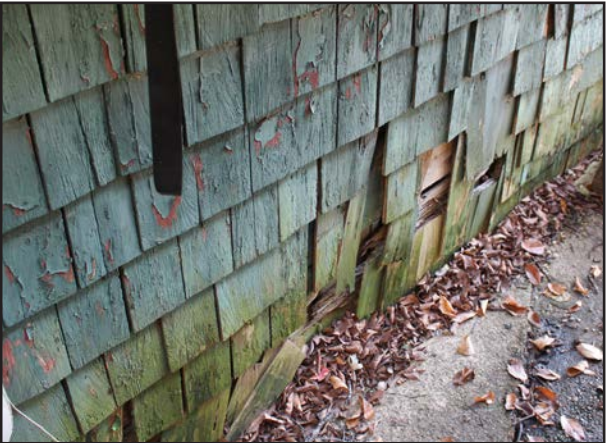
FIGURE 51 Detailing of weathered, cracked, missing, and dislodged shingles on the west elevation. Mold visible. Red paint (possibly original) exposed.

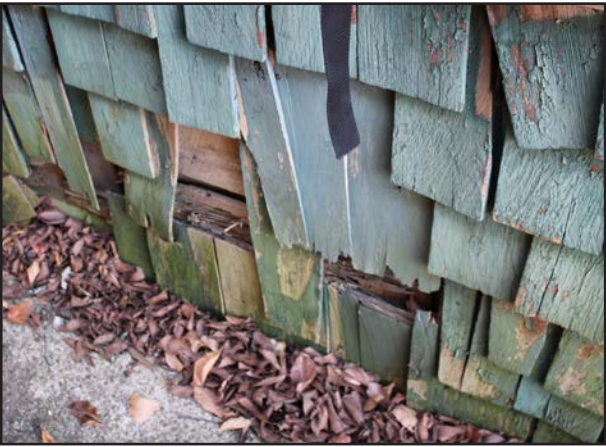
FIGURE 52 Detailing of weathered, cracked, missing, and dislodged shingles on the west elevation.

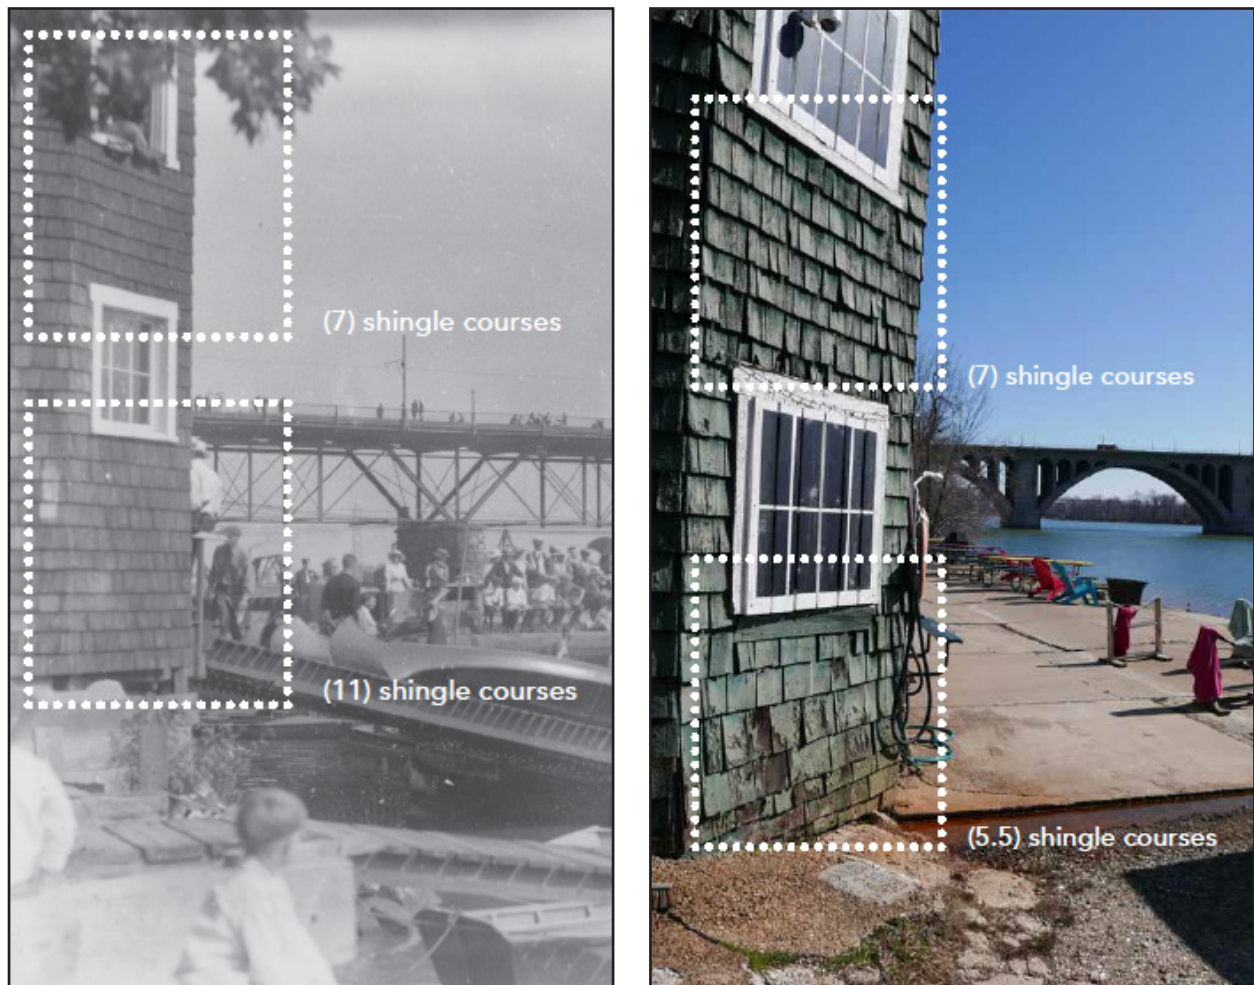
**FIGURE 53** Image on left, dated c. 1910 compared to image on the right, dated c. 2020, provides evidence that the building's relationship to the ground has changed since its initial construction. Cox Graae + Spack, 2020.

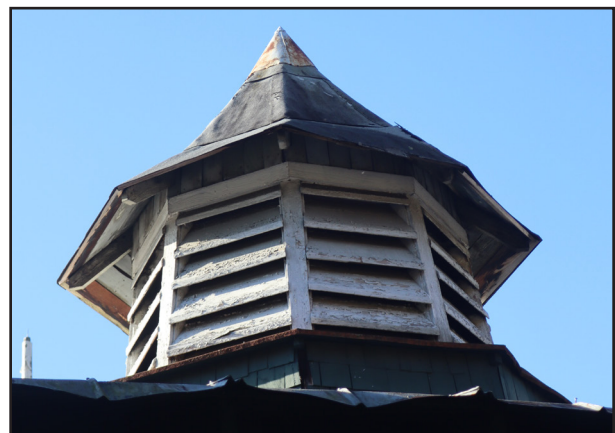
FIGURE 54 . Detail of deteriorated wood louver panels.

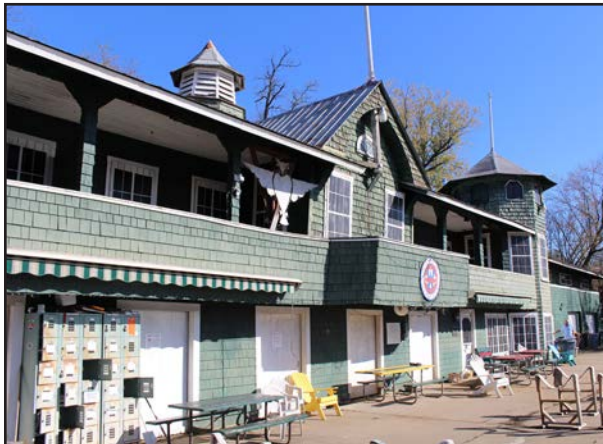
FIGURE 55 Balcony, looking northeast.

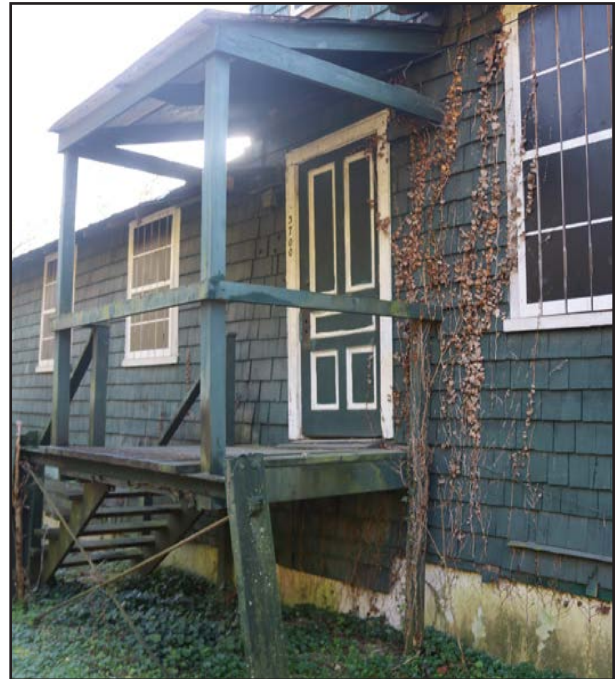
FIGURE 59 Porch sheltering north entrance.

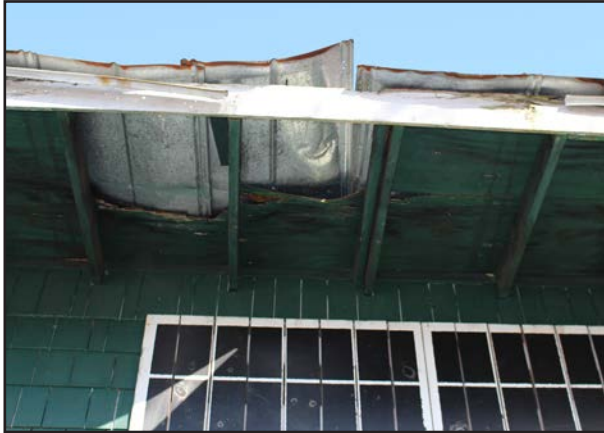
FIGURE 62 Detail of exposed sheathing and missing wood.

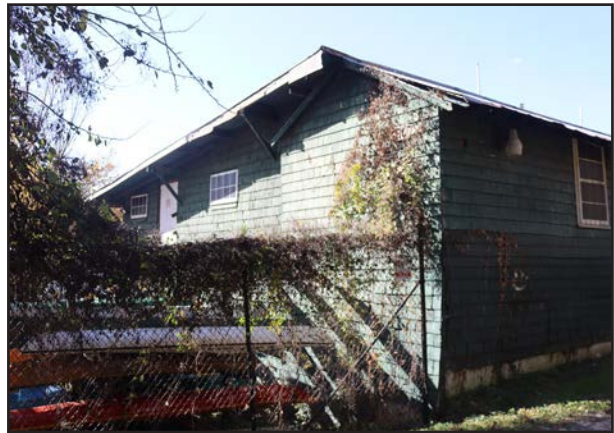
FIGURE 63 Shed roof enclosure of southern portion of East Storage Bay overlapping gable roof of Ladies Locker Room.

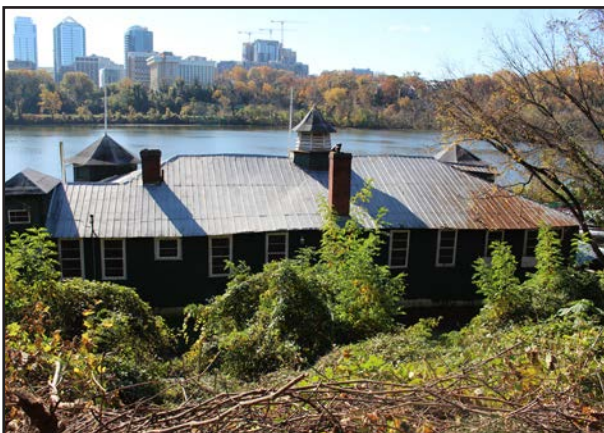
FIGURE 65 Roof on north elevation, looking south from C&O Canal toepath. Extensive rusting visible at northwest corner of the building.

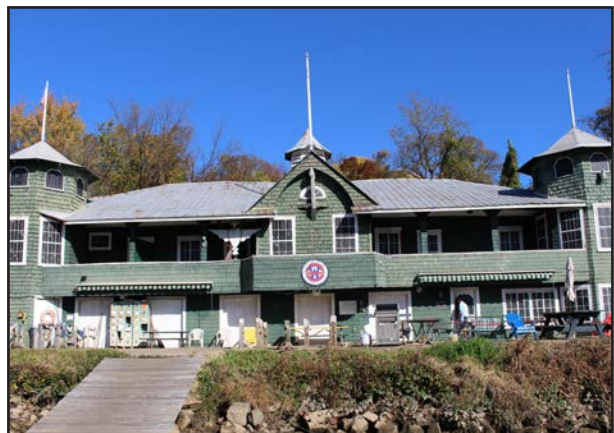
FIGURE 66 Roof on south elevation, looking north floating dock. Extensive rusting visible.

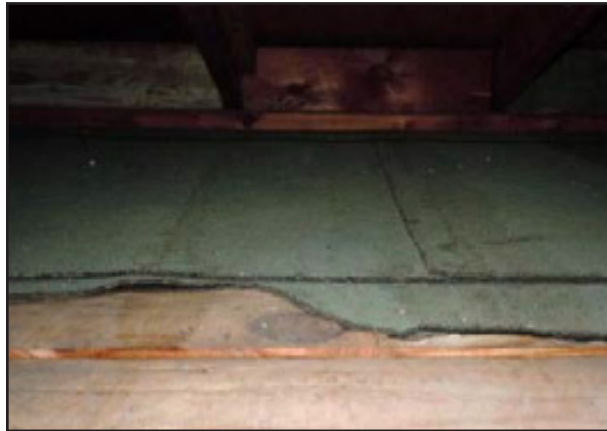
**FIGURE 67** South portion of Women's Locker Room clad in green-tinted mineral surfaced roll roofing material installed above plywood substrate visible as seen from Workshop.

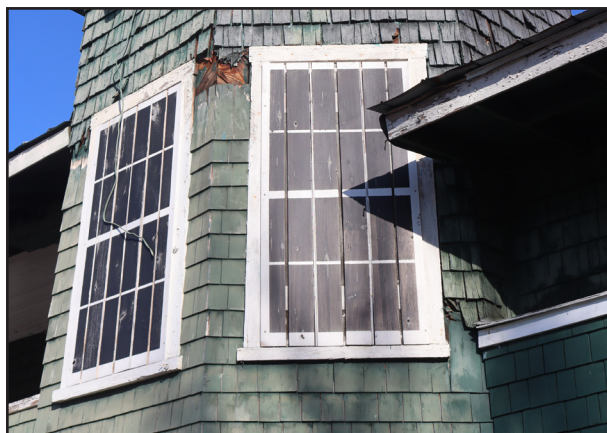
**FIGURE 68** Exterior view of second floor Board Room with painted mothball panels attached.

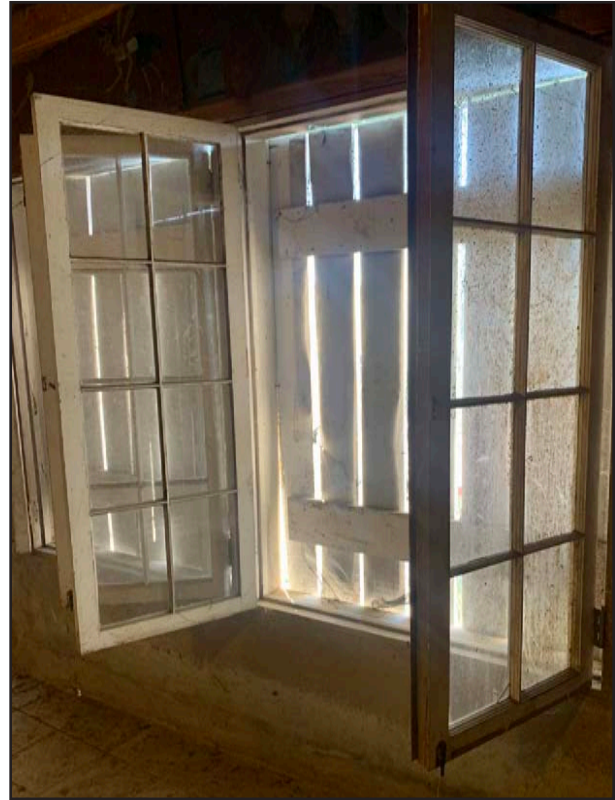
FIGURE 72 Windows in Grill Room, looking south. Windows are in fair condition.

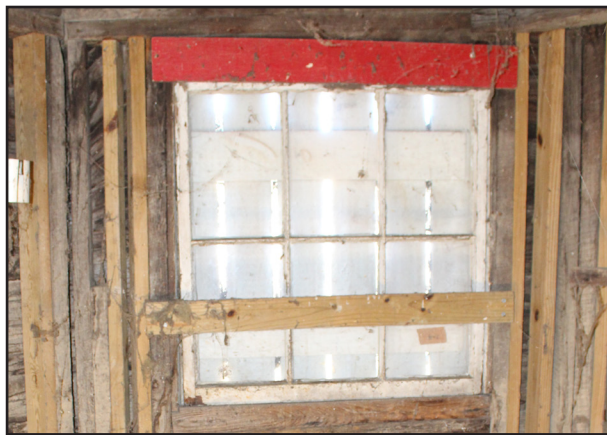
FIGURE 70 Detail of window in West Boat Storage Area.

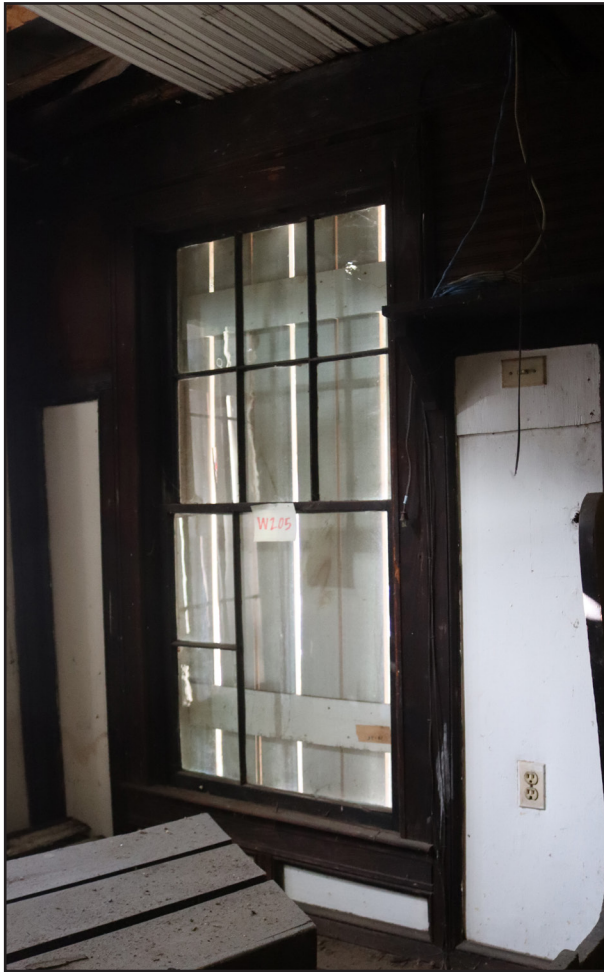
FIGURE 73 Typical double-hung window in Ballroom around the stage. This particular example has missing muntins.

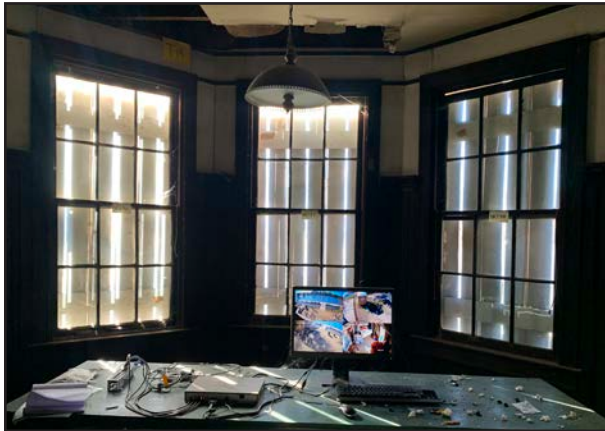
FIGURE 74 Six-over-six windows in Board Room.

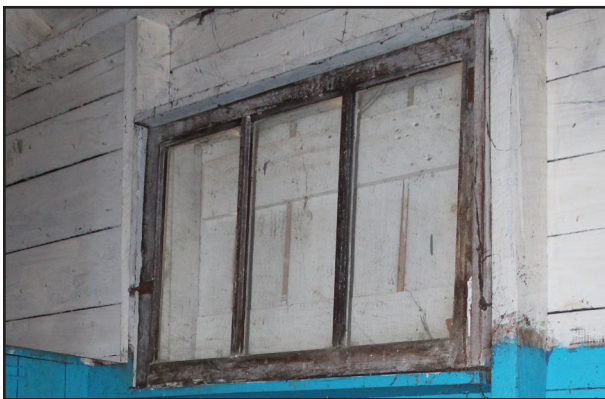
FIGURE 76 Three-light hopper window in the Men's Locker Room.

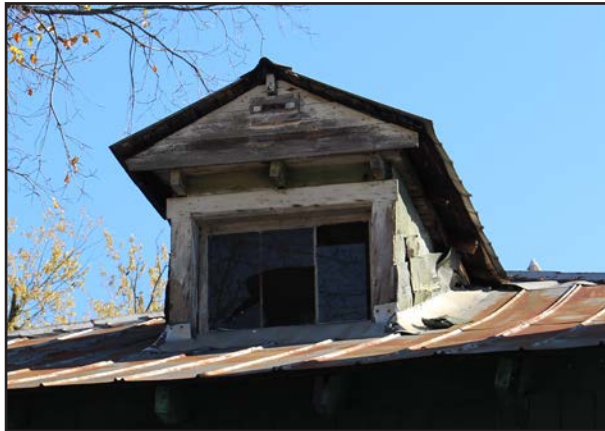
FIGURE 77 . Detail of deteriorated dormer.

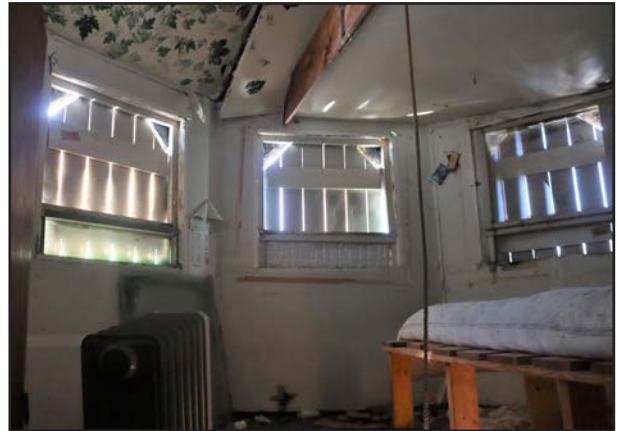
FIGURE 78 Windows in upper level of west tower.

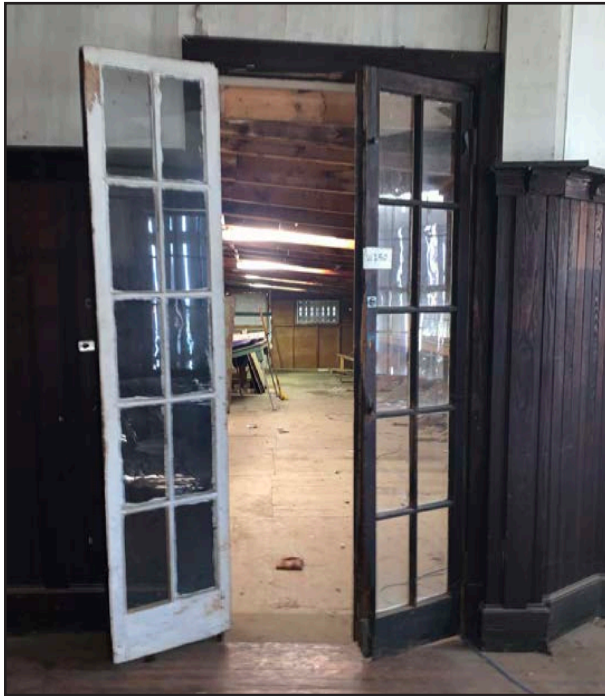
**FIGURE 79** Eight-light double door leading from Board Room to Workshop.

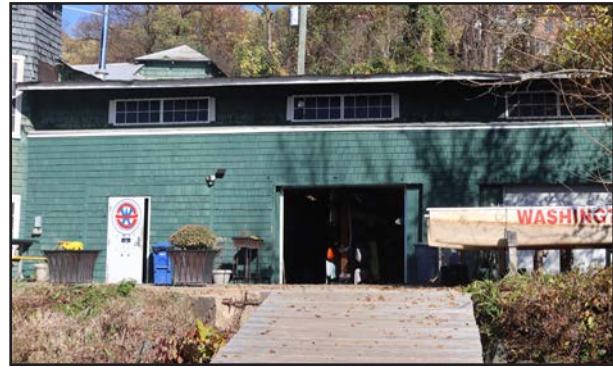
**FIGURE 85** Openings of south side of East Boat Storage Area. The eastern and middle bay feature metal roll-up doors; the western bay has been infilled.

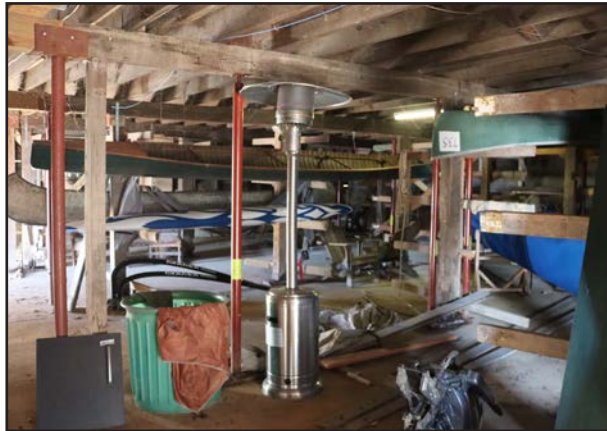
FIGURE 86 Temporary pipe columns installed in West Boat Storage Area.

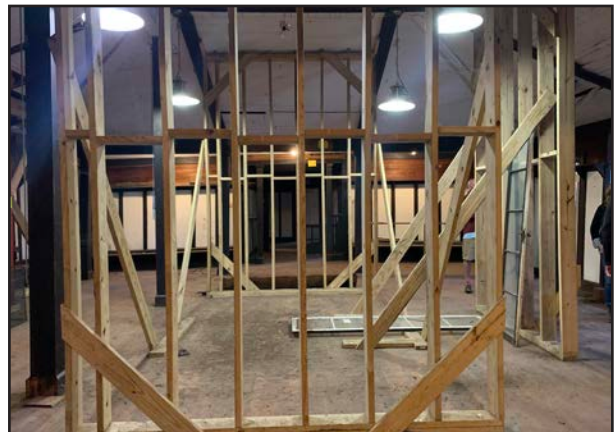
FIGURE 89 Bracing in Ballroom.

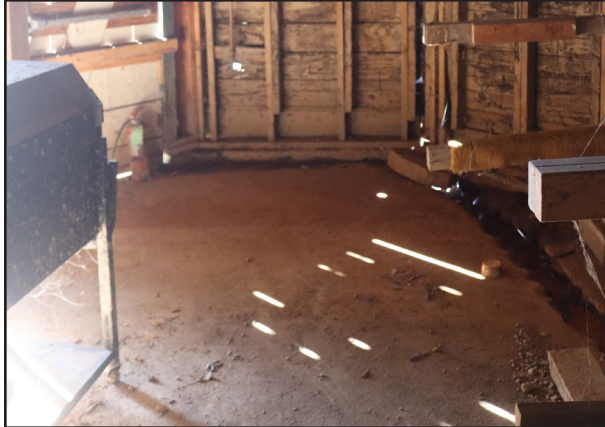
**FIGURE 90** Concrete foundation with channel at the right hand side of the image.

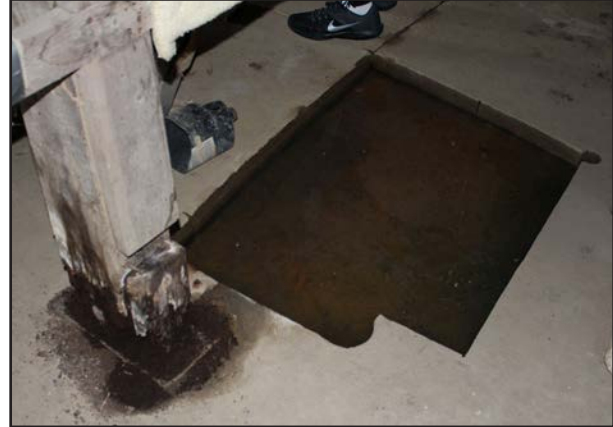
**FIGURE 91** Missing section of concrete floor in West Boat Storage Area.

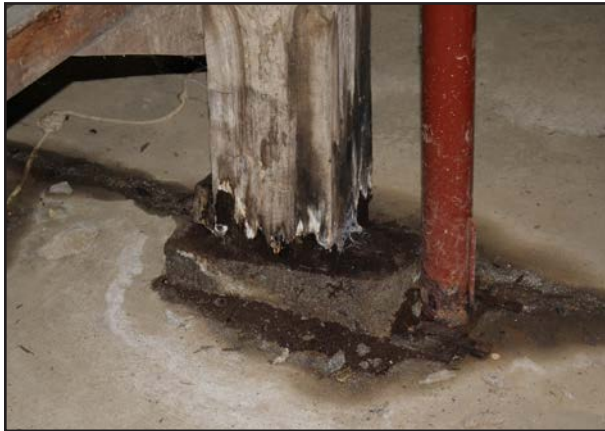
FIGURE 92 Rotted post on block in west boat storage area.

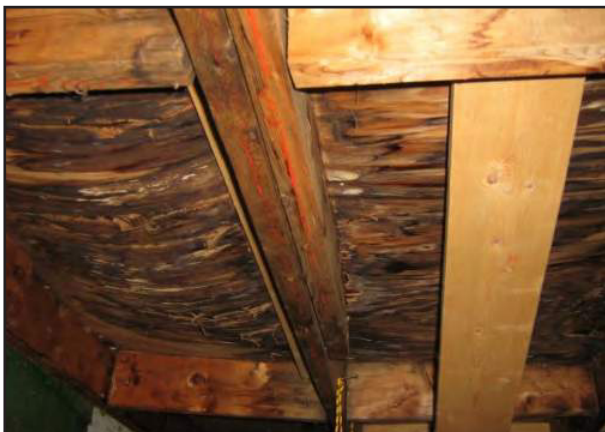
FIGURE 94 Severe rot in roof sheathing over workshop.

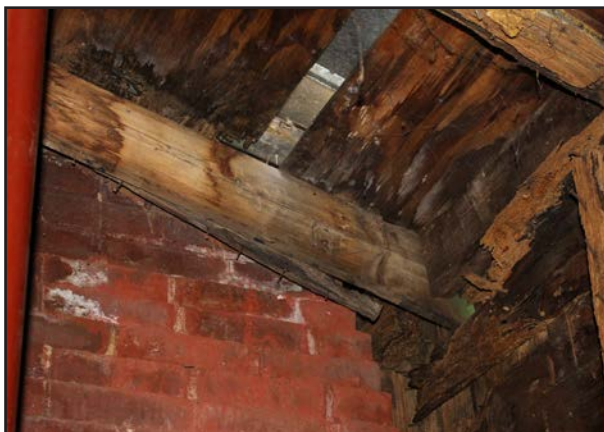
**FIGURE 95** Rot in rafters, wall studs, and top plate around the fireplace due to water intrusion.

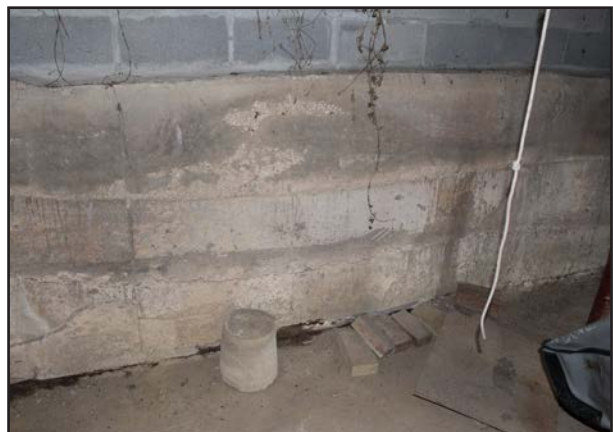
**FIGURE 96** Water damage, cracking, and biological growth at north wall of west boat storage area.

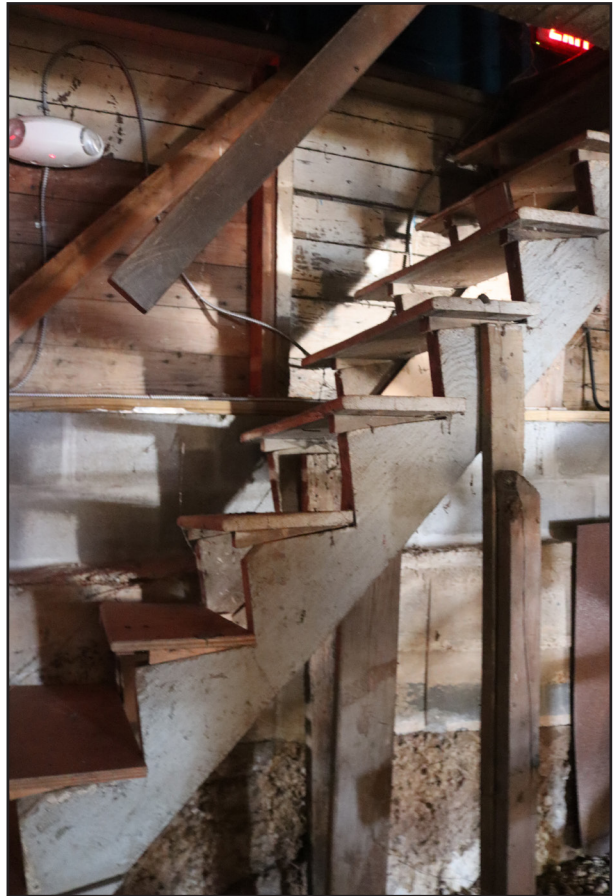
FIGURE 112 Non-compliant and flimsy stairs in northwest corner of West Boat Storage Area.

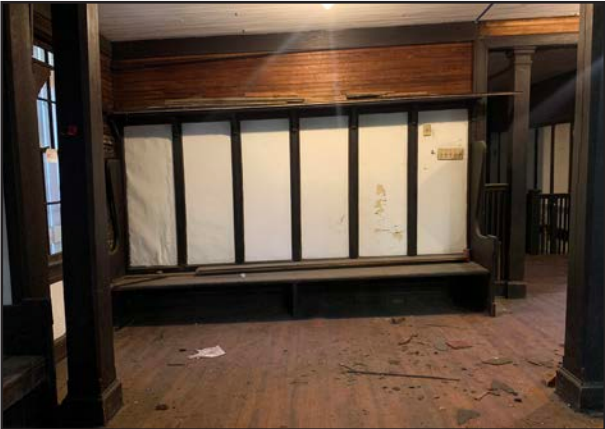
FIGURE 117 Wall treatment in Ballroom. Note areas of peeling and bubbling paint.

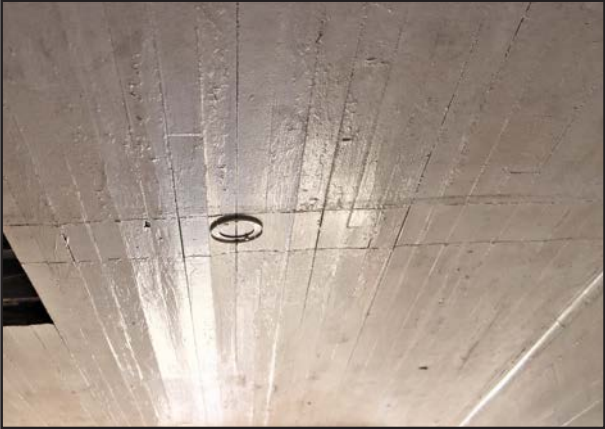
FIGURE 120 Painted bead board, first floor.

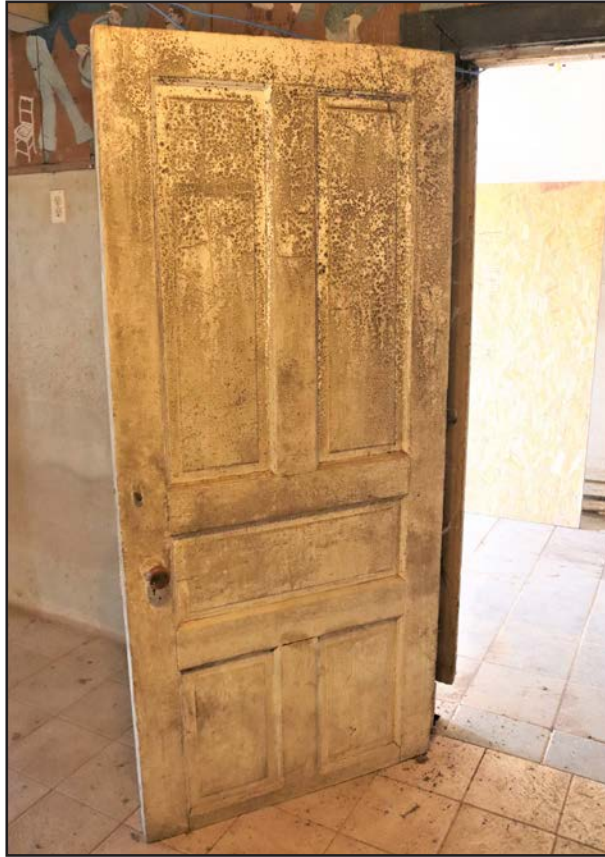
**FIGURE 121** Original five-panel wood door with original hardware. Note that the door was cut down to fit in the opening after the floor was raised.

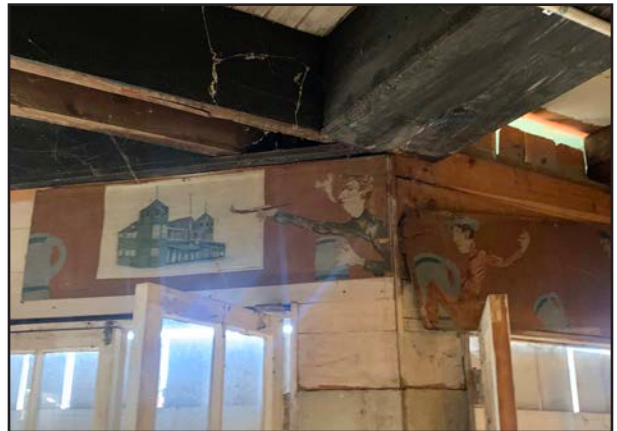
FIGURE 126 Section of the frieze falling off of the south wall; another section showing an illustration of the Canoe Club.

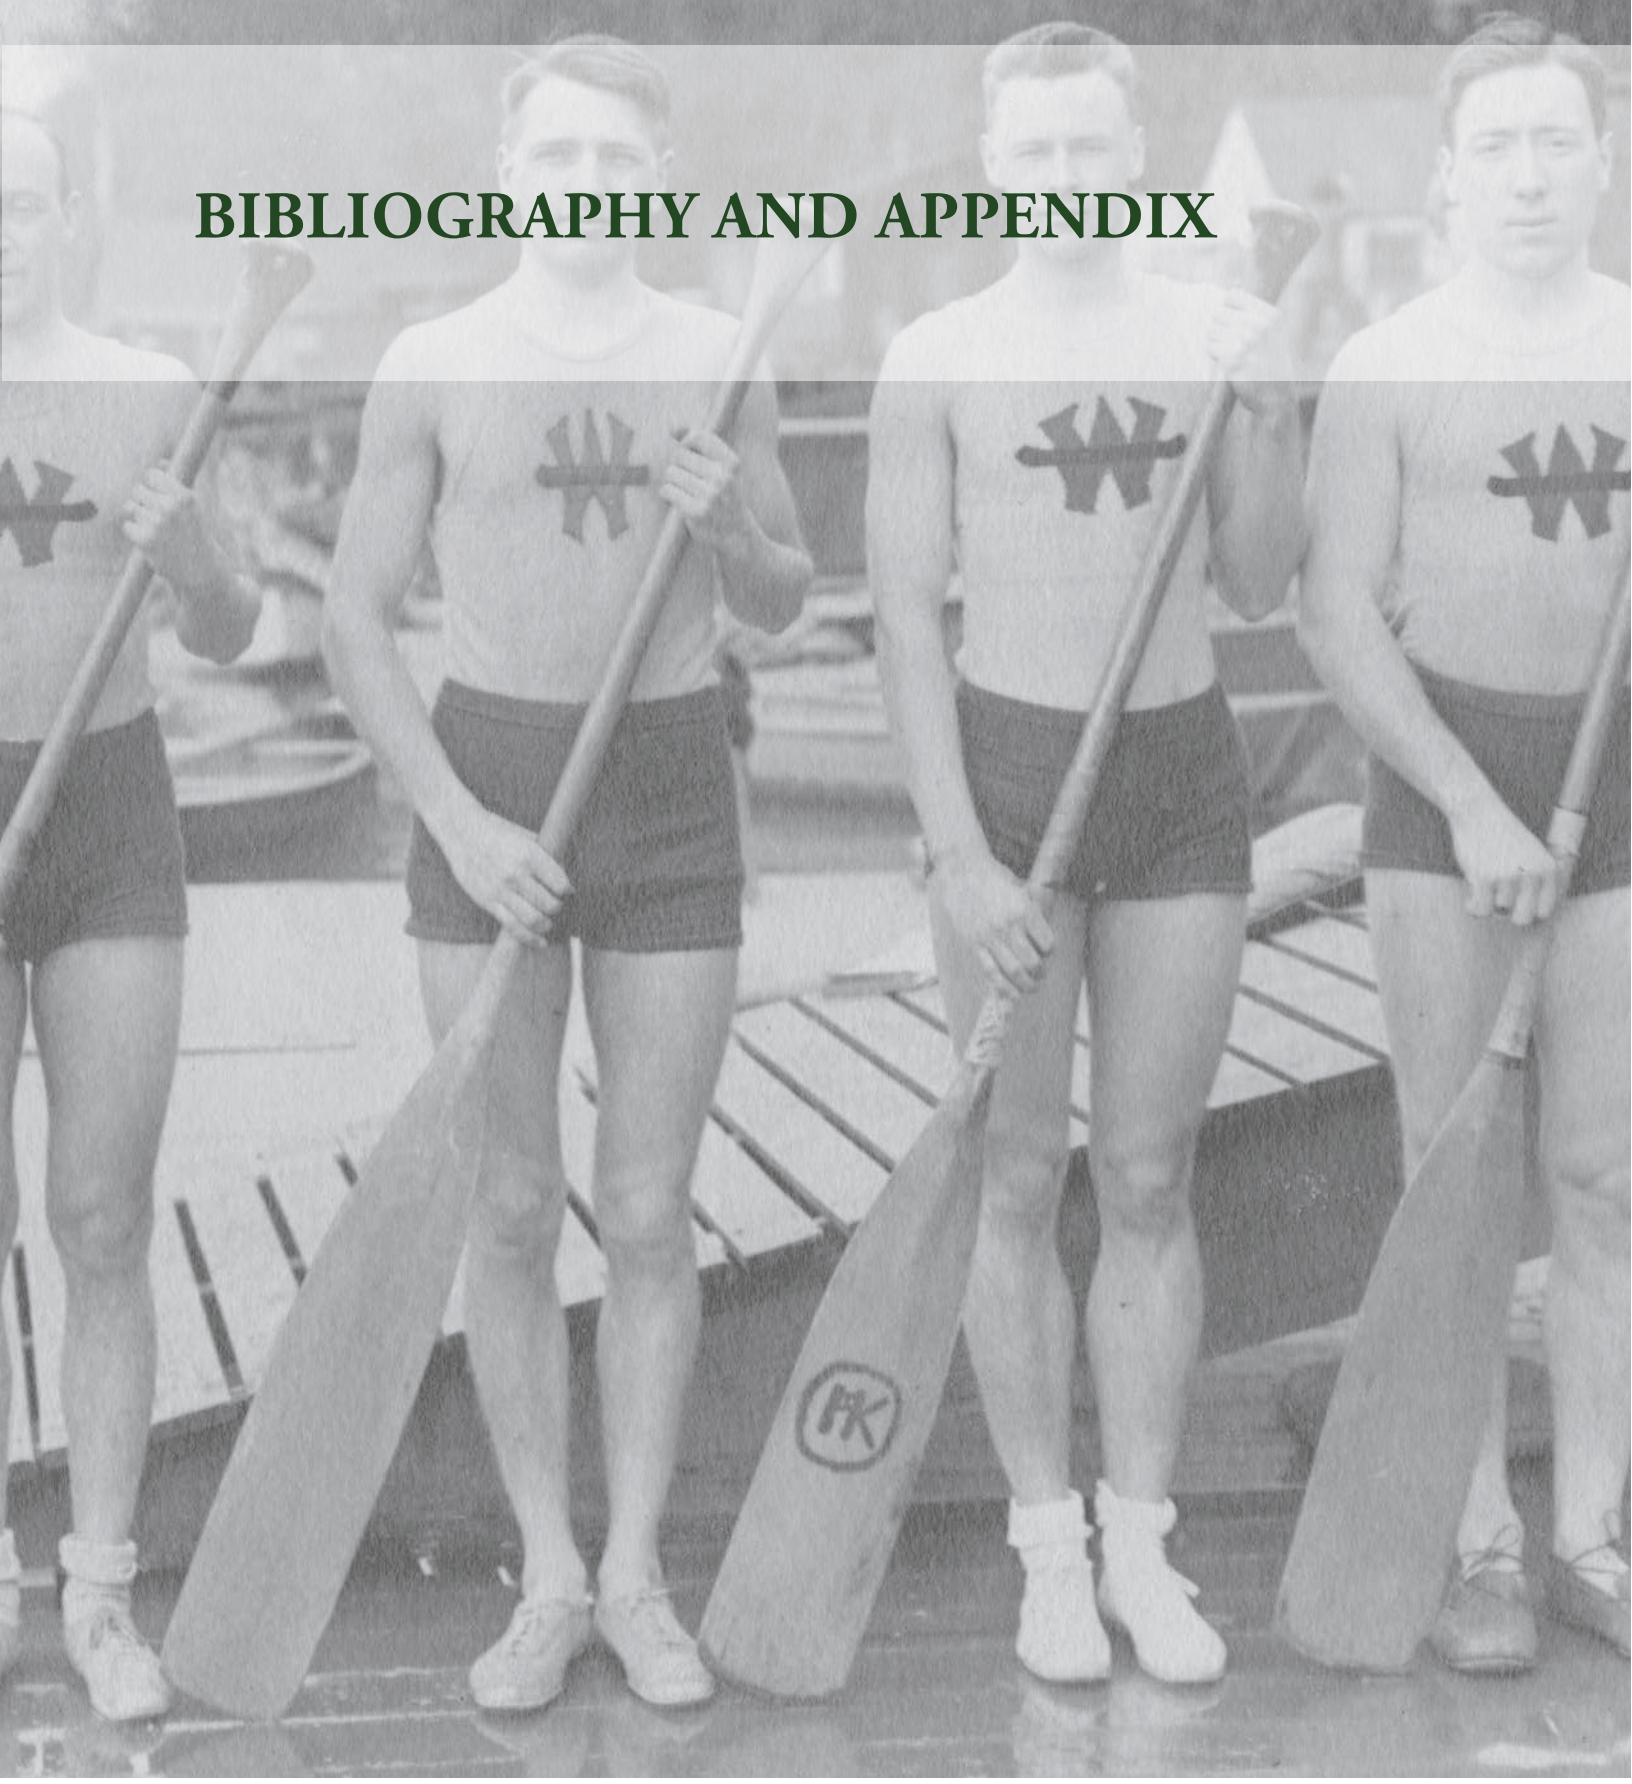
# BIBLIOGRAPHY AND APPENDIX

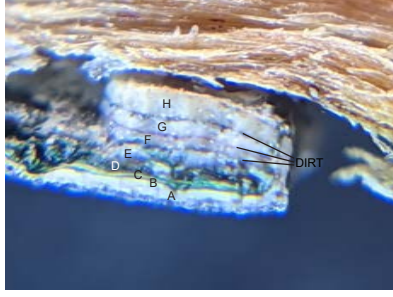
**SAMPLE 4: WINDOW TRIM**

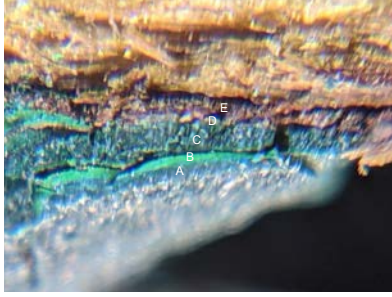
**SAMPLE 5: SHINGLE**

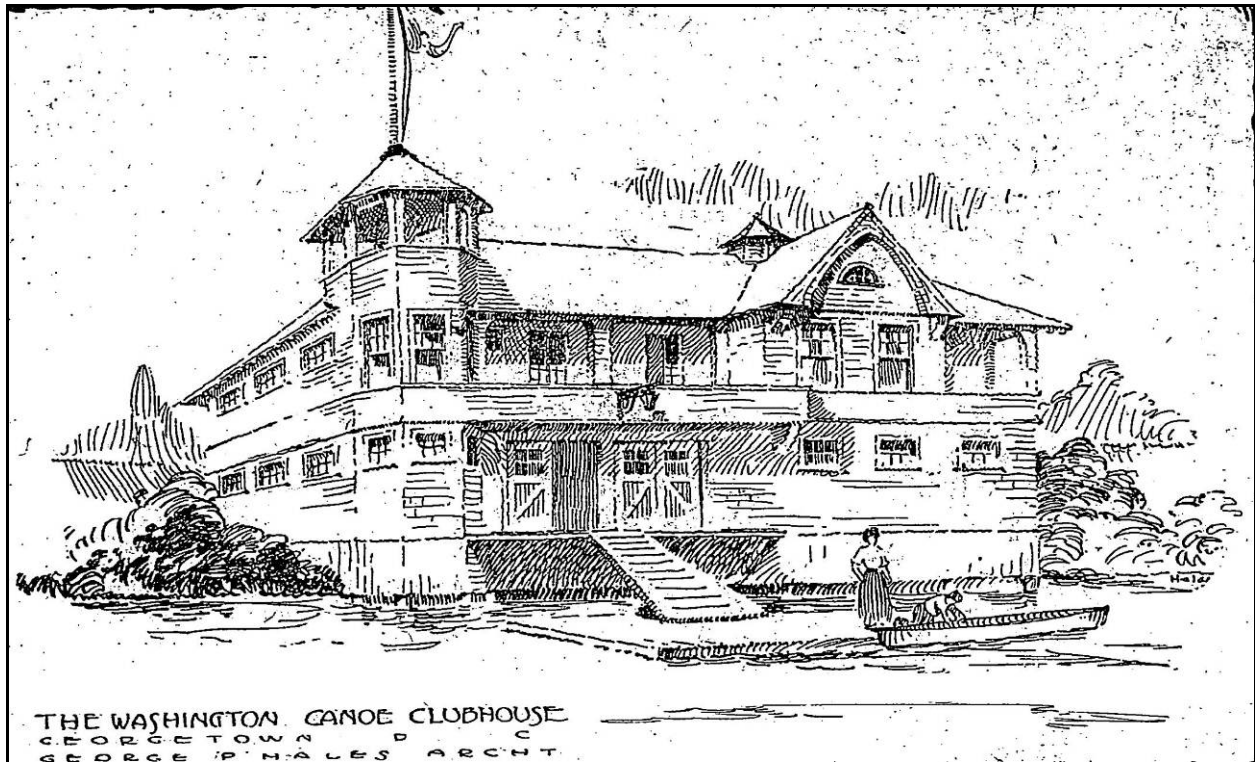
Architect George P. Hale's ca. 1904 rendering of the proposed Washington Canoe Clubhouse. When constructed there were several architectural differences from this proposal. [HABS]

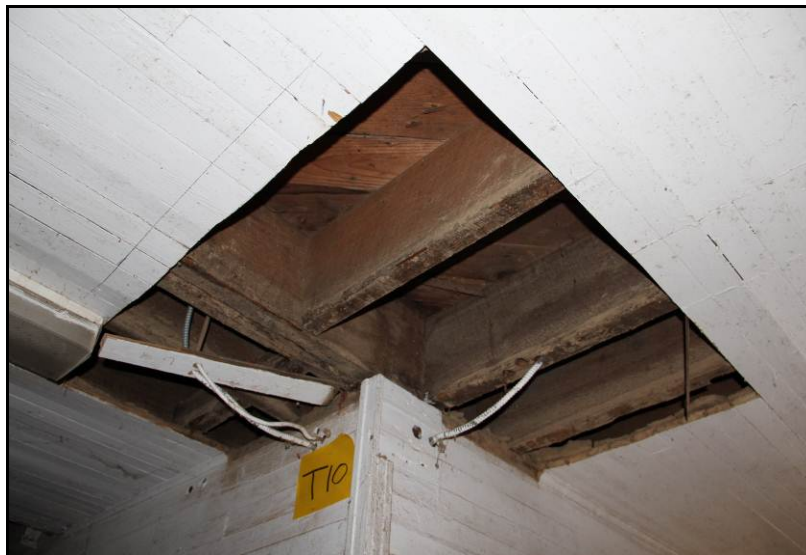
*Example of historic fabric removal by HPTC to expose the historic wood frame of building for assessment by structural engineer consultant. [HPTC]*

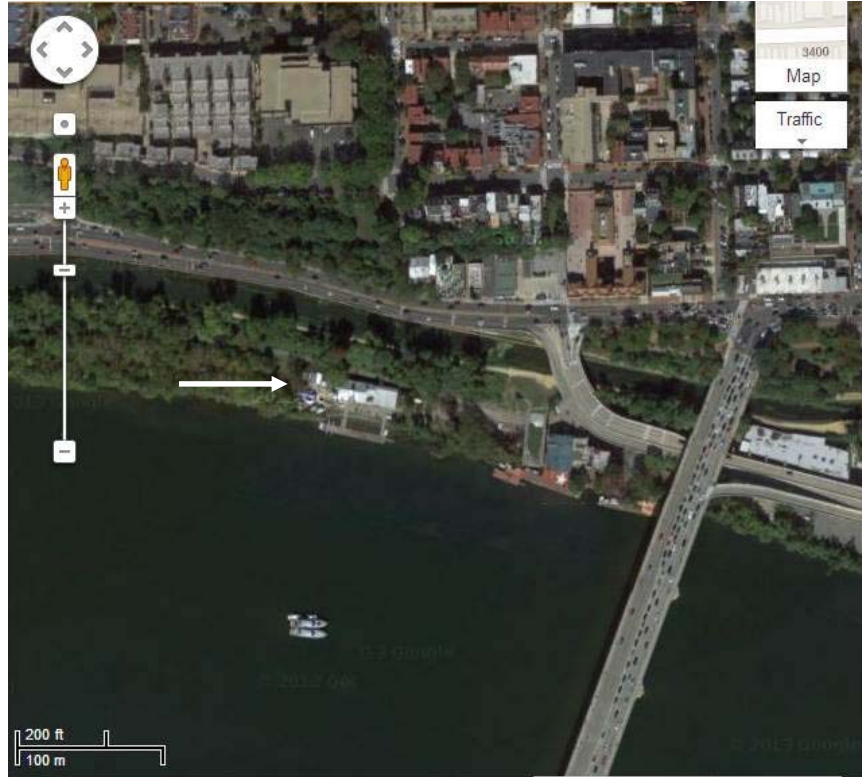
The Washington Canoe Club on the Potomac River, 3700 Water Street, NW, Washington, D.C. Arrow marks location of the Canoe Clubhouse. (<https://maps.google.com>, retrieved 02/19/14)

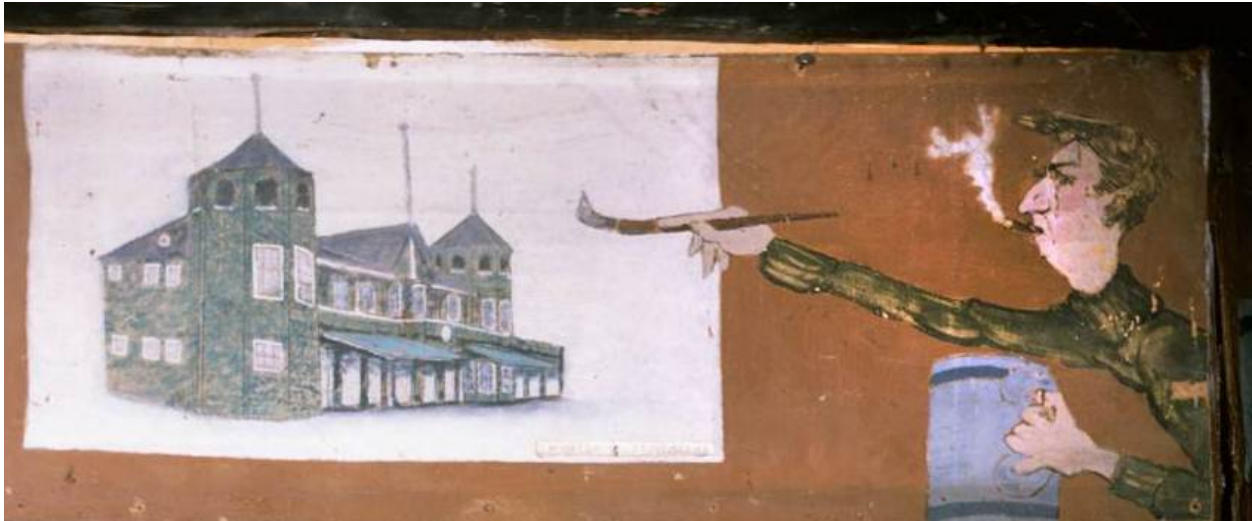
Rendering of Canoe Club Building being prepared by the Architect, George P. Hale, as seen in the Grill Room mural (undated) by Felix Mahoney, an early Canoe Club member. In this image, as well as the above panoramic photo, the character-defining features of the Shingle Style architectural components of the building are easily discernible and have not been significantly altered. (HABS)

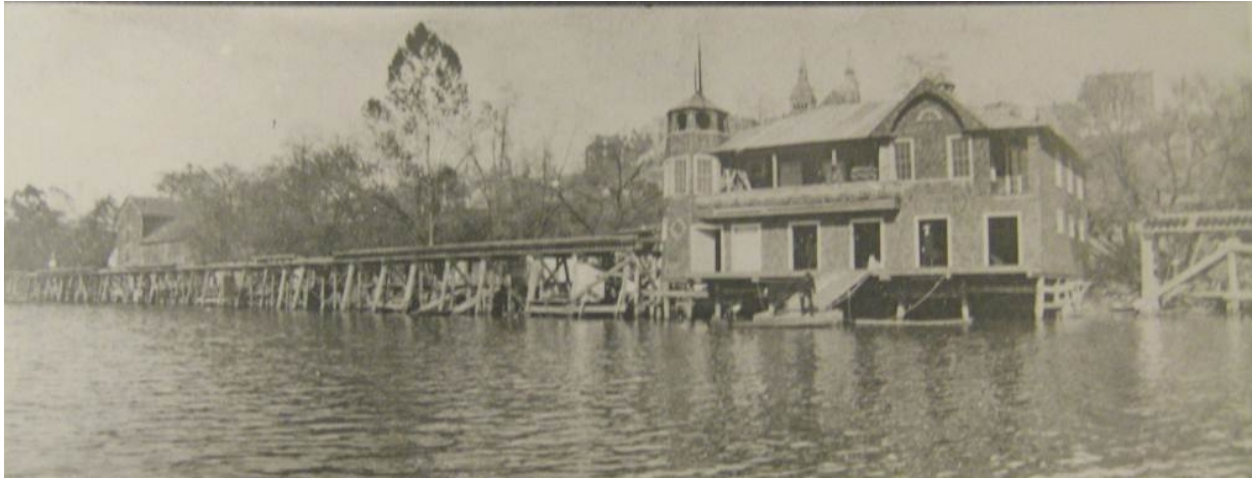
Completed Phase 1 Construction, ca. 1905-06 (HABS DC-876 Figure 3). Noted differences from architects' rendering include use of diamond windows in west tower instead of horizontal windows, reducing size of boat portals from double paired cross-braced doors with windows to solid hinged doors and increasing the quantity from two pairs to six single portals. The redesign of the ground floor fenestration changes the look of the building. It likely provided more room for boat storage and less room for other indoor functions therefore necessitating (or planning) the need for Phase 2 and additional functional interior space; such as the Grill Room.
