1200 Architectural Engineers PLLC

EHT Traceries Historic Preservation

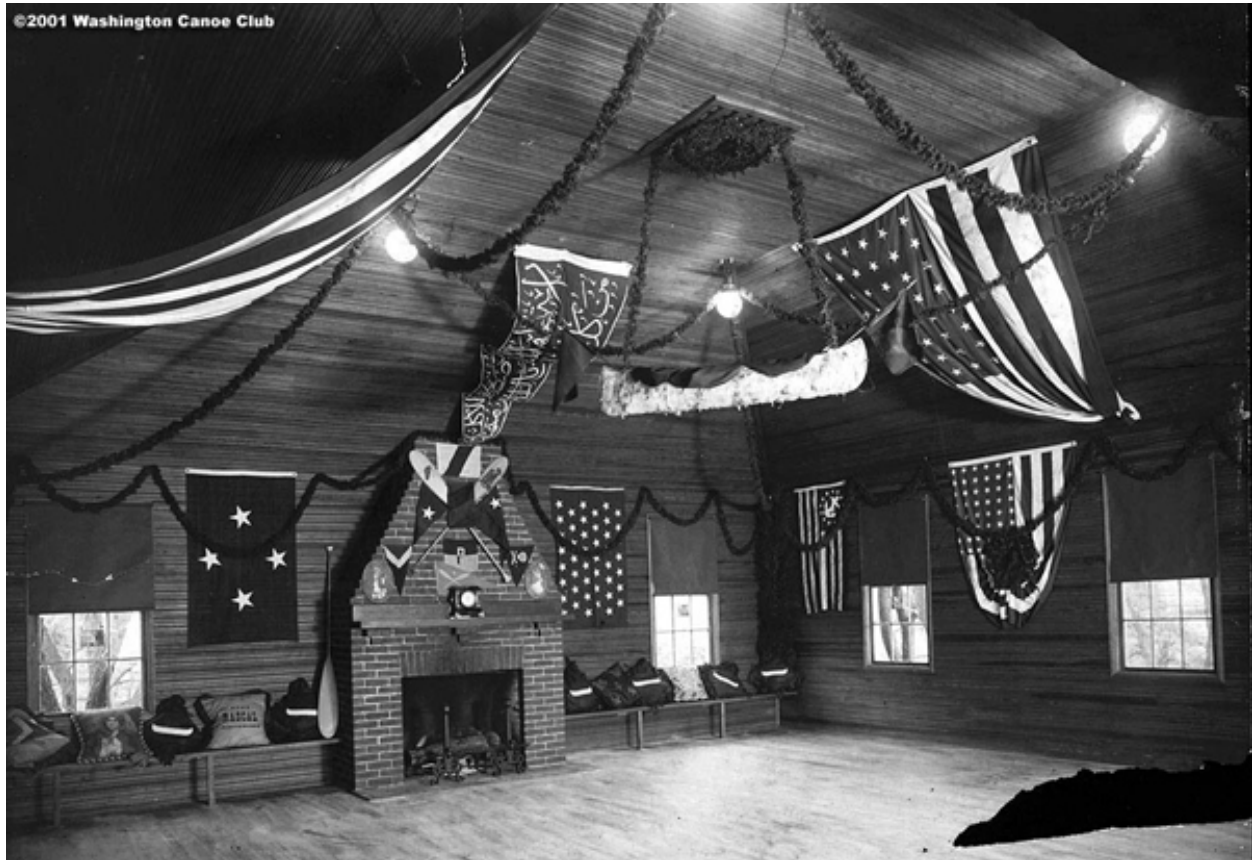
Interior of the Ballroom as it appeared on opening night, December 28, 1905 (HABS DC-876, Figure 7; loaned by Washington Canoe Club), originally published in *The Evening Star* newspaper. The original east exterior wall of the building, with its two six-over-six double hung wood windows, seen at the right in the photo, will be removed and redesigned as the east gallery space when Phase 2 is constructed. Also seen in this photo is the original interior wall and ceiling surfaces of the Ballroom and the use of the built-in bench along the north wall on either side of the fireplace. Note the unpainted brick chimney and the centrally positioned ceiling grill just under the roof-top louvered ventilation cupola.

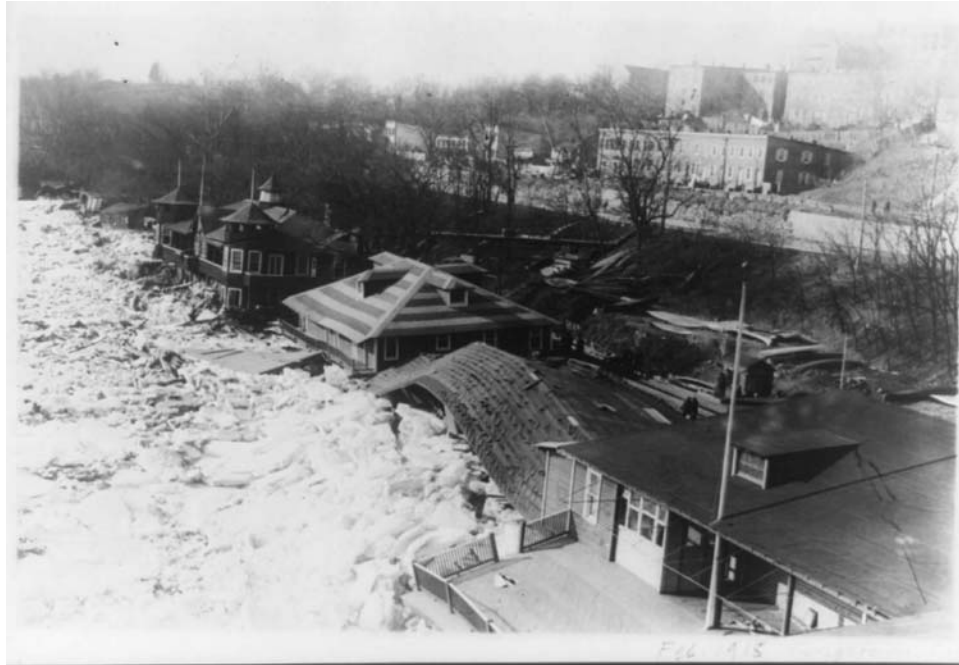
Bird's-eye View of Boathouses, along the Potomac River, Georgetown, damaged by flood (Feb 1918) LOC Call #: LOT 12354-2.

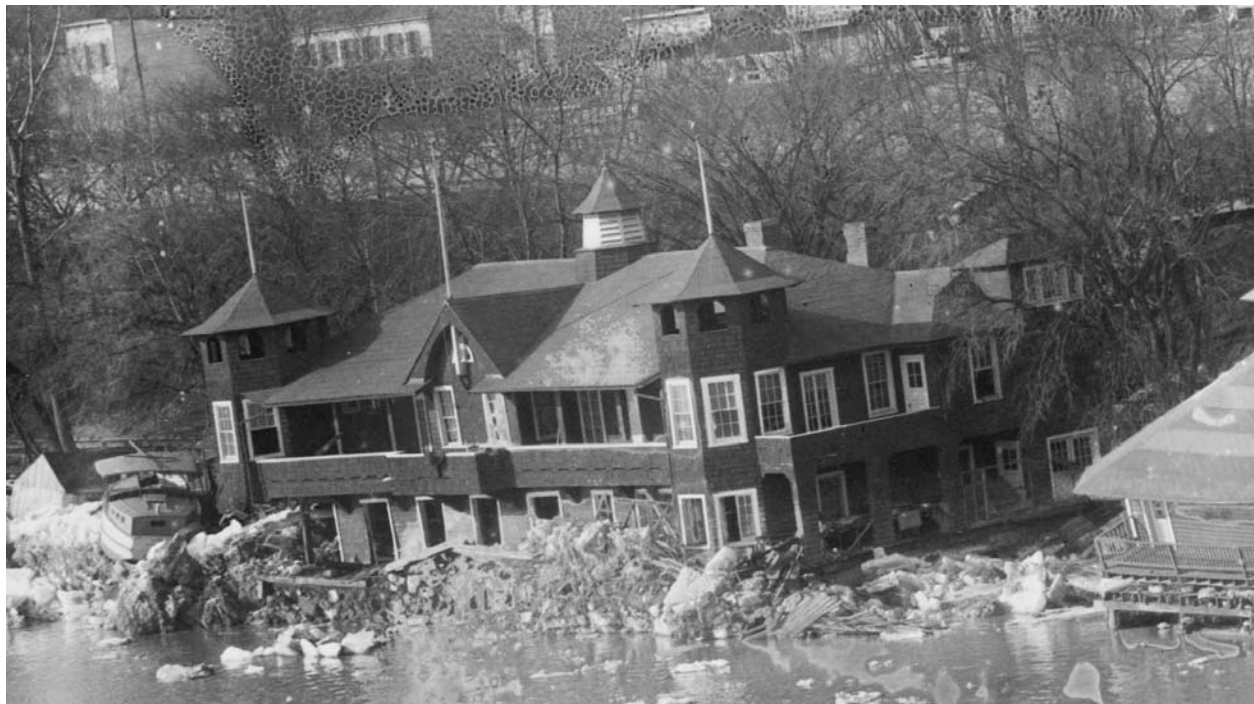
Image enlarged from Potomac Flood, Georgetown, D.C.; LOC Call Number: LC-F81-44573, undated. Thought to be the same flood event as depicted in ca. 1918 image. Clearly illustrated the east elevation of the building prior to any additions.

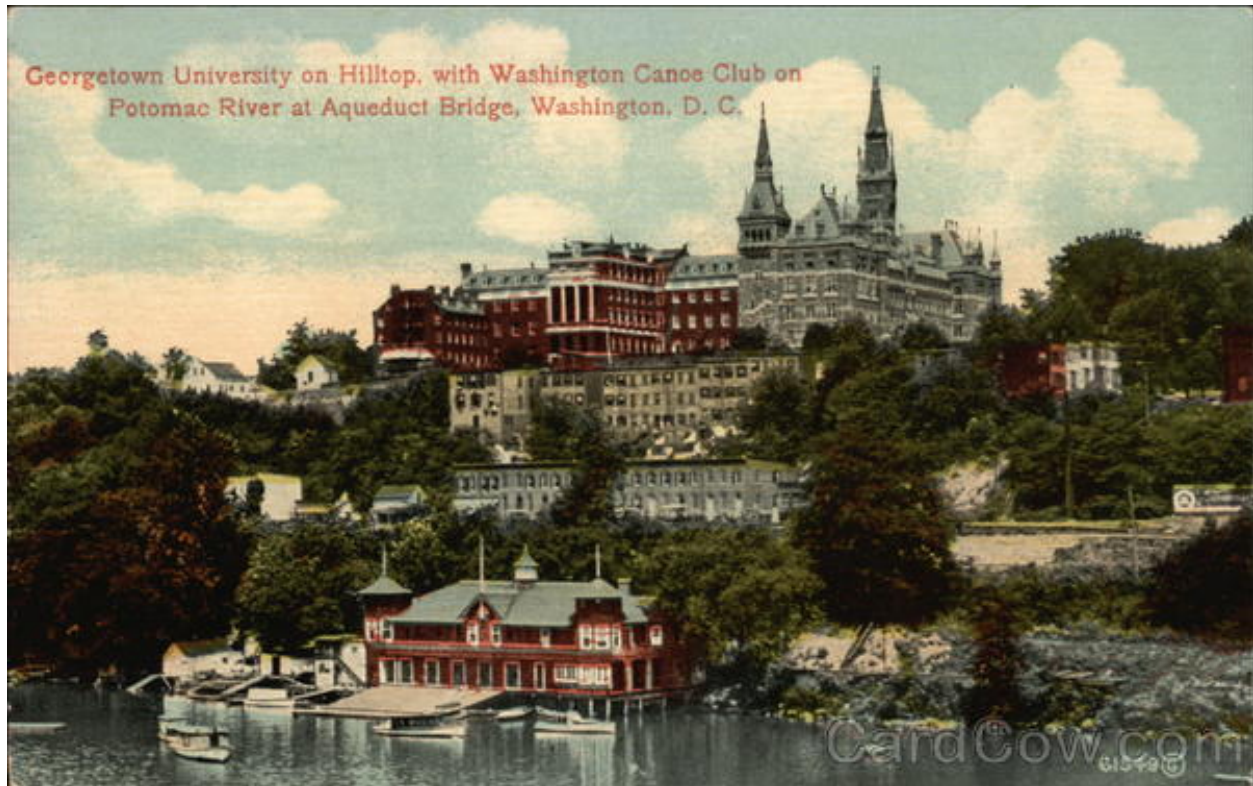
Ca. 1920 postcard image (WCC website). The red-painted clubhouse. Based on development of rip-rap under building this image seems almost contemporaneous with the above image. With the exception of the color (red has been found on original wood shingles at the Canoe Club) this image is slight oblique to the preceding image. Note white-painted building to the west (left) of the Canoe Club building still extant (first seen in 1910 image).

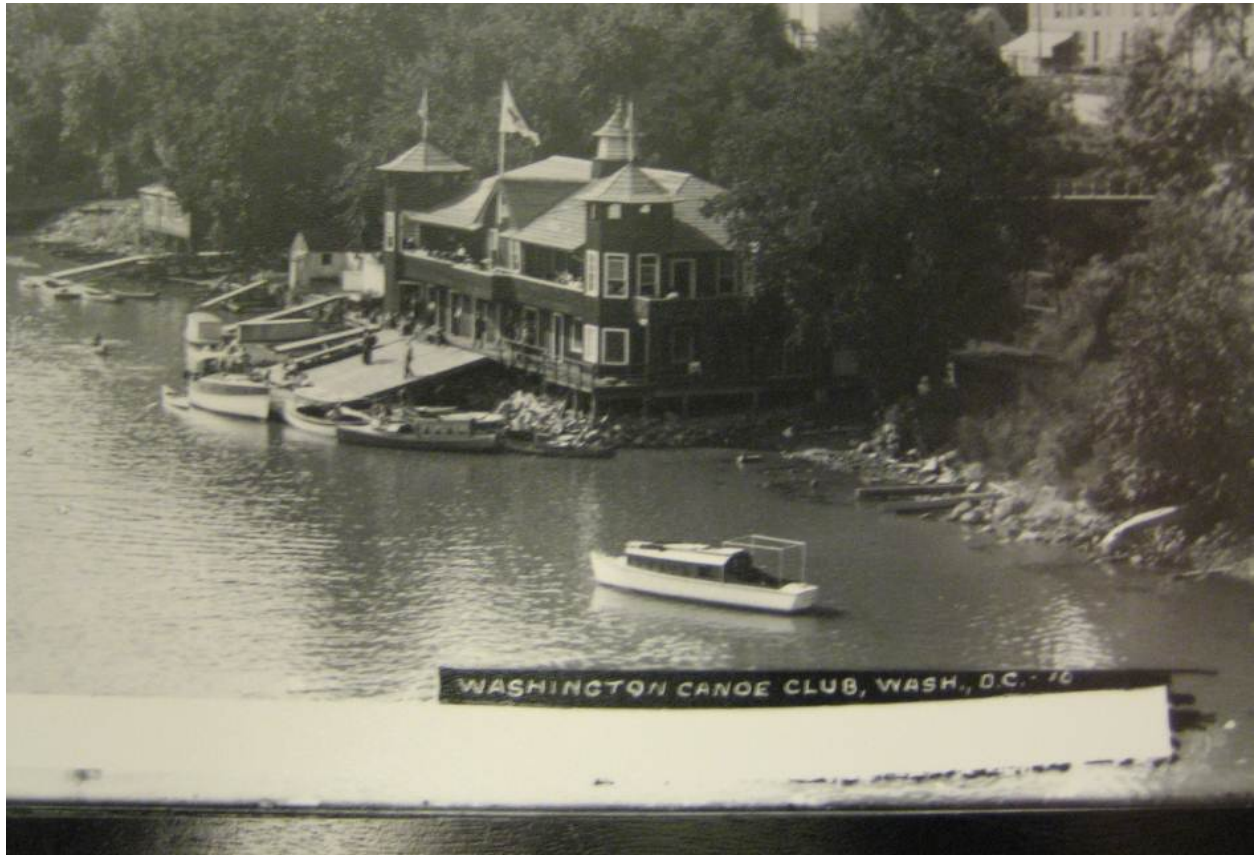
Ca. 1920-30 (HABS DC-876, Figure 4). Note balcony, door and windows at east tower, construction of building on wooden platform supported by pilings in the river; also bridge to Towpath. Filling in of under-building area with stone rip-rap (ACOE?) has been extended along the east elevation under the buildings riverfront elevation (compare to previous photo).

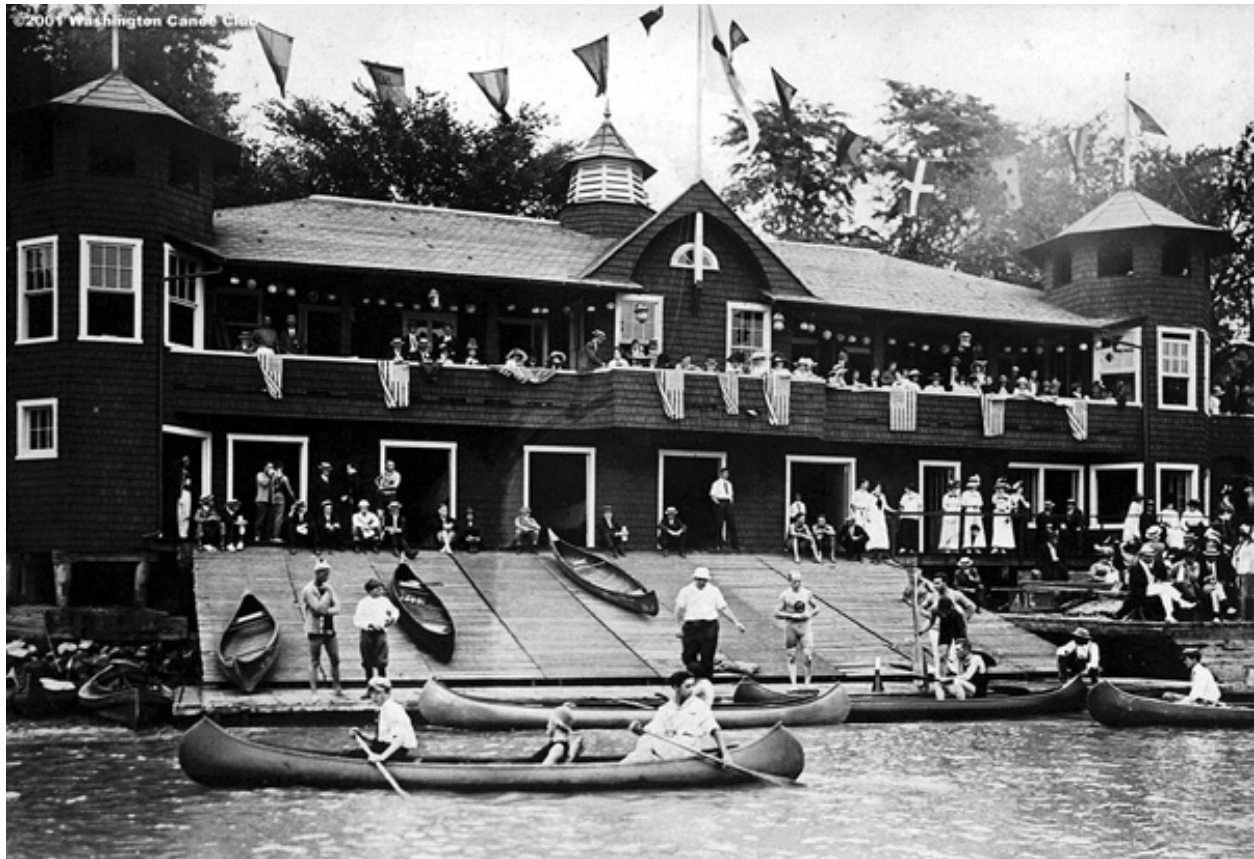
Iconic 1930s image of Washington Canoe Club (HABS DC-876, Figure 6). Distinctive roof patterns indicate sheet metal or early composite shingle on the tower and cupola roofs and sawn wood or early synthetic shingles on the main gable roof. Note finial (now missing) on cupola and gathering of folks to the east of the boat ramp, perhaps indicating enough ground had been established over the rip-rap to allow for placement of picnic tables.

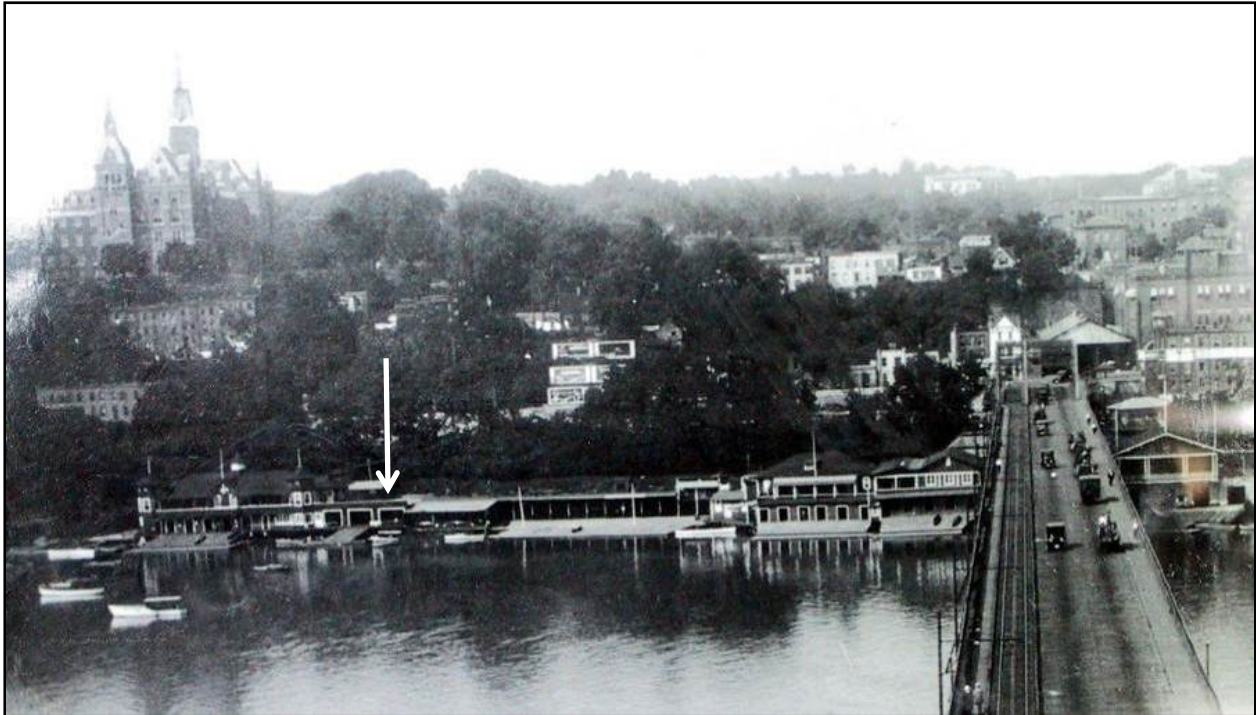
Identified by HABS as ca. 1920s (it may also be ca. 1930s) (HABS DC-876, Figure 5) this image is the first known to capture the three-bay east boat storage area extension; adjoined to the east by another roofed structure. Also seen is a roof form (red arrow) thought to be the gable roof of the Women's Locker Room although it appears to be smaller than the current locker room structure. It may also be associated with a structure that provided the connection to the overpass bridge entrance at the north entrance tower. NOTE: inclusion of Second Aqueduct Bridge indicates photo dates from between 1922 - 1933.

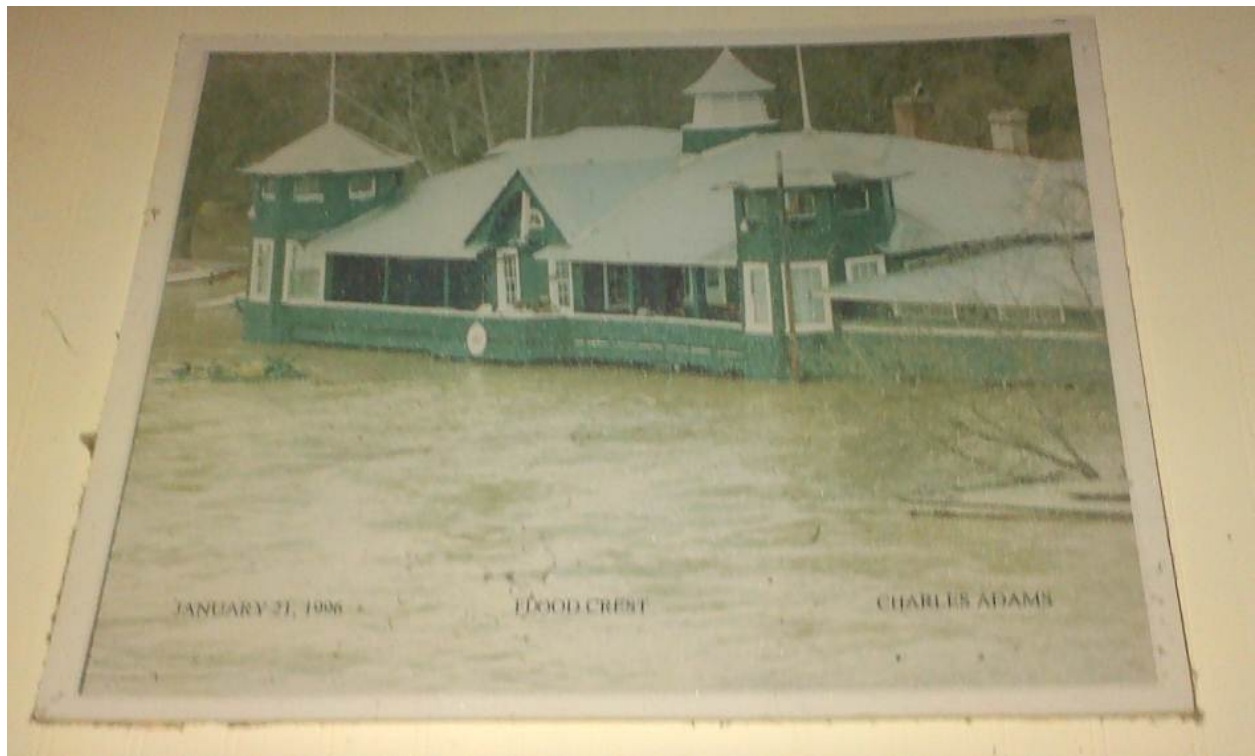
Flood Crest of January 21, 1996, by Charles Adams, found on the wall at the DC Boat House Restaurant. Clearly indicates flood waters inundating the ground floor of the Canoe Club building. Building appears much as it does today (2014).

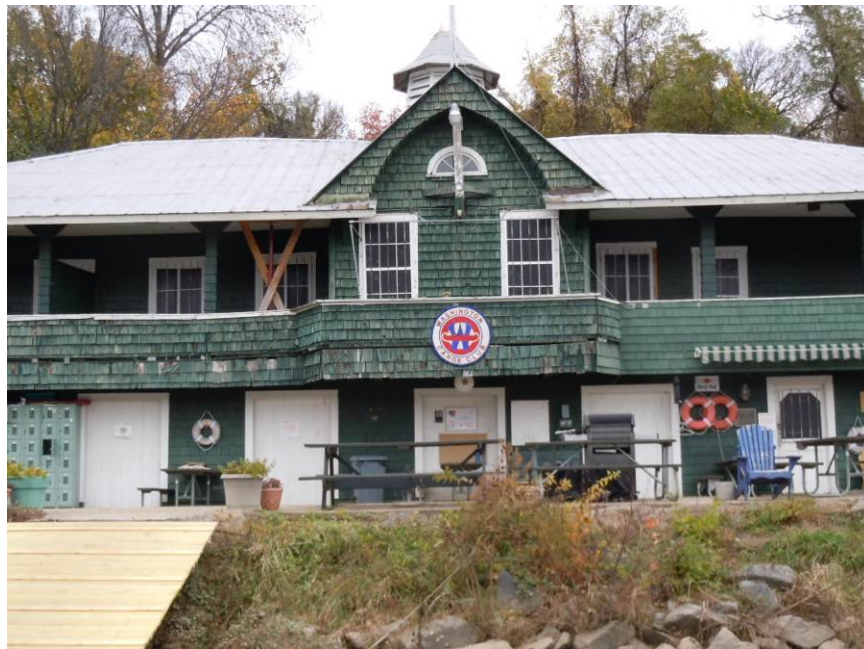
The primary character-defining exterior materials of the Canoe Club building include painted wood shingles, wood doors, windows, and trim. The extant sheet metal roof is not considered a CDF. The green and white exterior colors (although not original) are now considered a day-mark for the building and a character-defining feature. (HPTC photo)

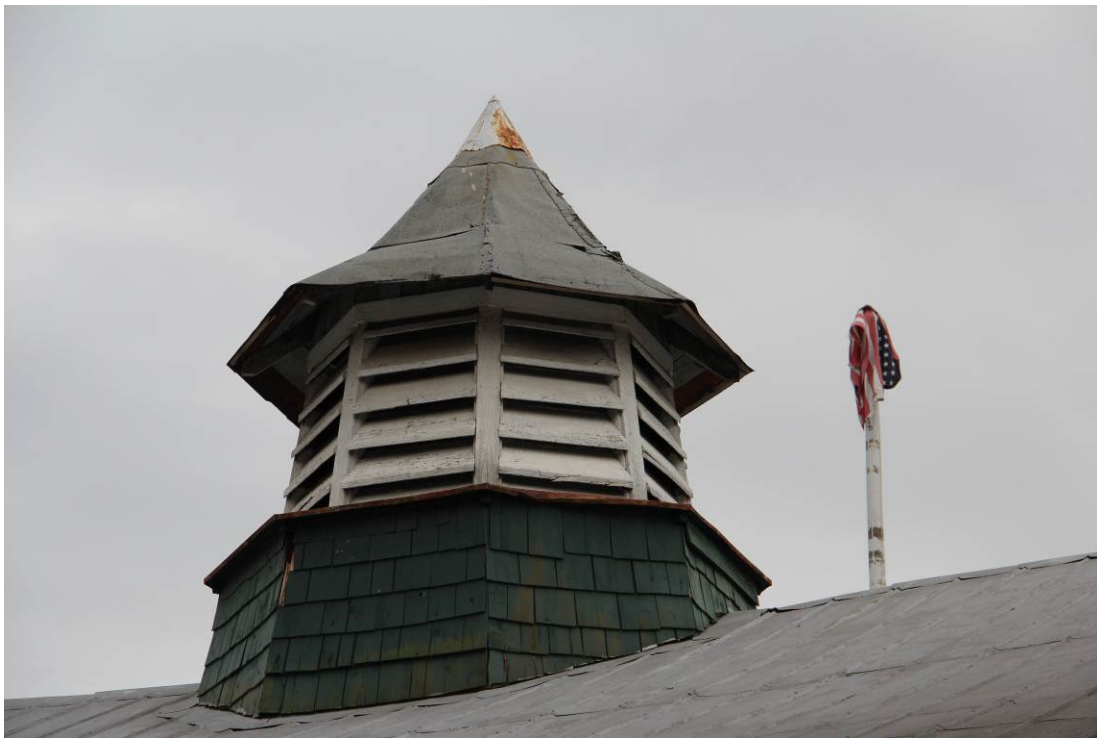
Louvered cupola with conical roof on the ridge of the main roof. (HPTC photo)

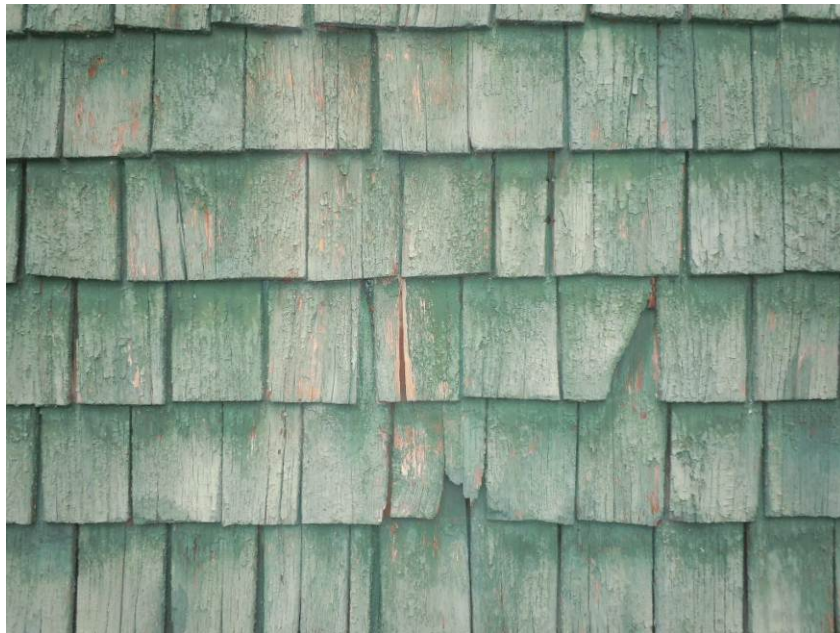
Detail of random-width painted wood shingle siding with approximately 5 inch weather exposure. Green shingles were originally stained red. (HPTC photo)

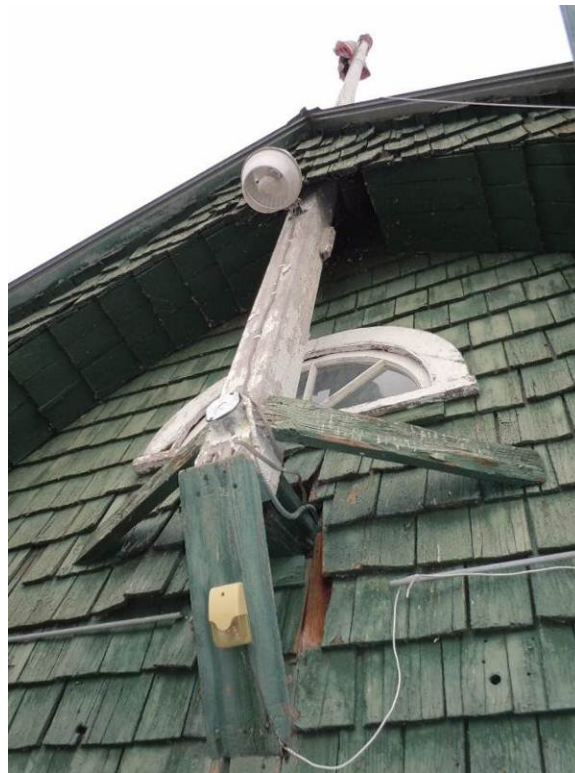
The flag mast pierces the recessed arch of the central gable. Note fan light in pediment area of gable. (HPTC photo)

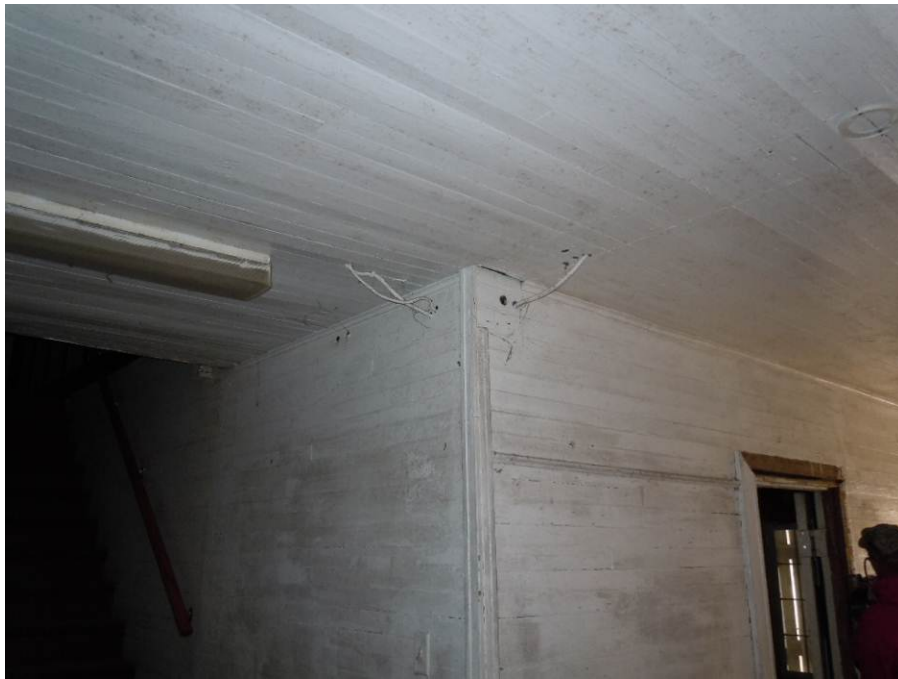
Painted tongue-and-groove wall and ceiling paneling in the Main Hall (Room 104) on the first floor. (HPTC photo)

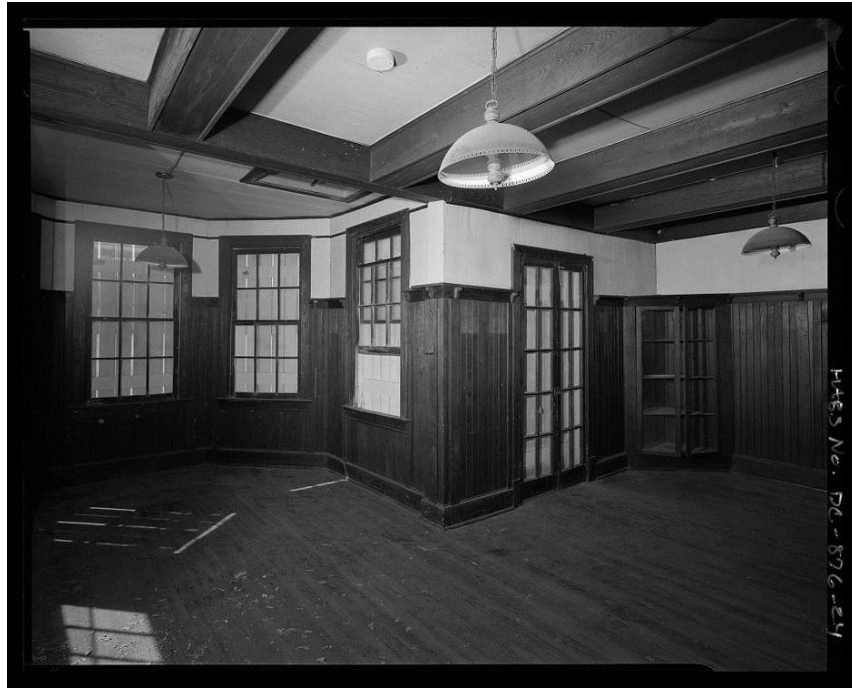
Stained vertical wall paneling, wood flooring and baseboard, door and window surrounds and false dropped ceiling beam enclosures are character-defining features of the Board Room. (HABS photo)

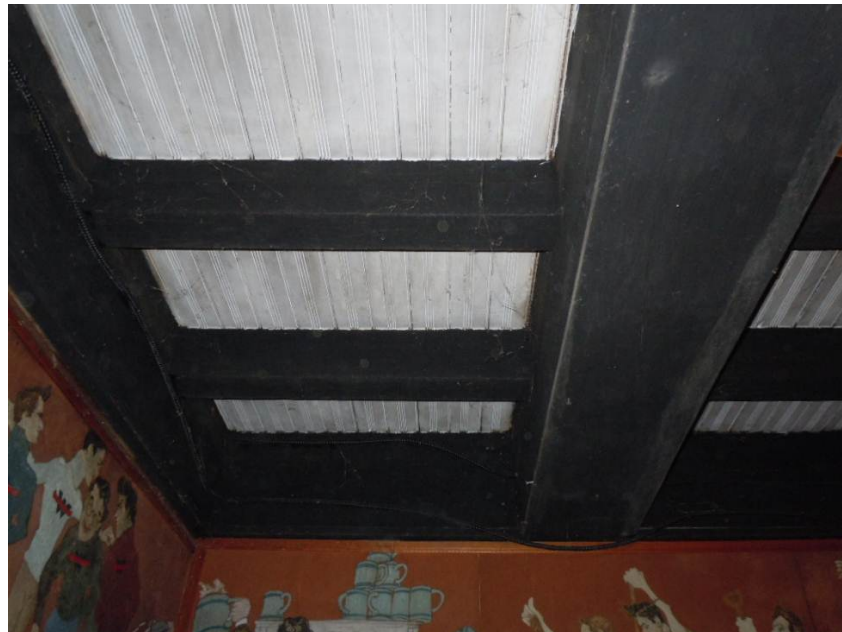
Painted beaded ceiling boards and stained wood-encased false dropped ceiling beams in the Grill Room (Room 105) on the first floor. (HPTC photo)

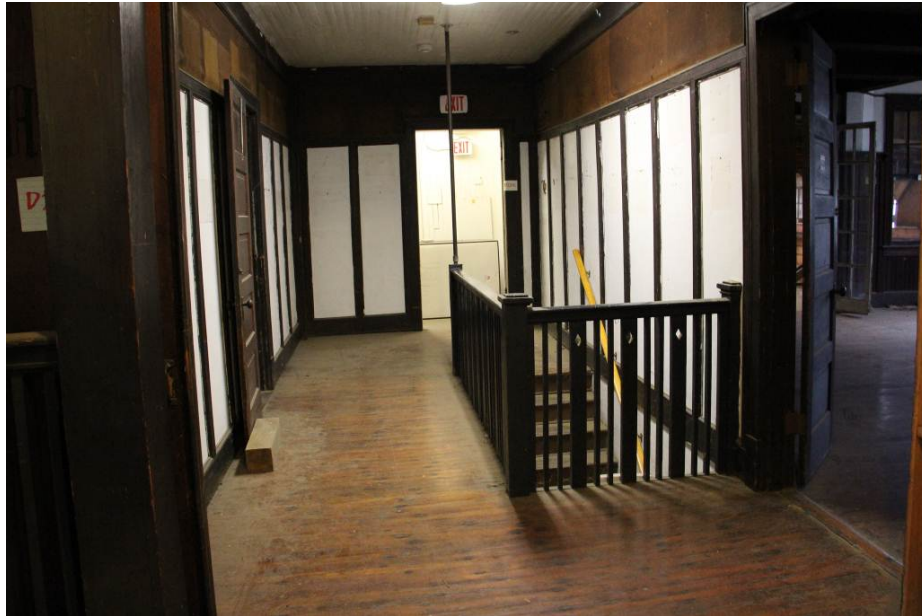
Vertical wall panels with white-painted fabric over dark stained beaded board paneling, wood strip beaded ceiling, wood plank floor, stair balustrade and newel posts are all character-defining features in the Entry Hall (Room 207) on the second floor. (HPTC photo)

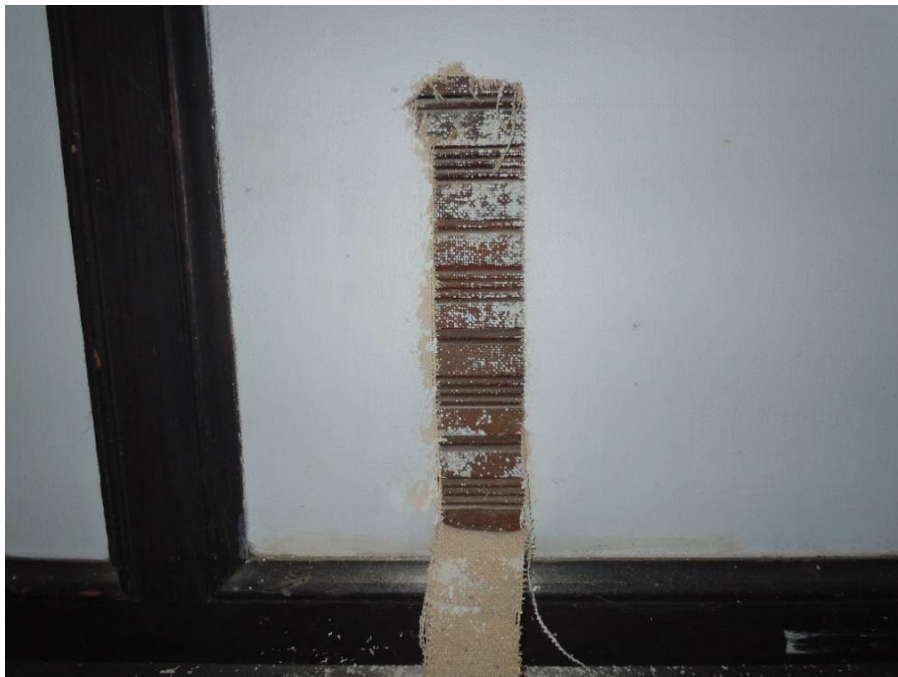
A section of torn painted fabric reveals the original beaded board paneling on the walls in the Ballroom on the second floor. (HPTC photo)

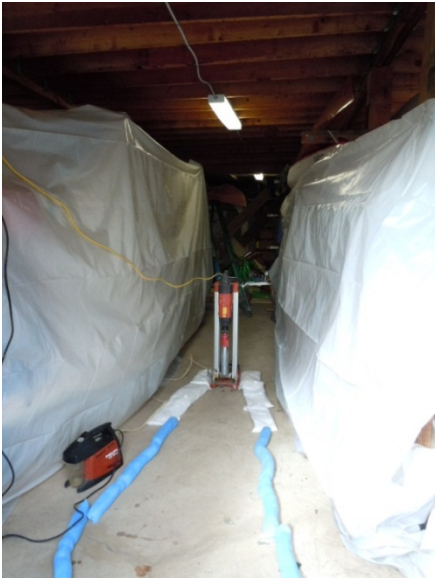
| | <p>Precautionary measures were taken by HPTC historic preservation field crew to protect WCC membership property while conducting slab coring operations in the East Boat Storage Area (11/05/13, HPTC).</p> |

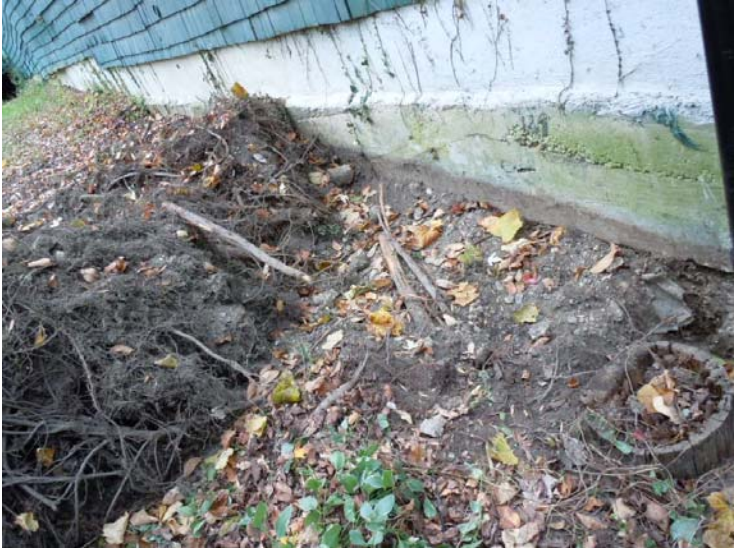
| Item | Task | Question/ Concern/ Outcome | Response/ Clarification |
|---|---|---|--|
| | | <p data-bbox="451 1024 1406 1087">Task 1 Outcome: unable to penetrate concrete placed in this area with backhoe. Determined depth to exceed sixteen (16) inches.</p> | |

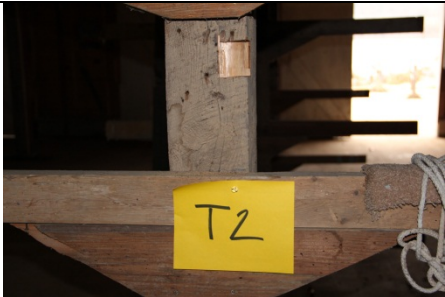
| Item | Task | Question/ Concern/ Outcome | Response/ Clarification |
|---|---|---|--|
| 2d | Column | | Southern Yellow Pine. |

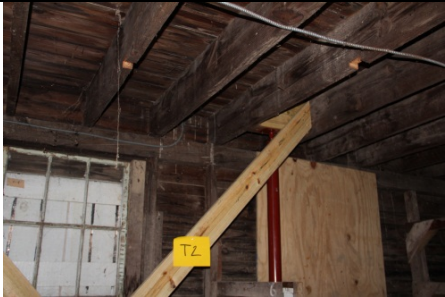
| Item | Task | Question/ Concern/ Outcome | Response/ Clarification |
|---|---|---|--|
| 2e | Joist | | Southern Yellow Pine. |

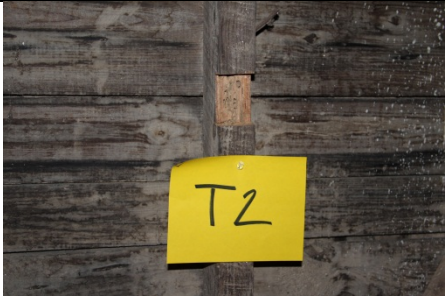
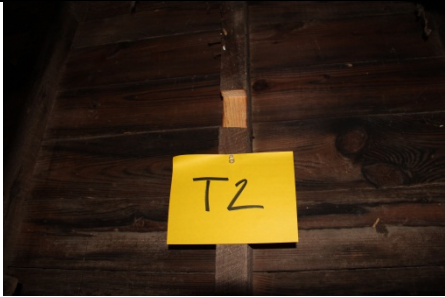
| Item | Task | Question/ Concern/ Outcome | Response/ Clarification |
|---|---|---|--|
| 2f | Stud | <br>Bad stud sample (extensive previous termite damage) | <br>Good stud sample.<br>Southern Yellow Pine. |

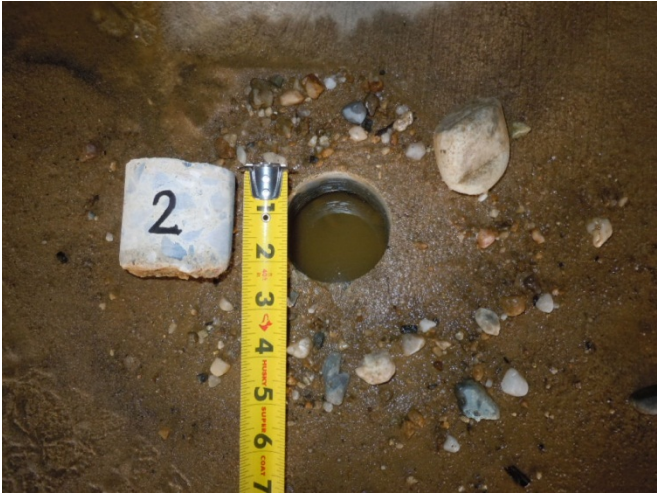
| Item | Task | Question/ Concern/ Outcome | Response/ Clarification |
|---|--|---|--|
| | | <p data-bbox="423 741 1433 877">Core #2 was later relabeled slab core # 2b. At this location a layer of sand and gravel was encountered under the 3 inch concrete slab core sample to a depth of sixteen (16) inches. No under-slab or concrete placement was encountered. See Task Location Maps for exact locations of core samples.</p> | |

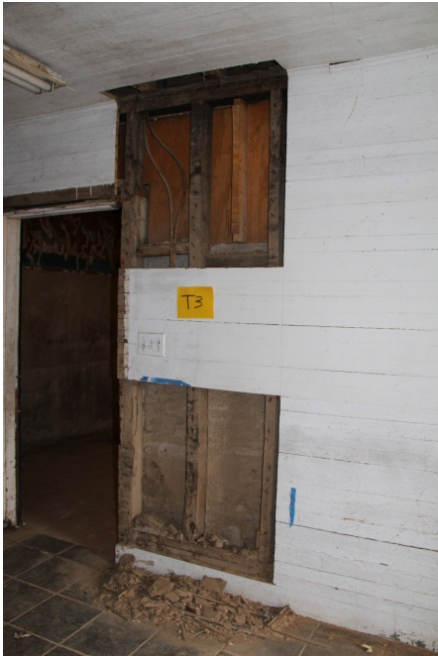
| Item | Task | Question/ Concern/ Outcome | Response/ Clarification |
|---|--|---|--|
| | | <p data-bbox="630 1856 719 1881">Task 3.</p> | <p data-bbox="954 1350 1433 1801">Outcome: wall frame revealed. Use of cut nails noted in wood frame construction Early balloon frame typology with fire-blocking wall base and top plates. Extensive deposition of silt revealed in wall cavity from previous river flooding episodes. Silt seen in this image on floor in front lo lower opening. The horizontal tongue &amp; groove siding removed in this area has been bundles for future reinstallation at this location. Painted finish tested positive for lead paint usage.</p> |

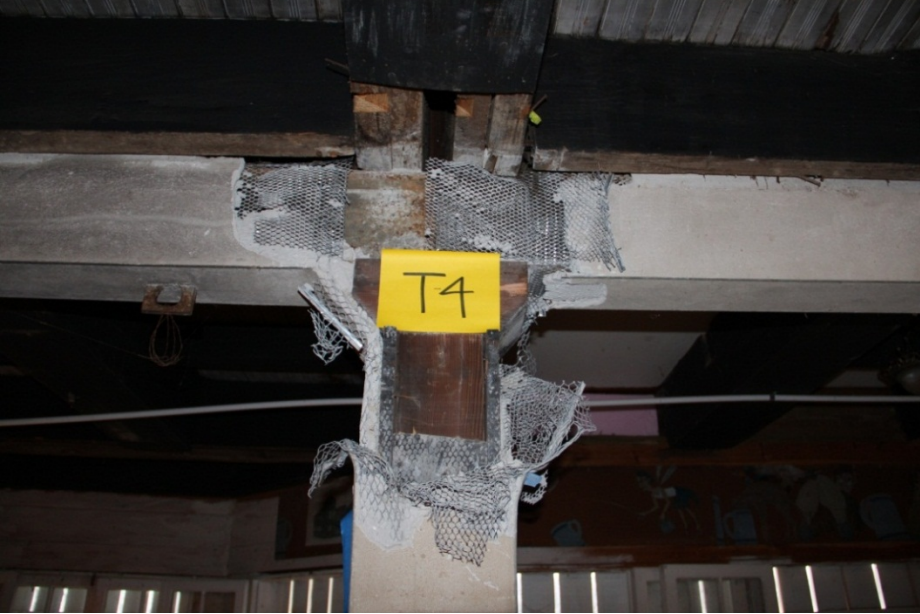
| Item | Task | Question/ Concern/ Outcome | Response/ Clarification |
|--|---|--|---|
| | | | |

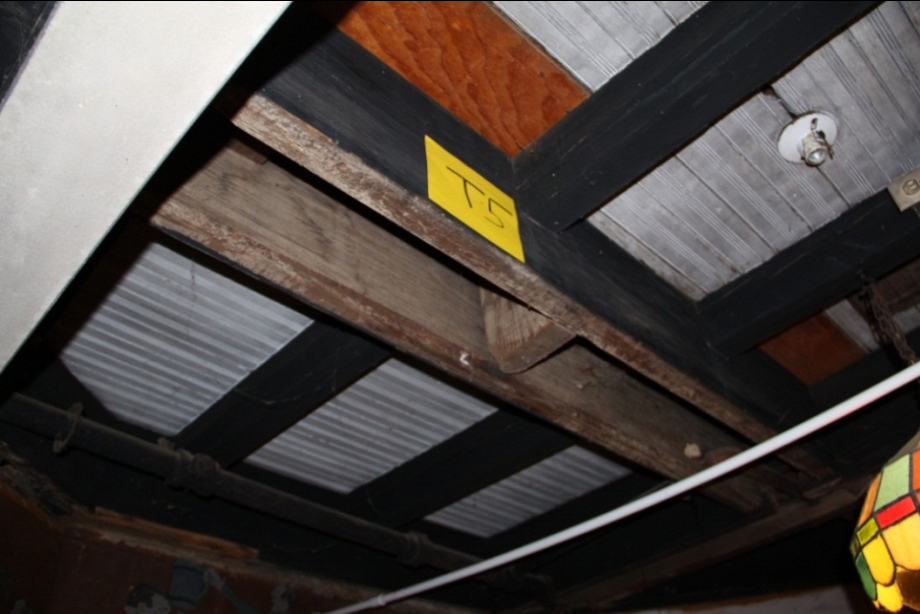
| Item | Task | Question/ Concern/ Outcome | Response/ Clarification |
|--|---|--|---|
| | | | |

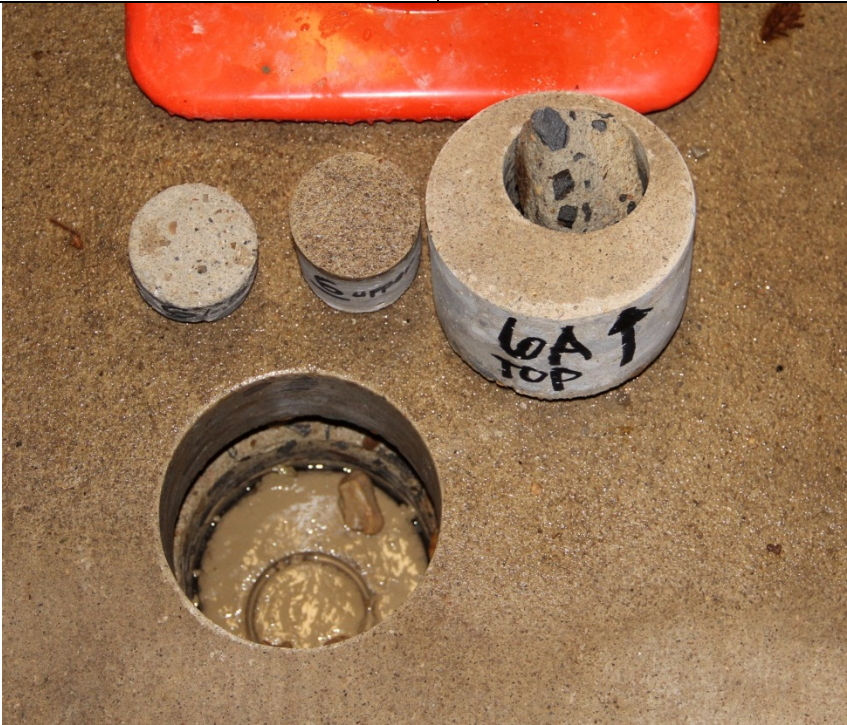
| Item | Task | Question/ Concern/ Outcome | Response/ Clarification |
|--|---|---|---|
| | | | |

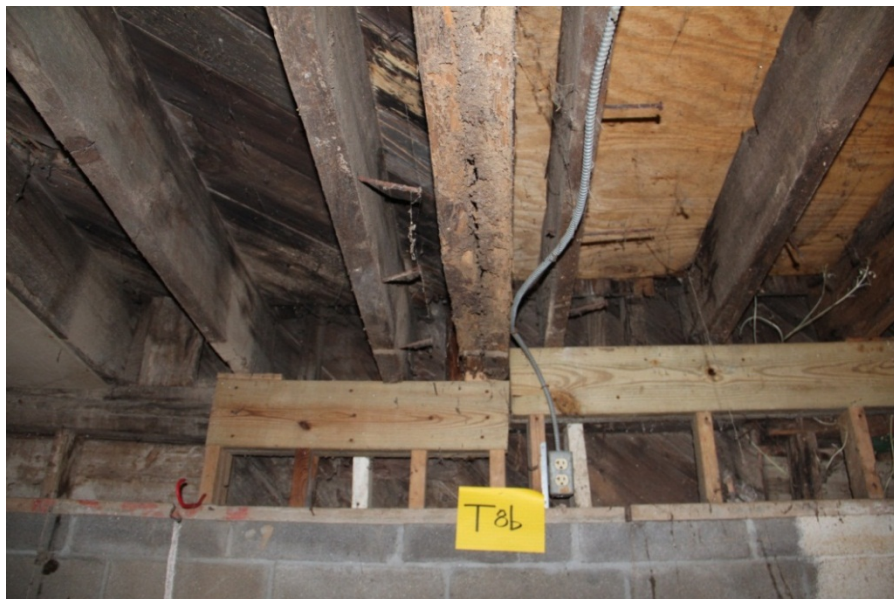
Outcome: extensive termite damage revealed in older structural members (joists and studs). Supplemental framing previously installed to support north exterior frame wall of building. Previous floor system repairs uncovered (note plywood floor sheathing).

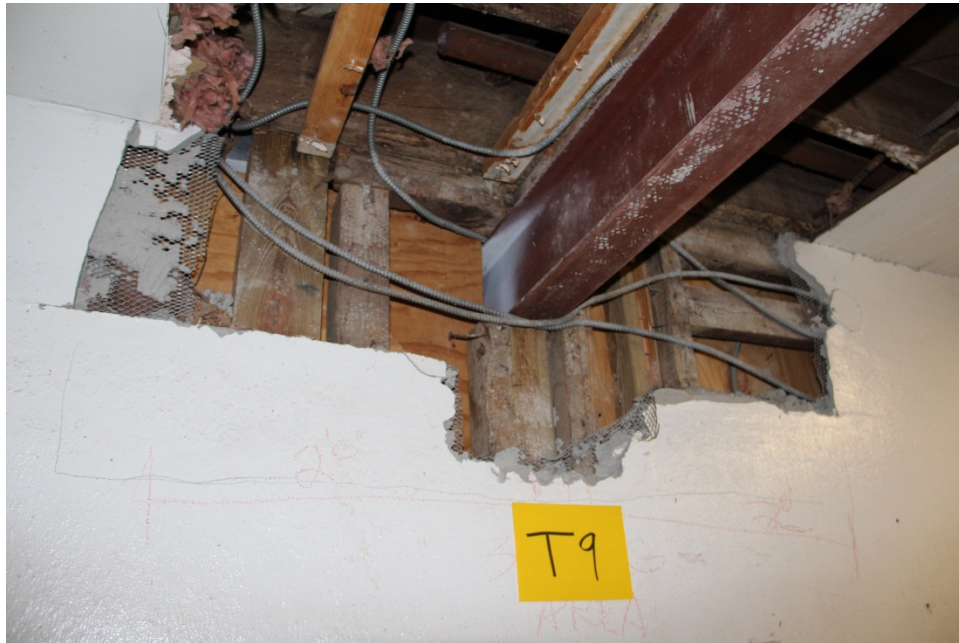
Task 9 Outcome: steel beam connection with wood wall frame revealed.

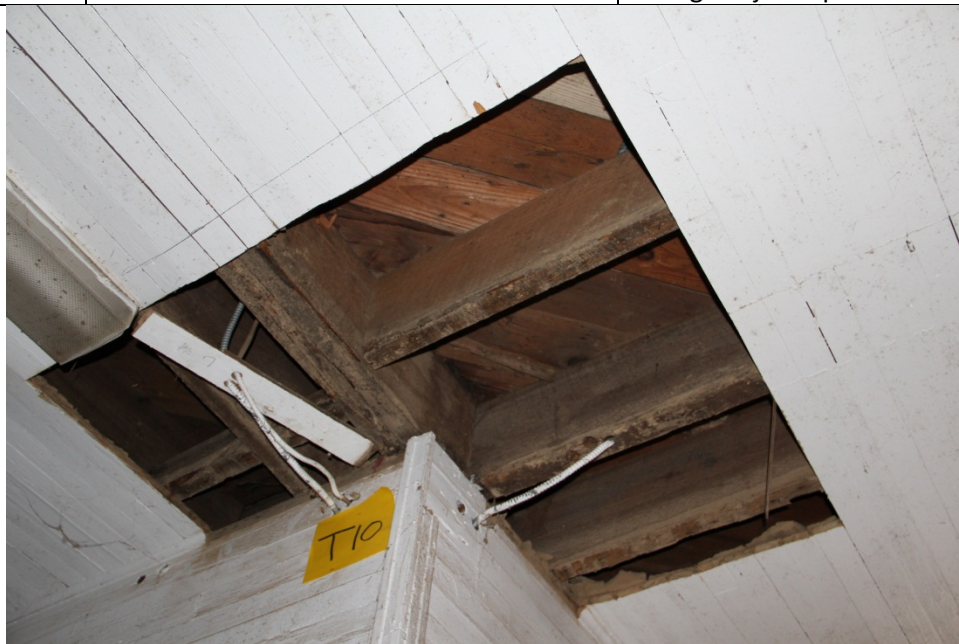
Task 10 Outcome: Floor frame structure revealed. Diagonally installed sub floor visible fastened to floor joists. Spacing, configuration, condition and perforation of frame revealed.

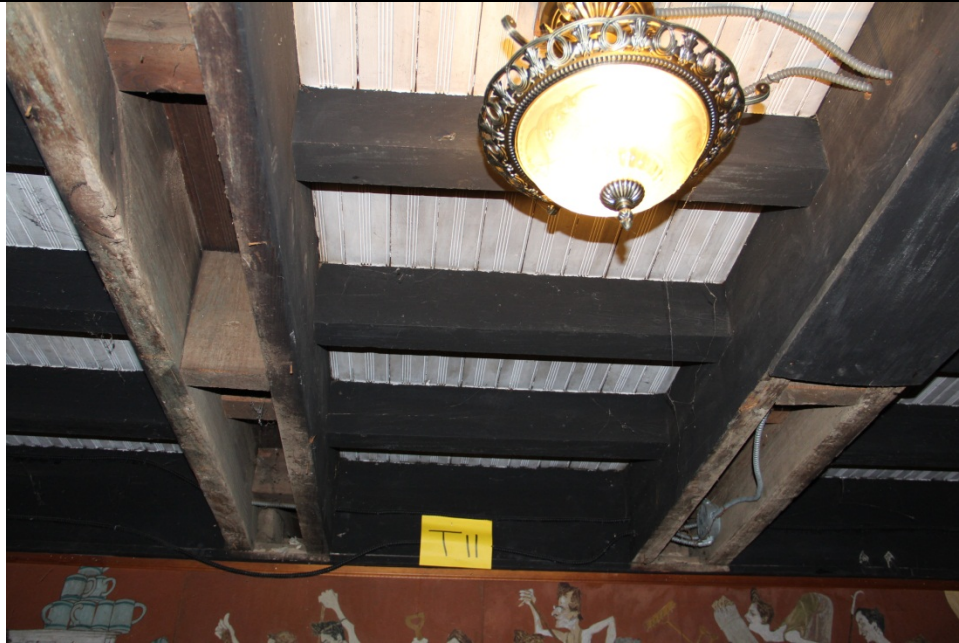
Task 11 Outcome: determined ceiling in Grill Room comprised of series of paired joists boxed in with skirt boards to create false beams. White painted tongue & groove beaded ceiling boards (seen between joists) are part of subfloor system of second floor.

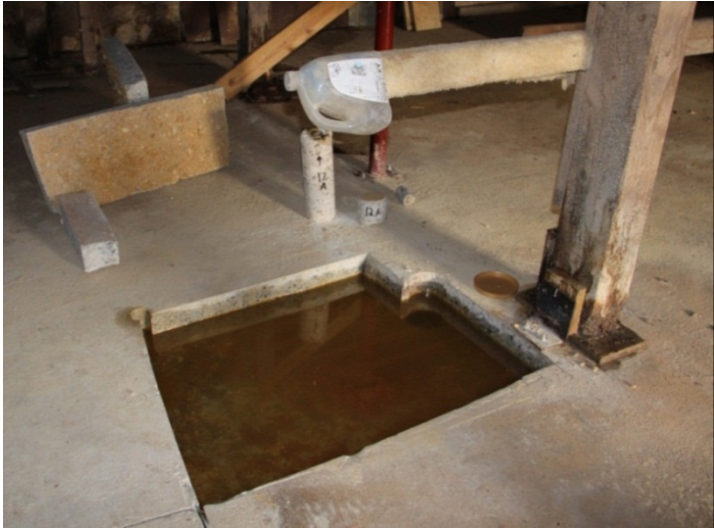
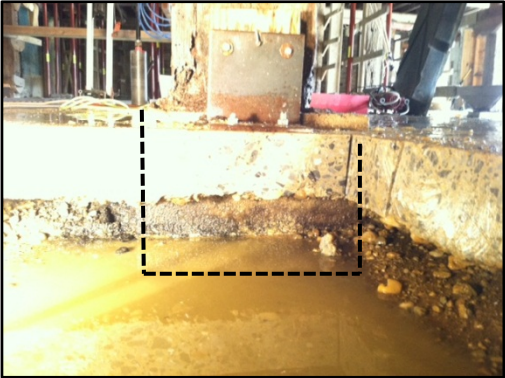
| Item | Task | Question/ Concern/ Outcome | Response/ Clarification |
|--|---|---|--|
| | | | |

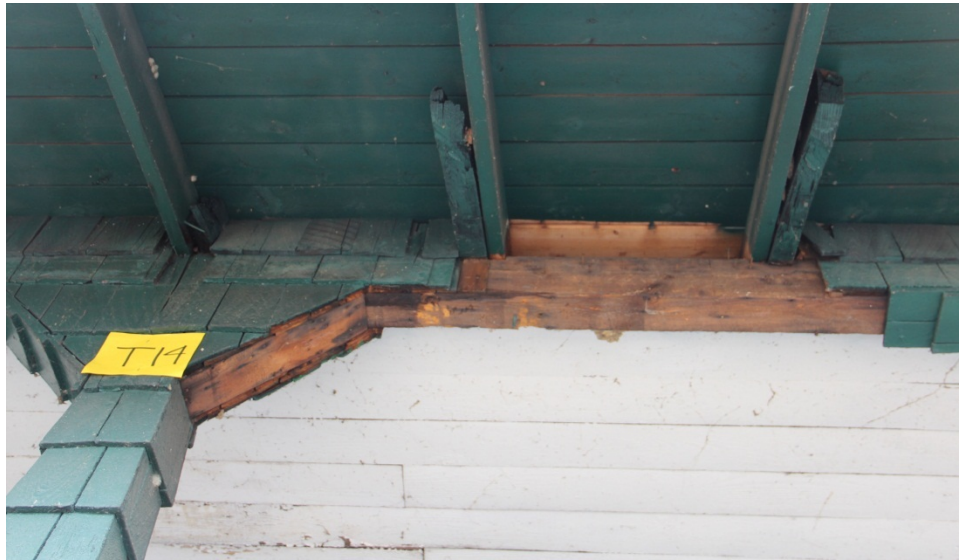
Task 14 Outcome: structural post, bolster (or half diamond capital) and porch breast beam structure revealed under original shingle cladding. Note solid beam used to support roof frame in this area of Phase 1 construction. See task 18 for comparison where a double beam was used in lieu of a solid hewn beam, as above.

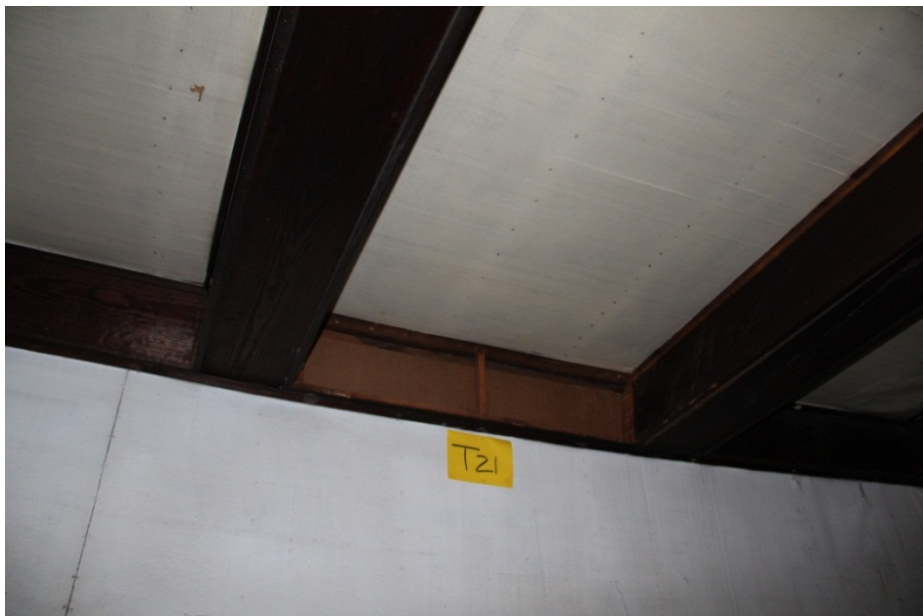
Task 21. Outcome: Interior north wall – ceiling finish removal to expose concealed structure. No hidden structure found, boxed beams are decorative (no hidden structure).
