1200 Architectural Engineers PLLC

EHT Traceries Historic Preservation

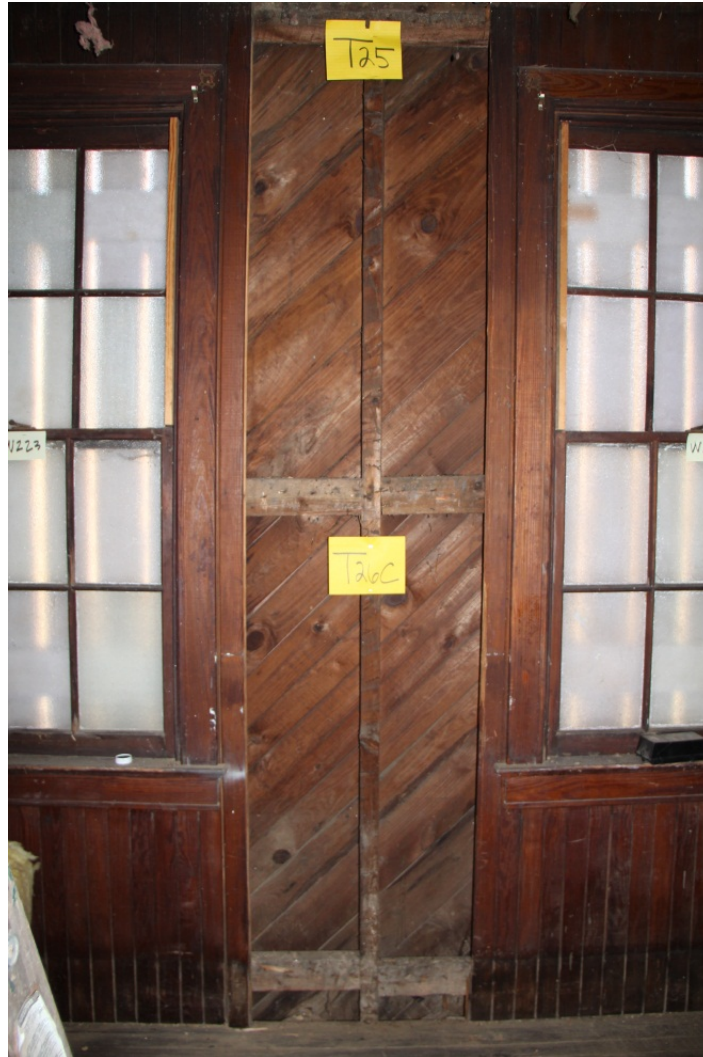
Task 26c. Exterior wall (north) in Women's Lounge. Interior vertical tongue and groove siding removed; use of cut nails noted throughout interior transitional balloon frame type construction. Diagonal sheathing is used as exterior covering of frame and wood shingles are applied over. Note darkened stain at bottom of T&G siding indicates height of historic baseboard - no longer extant.

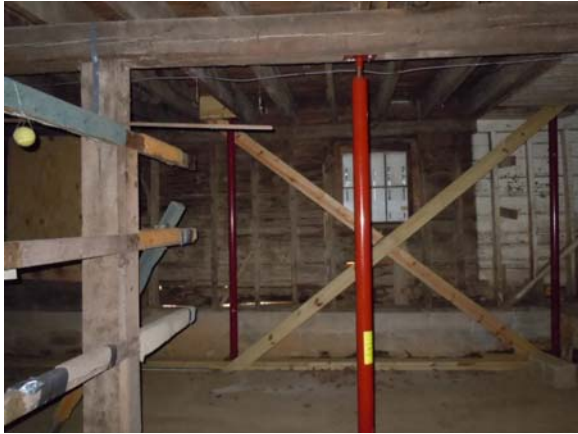
Temporary pipe columns (red) and wood cross-bracing was added by the NPS CHOH Maintenance Team according to stabilization plans by a structural engineer to correct deficiencies in the buildings superstructure. (10/23/13, HPTC)

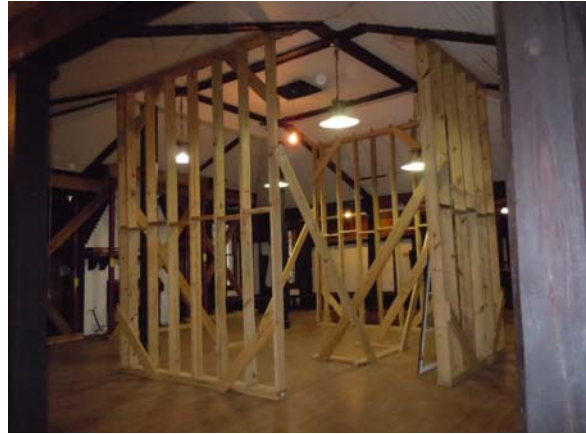
Cross-bracing was added in the Ballroom on the second level to assist in the support of the deflecting light-weight wood roof frame. (10/23/13, HPTC)

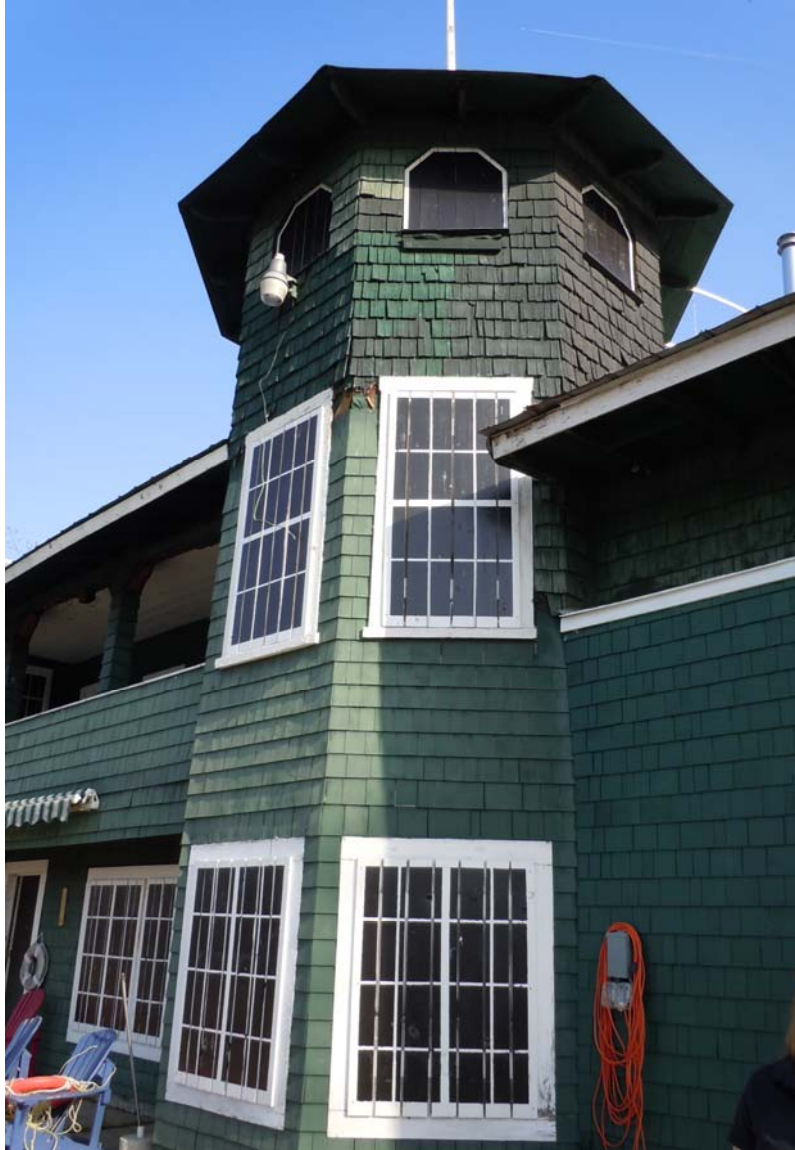
View of Washington Canoe Club exterior in April 2013. Vented window and door covers are seen covering many of the window and door openings.

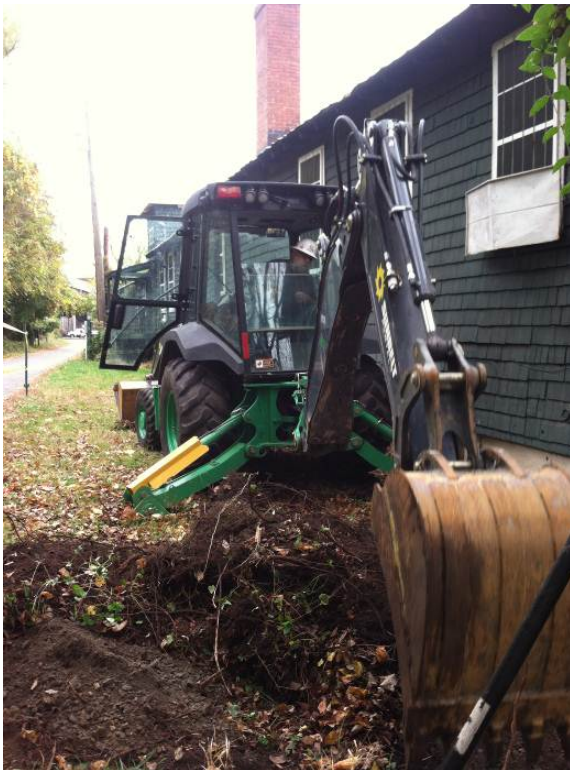
Exterior excavations conducted by the HPTC crew as part of the project of the north elevation attempted to determine the extant foundation conditions. (11/04/13, HPTC)

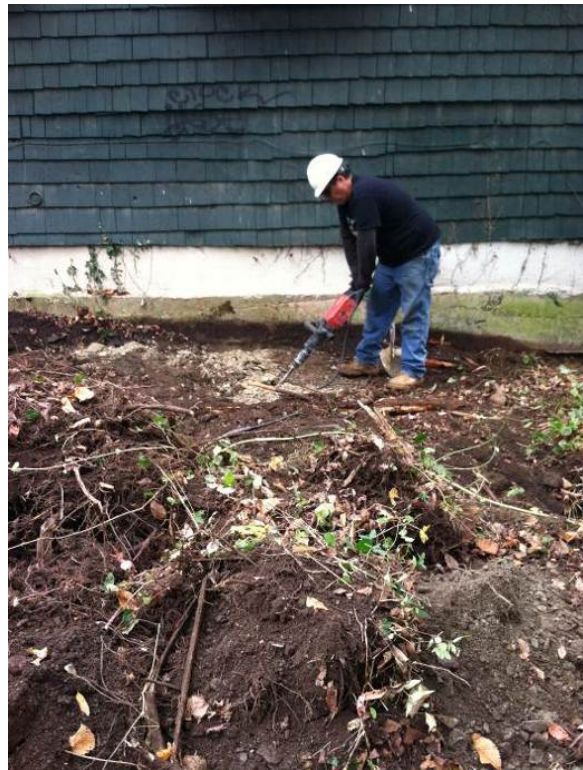
When machine excavation became problematic, hand excavation was attempted in order to uncover extent of concrete placements around base of building. (11/04/13, HPTC)

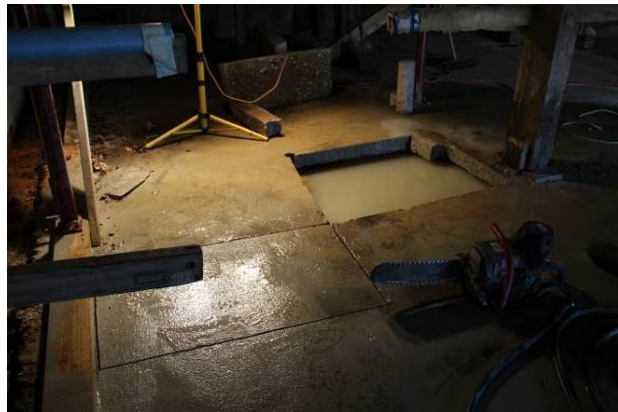
Core drilling gave way to saw cutting of slab to open up larger areas to view slab thicknesses, fill material between slabs, and lower slab conditions. This work was carried out by HPTC Masonry Team as part of the HSAR team. (11/22/13, HPTC)

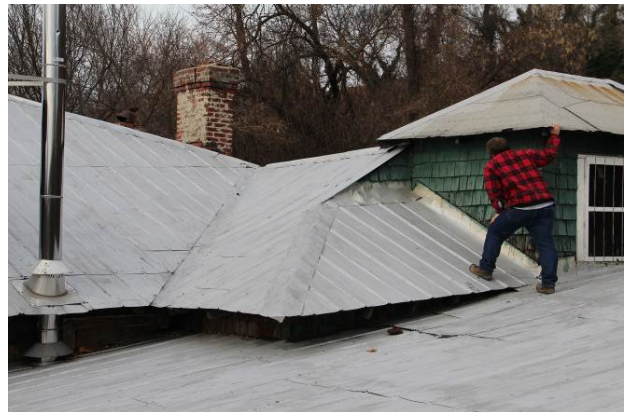
Roof observation and assessment was conducted in late December on an above average temperature day. (12/20/13, HPTC)

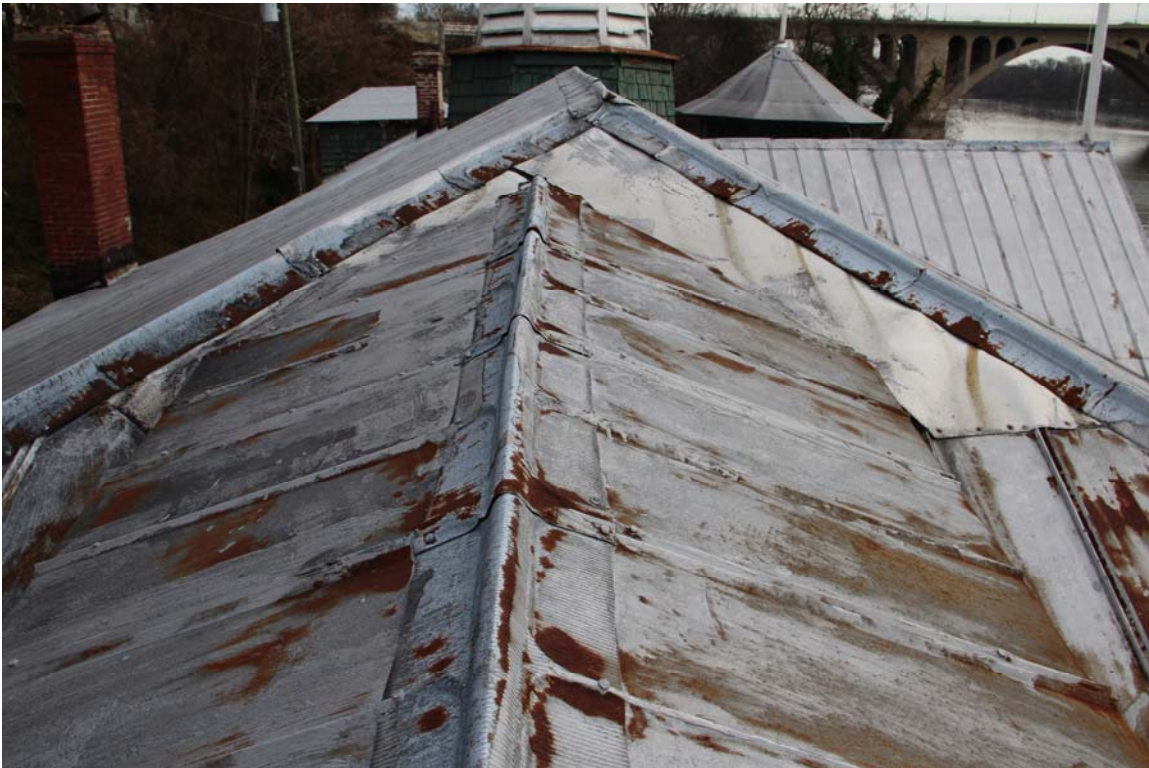
Deteriorating existing metal roof finishes and flashings.

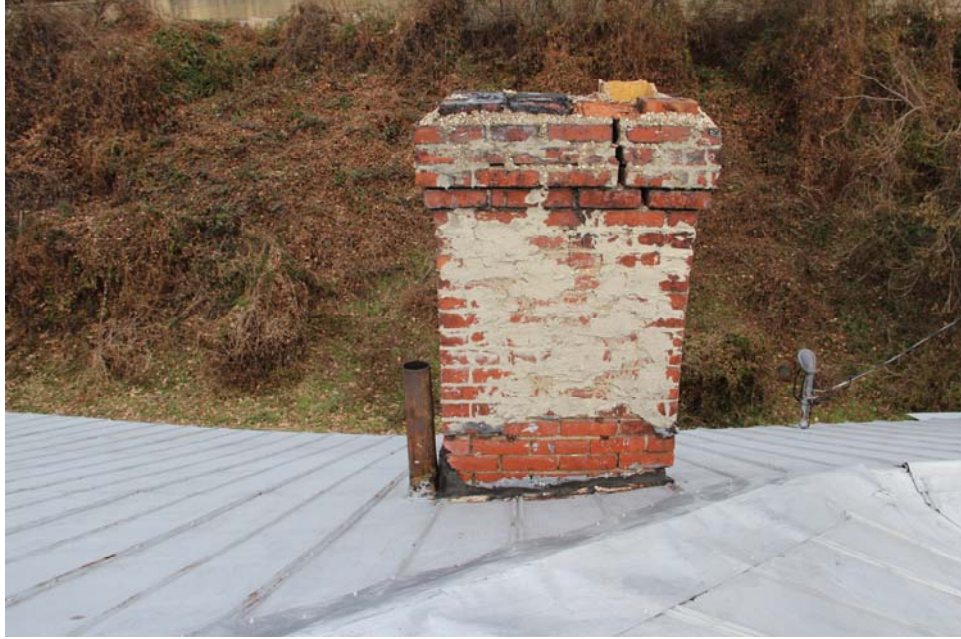
The brick chimneys are failing and lack adequate flashing.

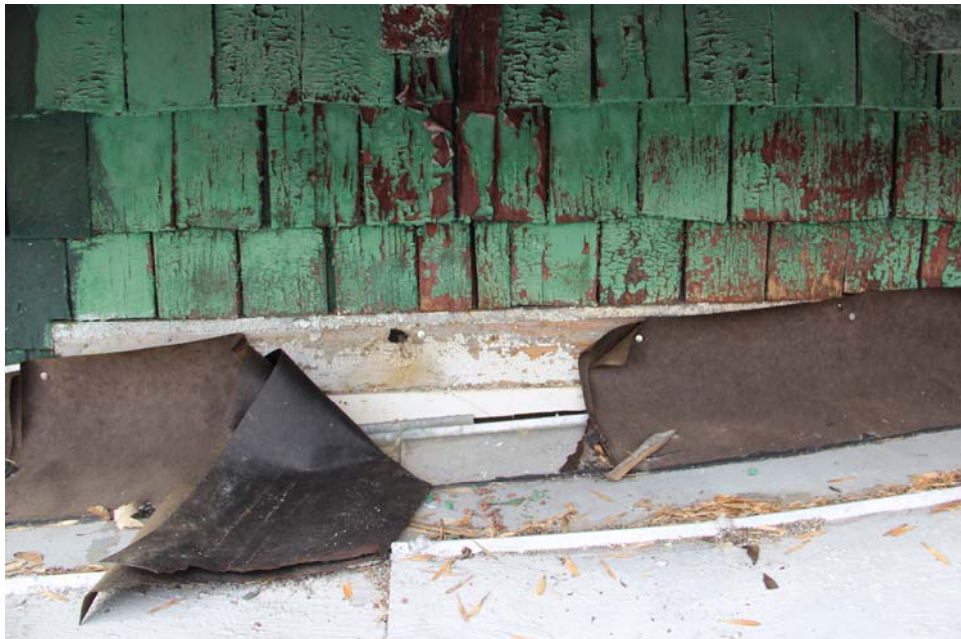
Flashings at roof intersections are failing or non-existent.

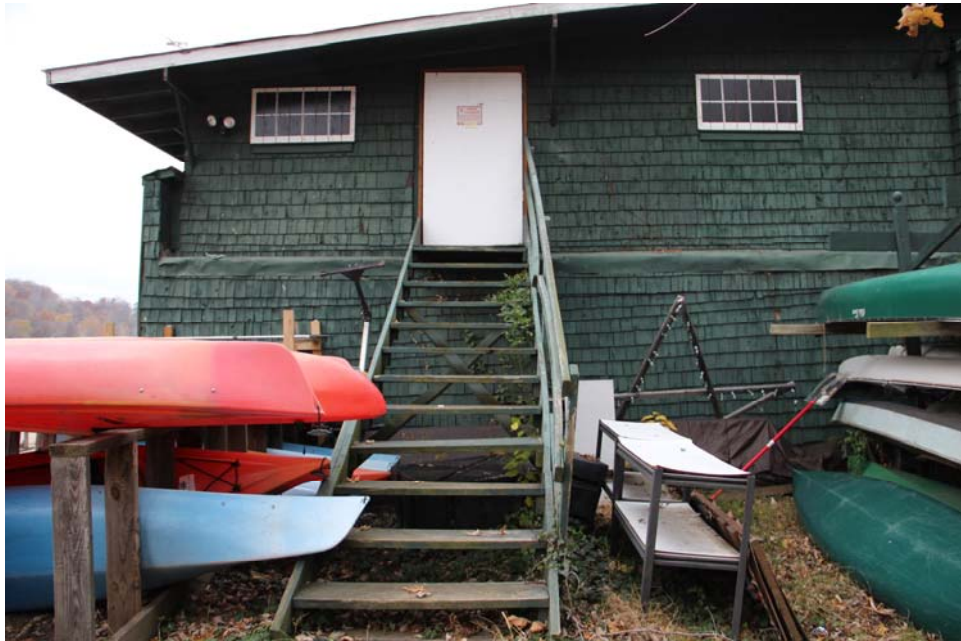
The stairs at the east entrance to the building are unstable and non-compliant with building codes.

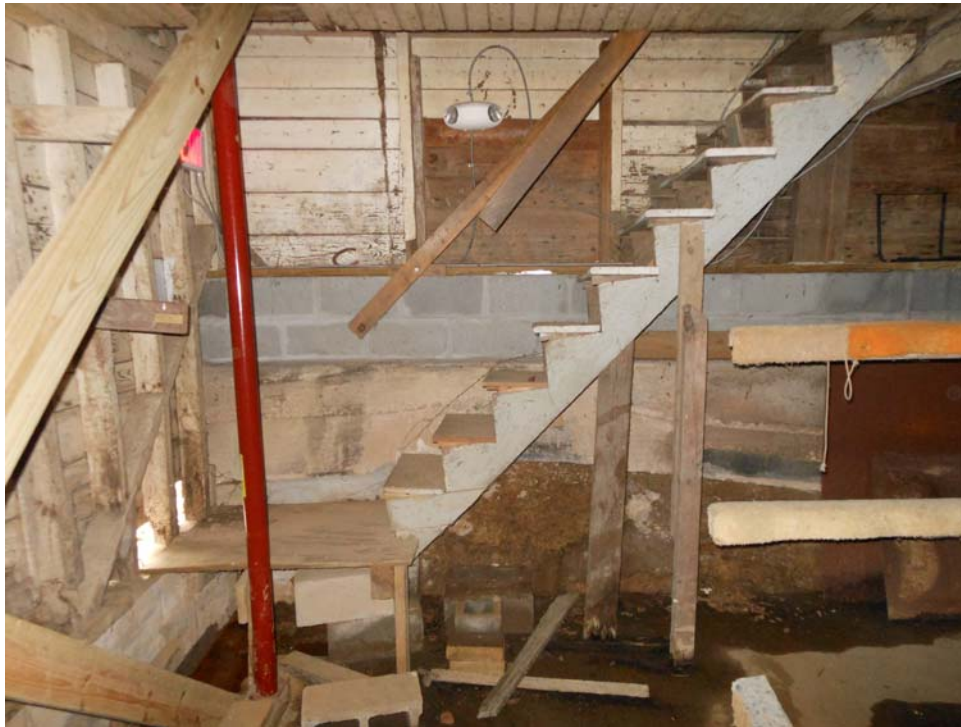
The stairs (ST01) in the northwest corner of the West Boat Storage Area (Room 101) are failing and unsafe.

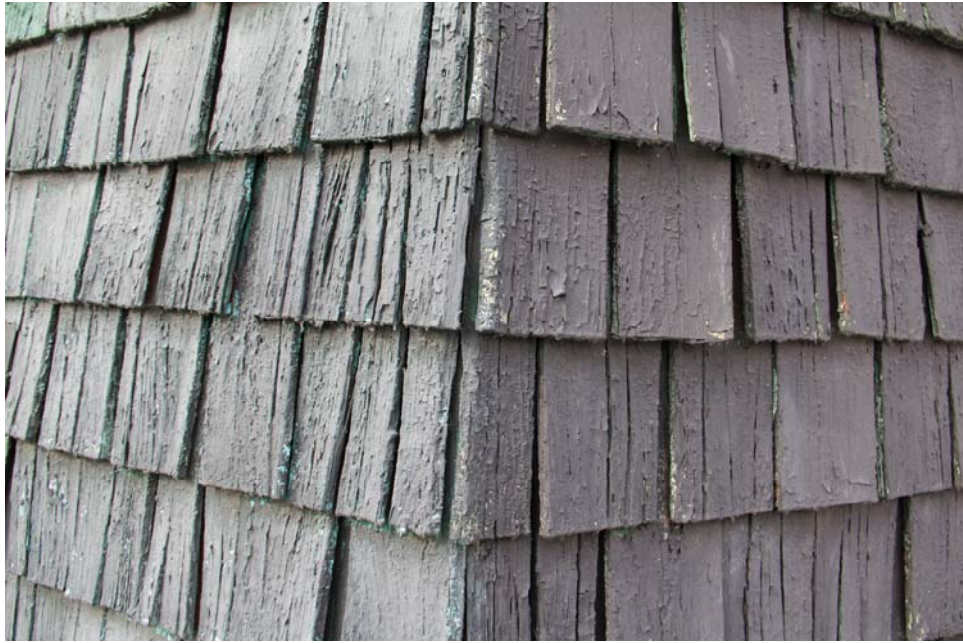
Many of the exterior wood shingles are broken, cracked, or missing, and the paint finish is failing.

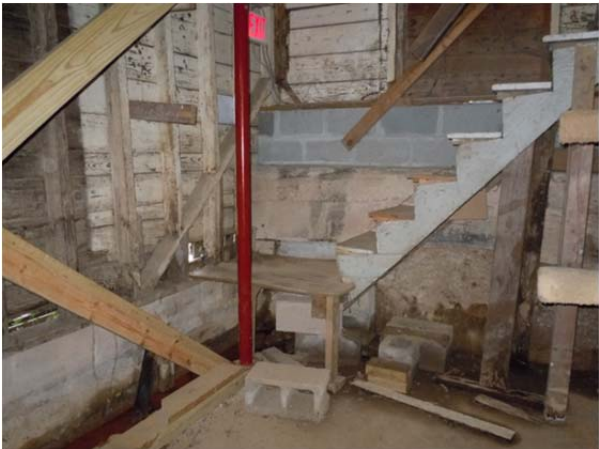
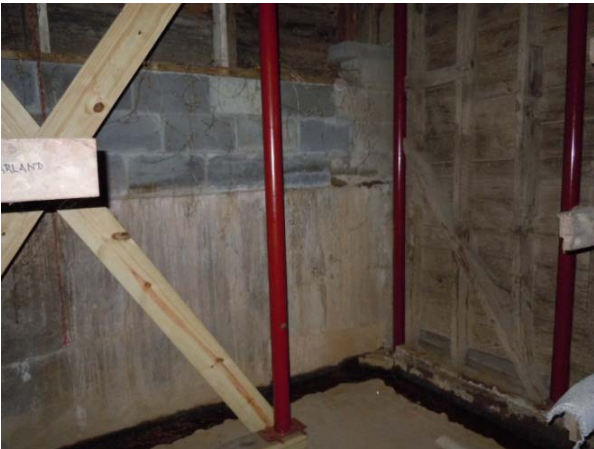
| | | | |

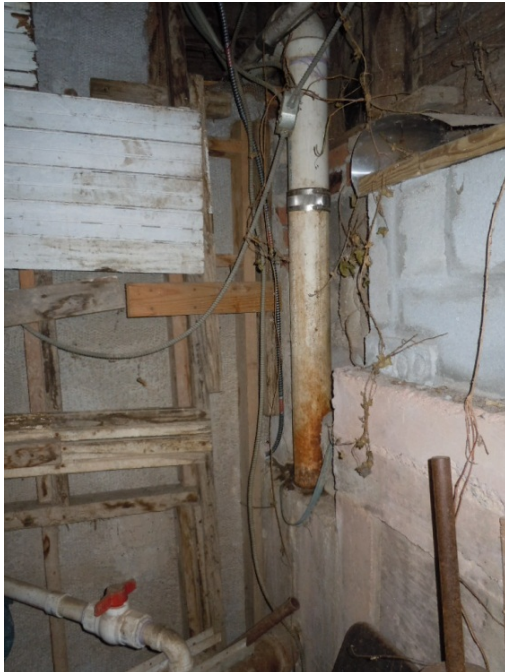
View of north west corner of east addition area showing CIP at base of wall.

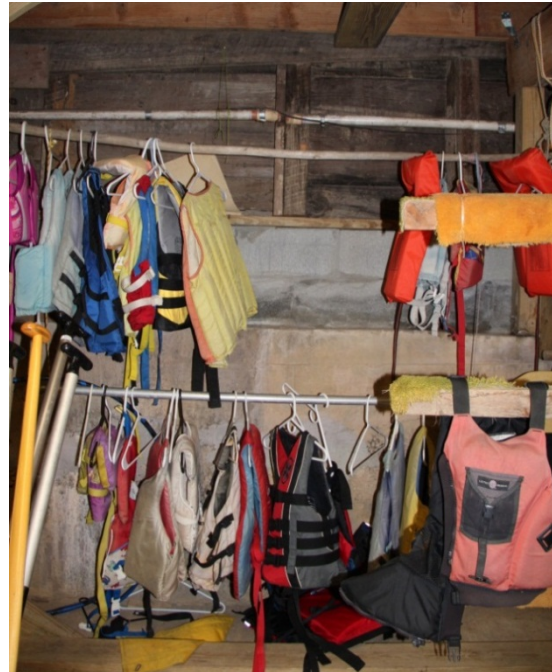
View of north wall in east addition area showing CIP surmounted by CM and north exterior wood frame wall.

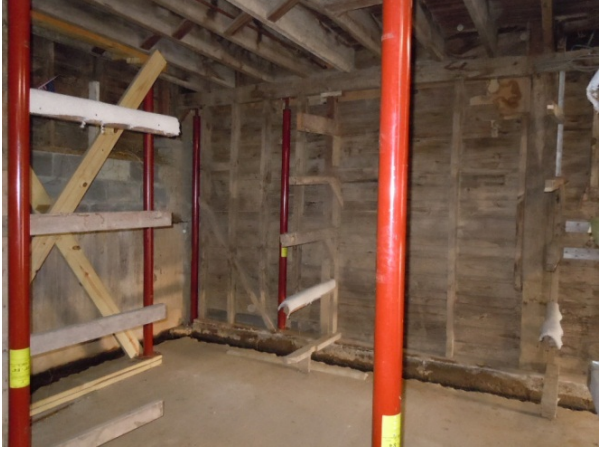
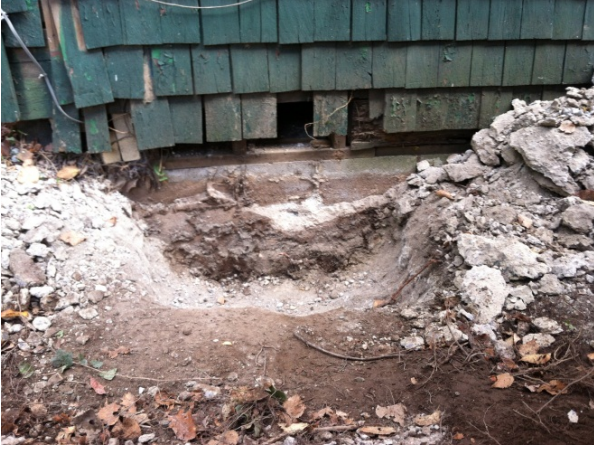
| | | |

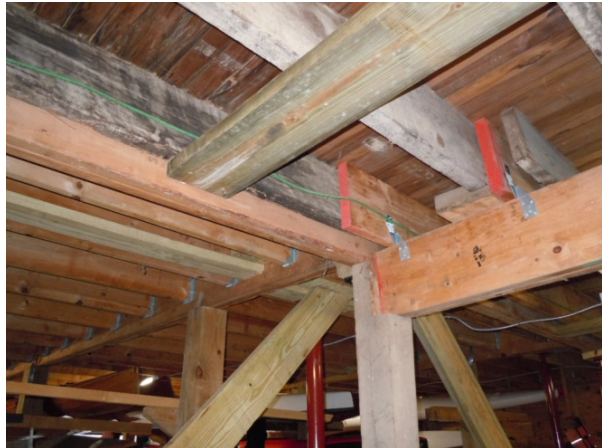
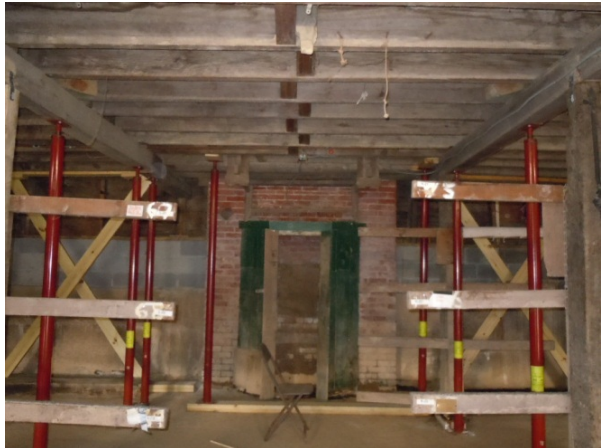
| <p>Example of supplemental framing inserted to support floor frame of Ballroom area in West Boat Storage Area.</p> | <p>Example of supplemental framing inserted to support floor frame of Ballroom area in West Boat Storage Area.</p> |

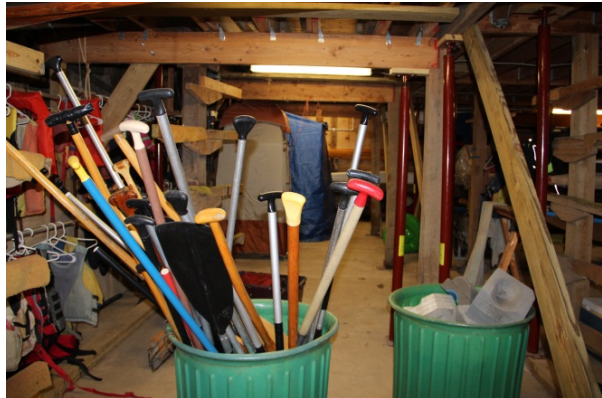
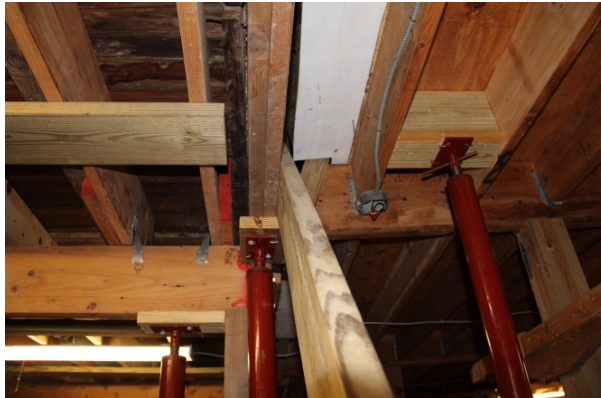
| <p>Example of supplemental framing inserted to support floor frame of Women’s Locker Room Addition in the East Boat Storage Area.</p> | <p>Example of supplemental framing inserted to support floor frame of Women’s Locker Room Addition in the East Boat Storage Area.</p> |

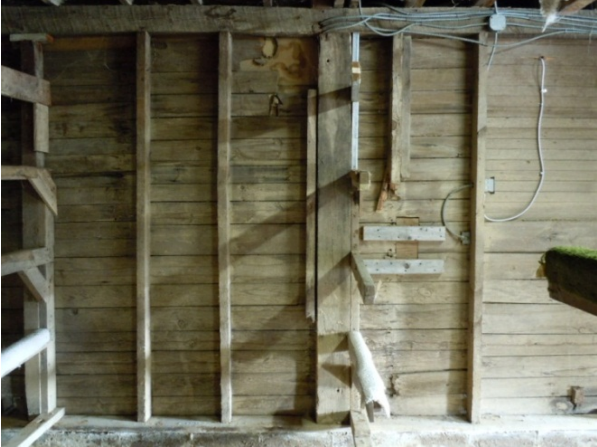
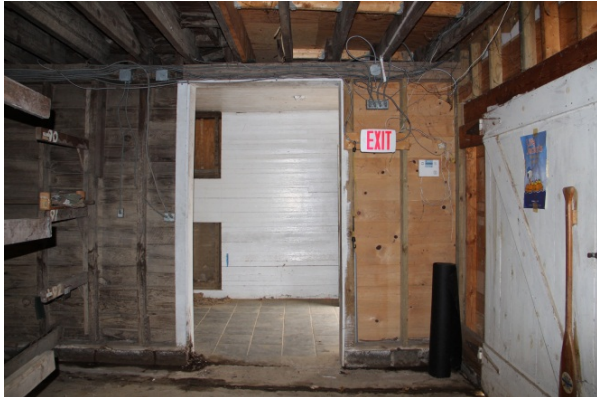
| <p data-bbox="188 751 800 909">View of center section of west interior side of original end wall of the Phase 1 construction sequence. This wall separates the West Boat Storage Area (Room 101) from the Hall (Room 104) on the first-floor level.</p> | <p data-bbox="821 751 1433 909">View of dividing wall and doorway (Door 108) between the West Boat Storage Area (Room 101) and the Hall (Room 104). This wall was the original east exterior wall of Phase 1 construction.</p> | |

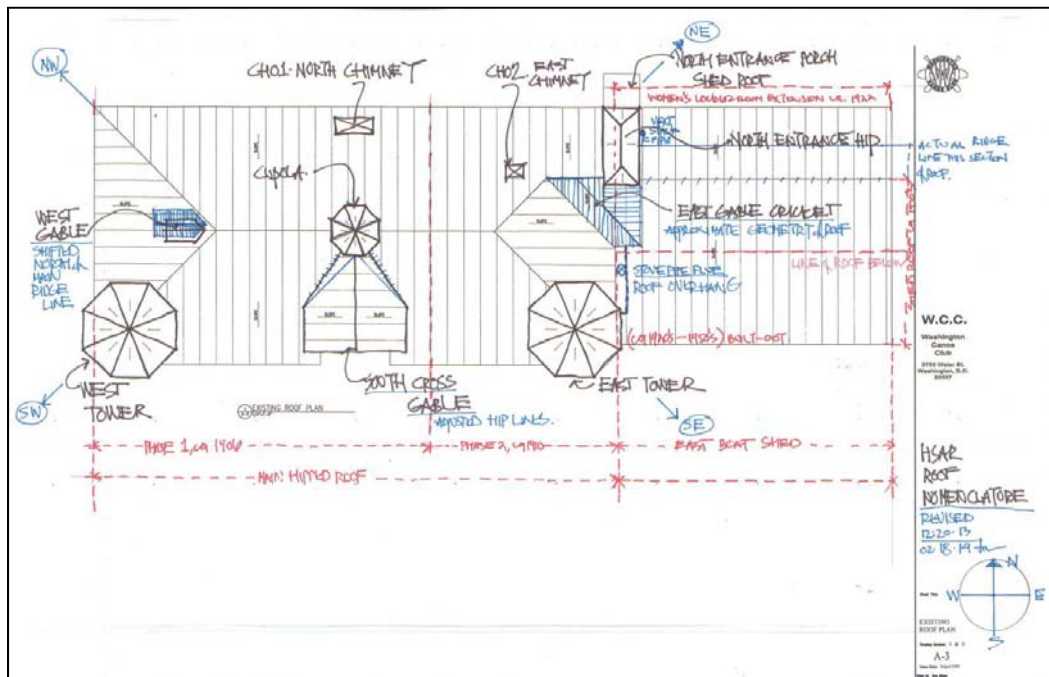
| | <b>B102001-1a</b> | <b>Main Block Hipped Roof Frame</b> |

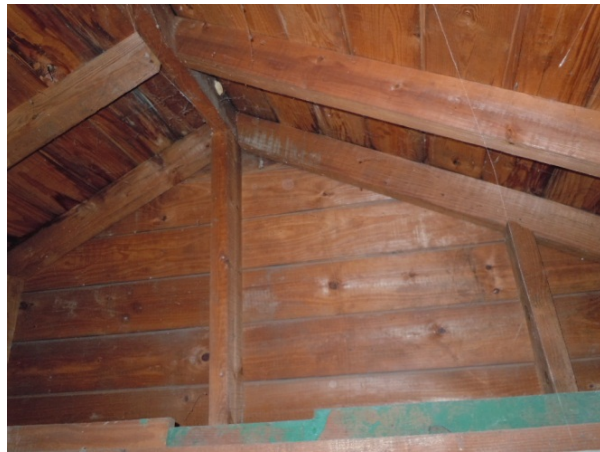
View of underside of simple gable truss roof frame at the Women’s Locker Room. The locker room was constructed in two phases and minor variations occur between the two sections of roof frame.

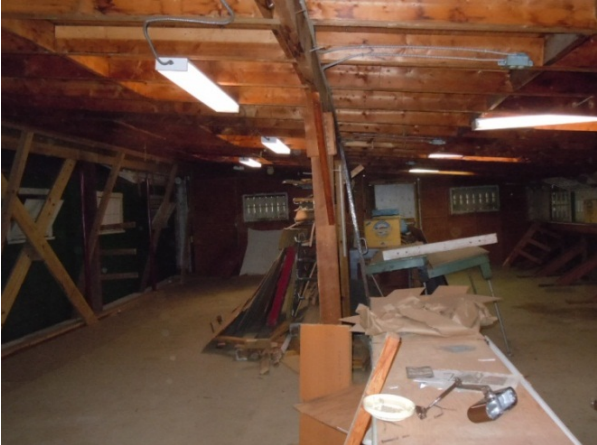
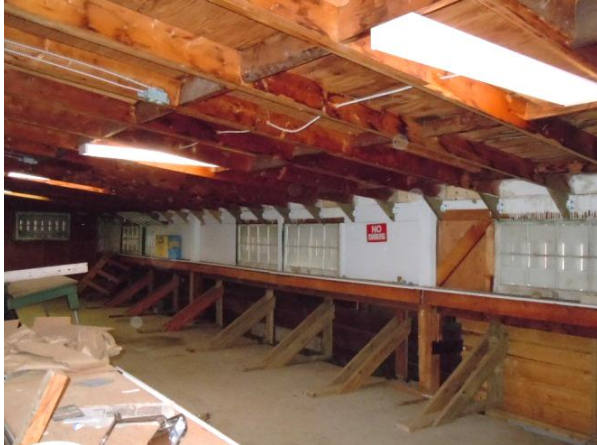
| <p>Interior view of work room, looking towards east, showing roof frame with central row of vertical supports. This area was originally an exterior open-roofed deck.</p> | | <p>Interior view of work room, looking towards east, showing southern side of roof frame and exterior wall supports along the river elevation of the building.</p> |

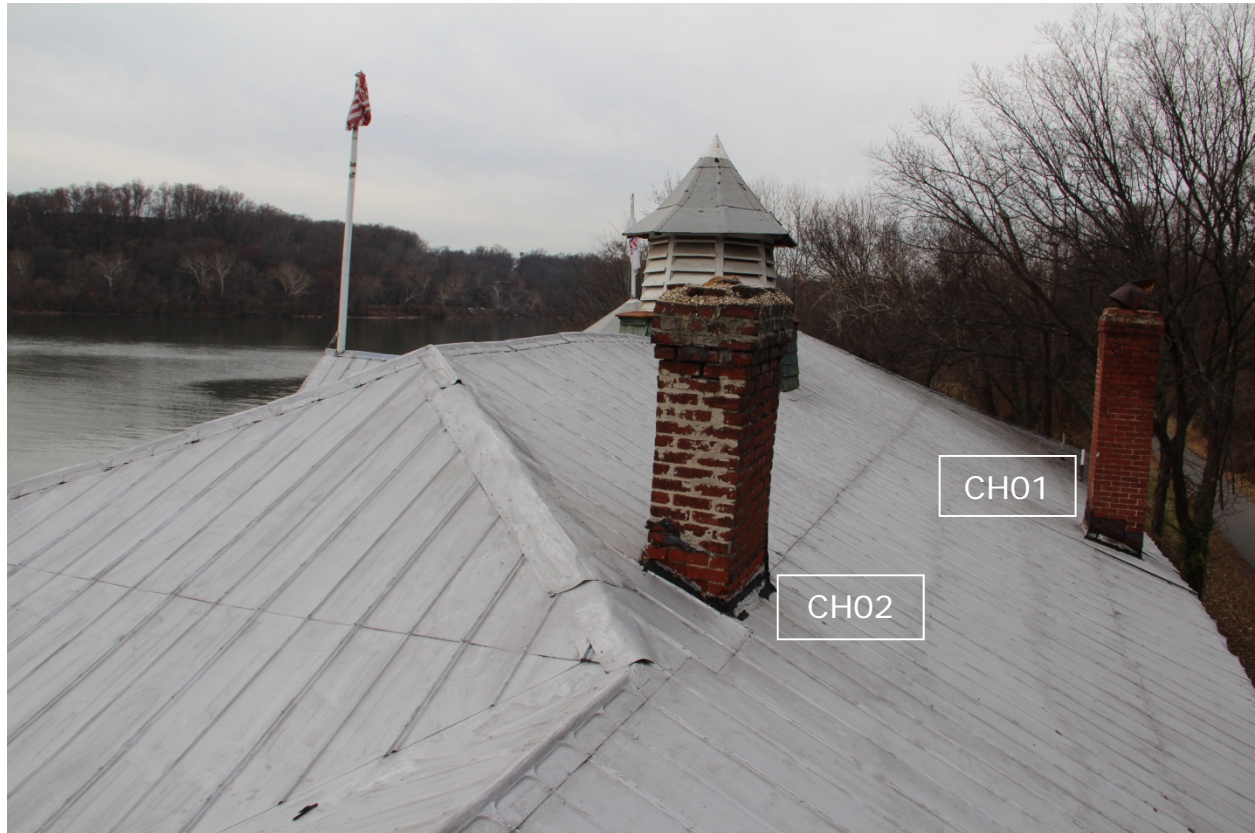
View of north slope of main house hipped roof showing relative positions of two chimneys. The north chimney (CH01) services the ballroom fireplace and exhibits a brick base in the lower boat storage room of the main house area. The east chimney (CH02) services the kitchen area and may have provided a flue for the former heating system.

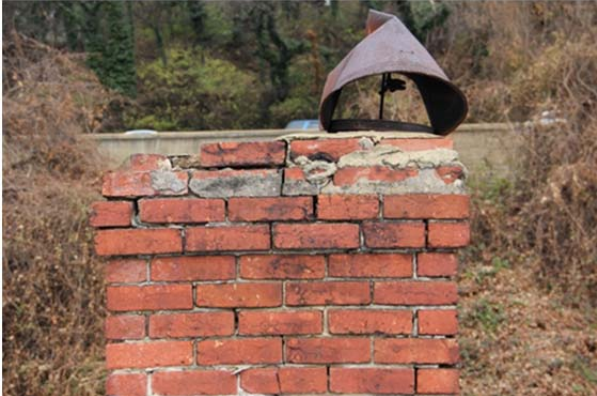
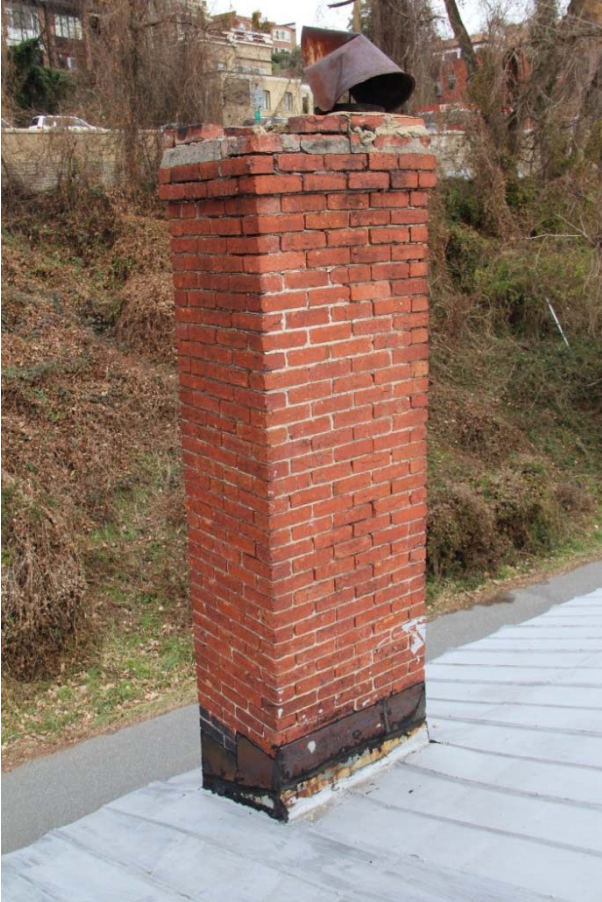
| <p>South elevation, top of chimney. Note deterioration of brickwork, eroded chimney top and metal flue cover.</p> | | | <p>South and west elevations of chimney and flashing. Note open mortar joints and general erosion of mortar. Chimney brick is laid in common (running) bond with corbeled course near the top.</p> | |

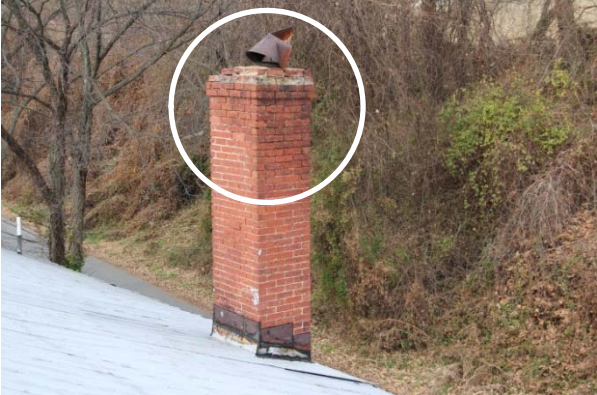
| <p>South and east view of chimney in poor condition; loss of chimney brickwork corbel features, open flues with no cover. Area in circle shows large loss of mortar between joints.</p> | | | | |

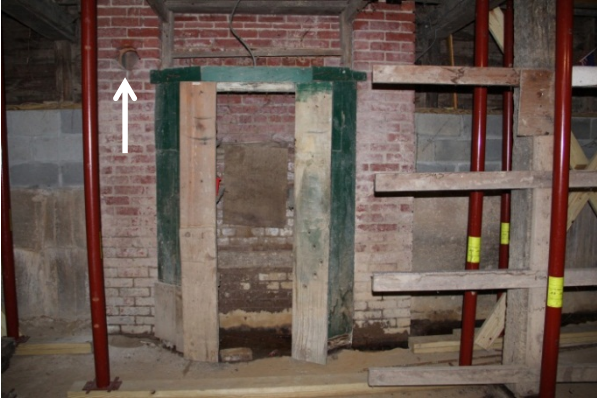
| <p>Base of chimney on first floor with storage cabinet built into the cavity of base. Note stove pipe hole at upper left (arrow).</p> | <p>View of fireplace in Ballroom (white paint is not a CDF) with cracking visible at the base on either side of the firebox opening (obscured in this photo on left by wood brace).</p> |

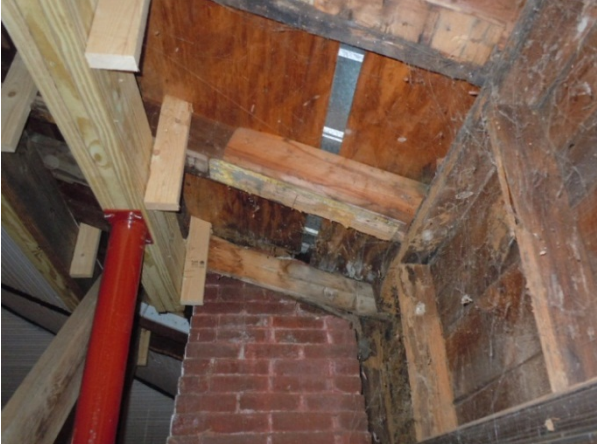
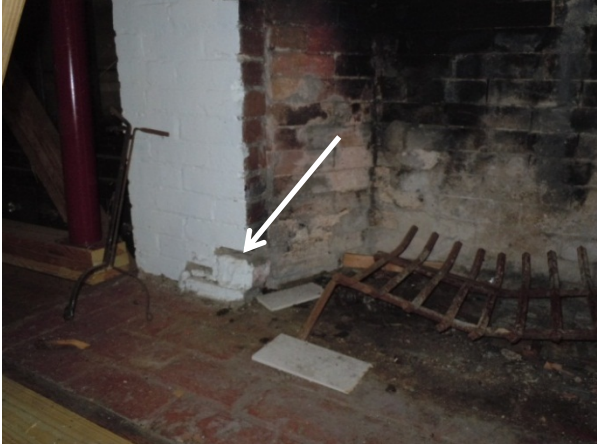
| <p>Unpainted side elevation of brick chimney in Ballroom (Room 201). Brick is laid in common (running) bond.</p> | <p>Base of fireplace with displacement and settlement of brickwork near floor (arrow).</p> |

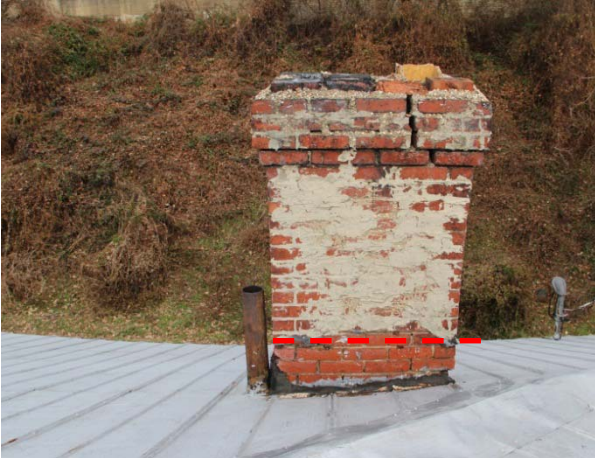
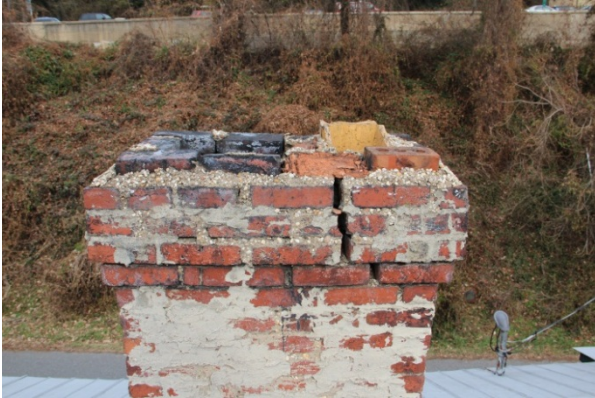
| B102099-2 | East Chimney (CH02) - Kitchen |
|---|---|
| <p data-bbox="188 724 800 850">View of south elevation (upslope) of east chimney. Note line of non-extant original base flashing and extreme parge-like application of mortar to cover brickwork.</p> | <p data-bbox="823 724 1435 819">Note extreme displacement of bricks at top of double-flue chimney and erosion of mortar cap.</p> |

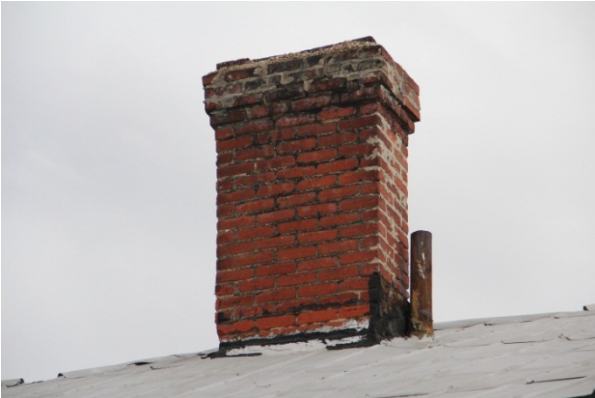
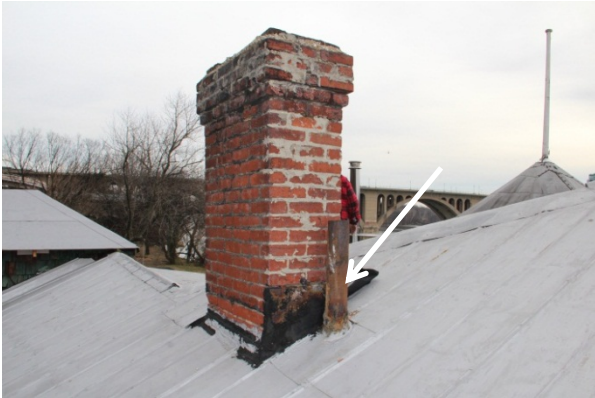
| B102099-2 | East Chimney (CH02) - Kitchen |
|---|---|
| <p data-bbox="188 1312 800 1375">North elevation of chimney with brick laid in common (running) bond.</p> | <p data-bbox="823 1312 1435 1470">North and east elevations of chimney in poor condition without chimney cap. Adjacent cast iron pipe (arrow) is a vent stack likely servicing the kitchen and first floor men's and women's restrooms.</p> |

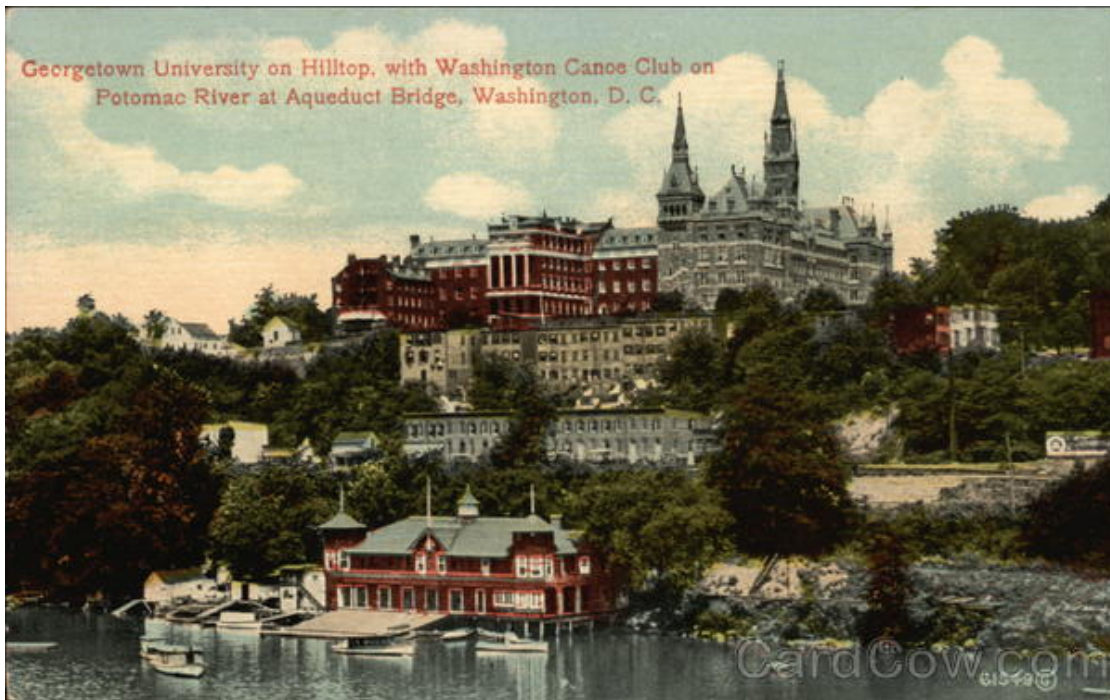
This image of a postcard shows the canoe club building prior to construction of the east addition which was built in ca. 1922. Note the red siding color.

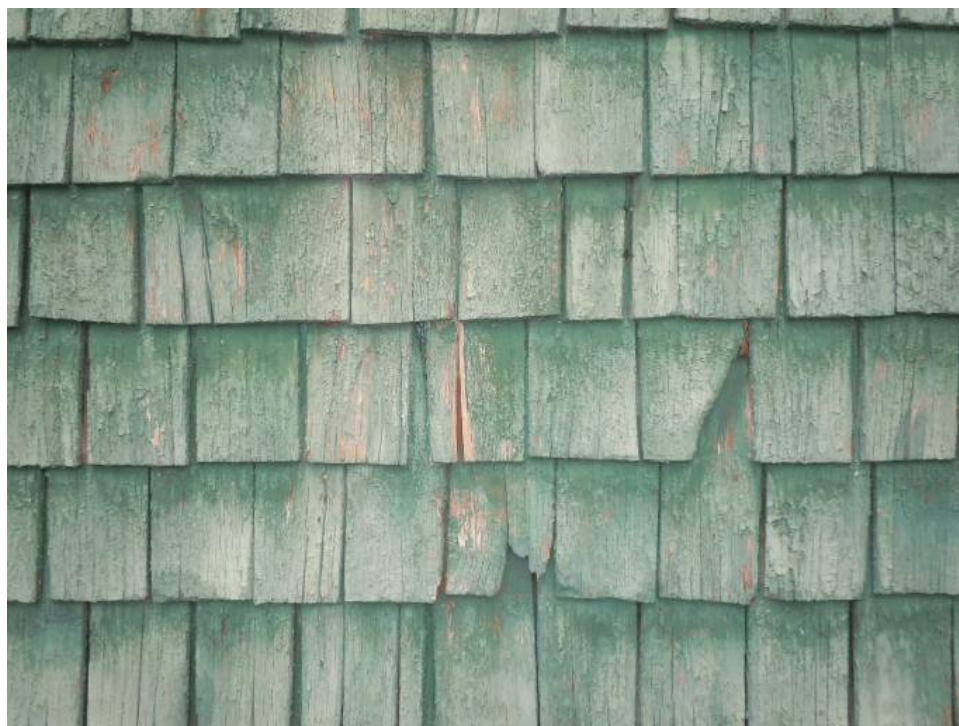
Detail of shingle siding with cracked and broken shingles and failing paint finish.

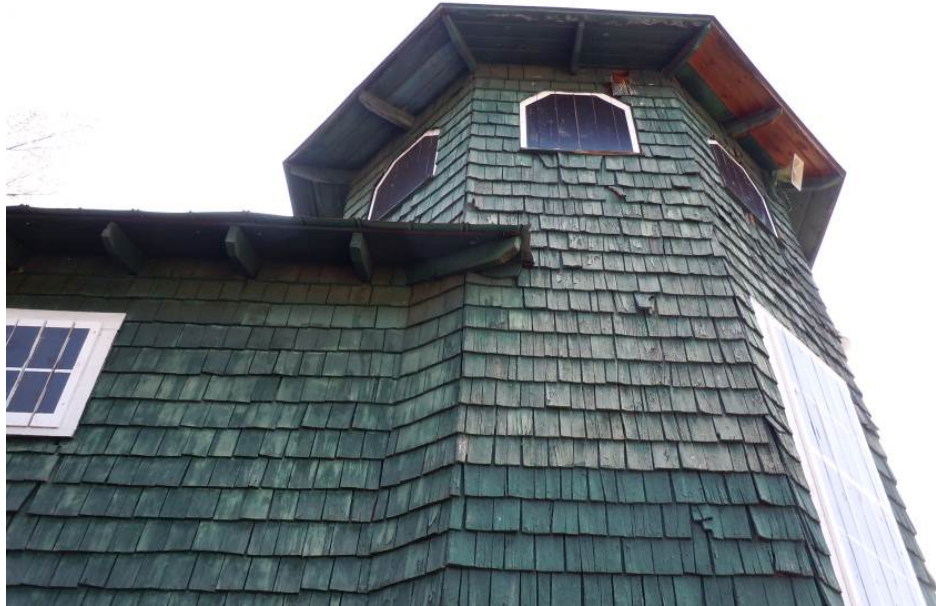
Weathered shingles on the west elevation of the west tower.

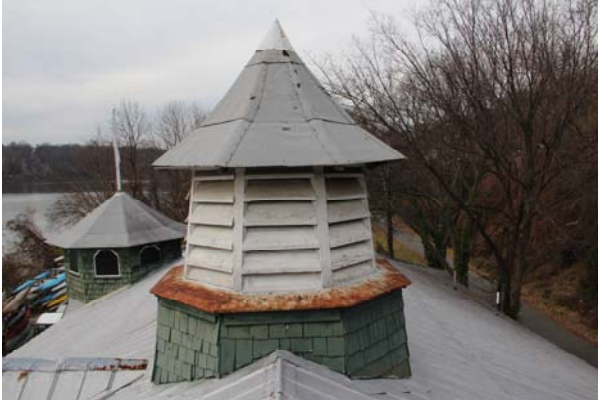
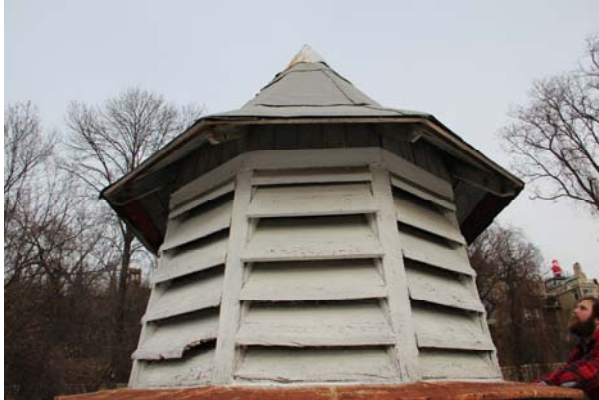
| <b>B201005</b> | | <b>Exterior Louvers &amp; Screens</b> | |
|---|---|---|--|
| | | | |

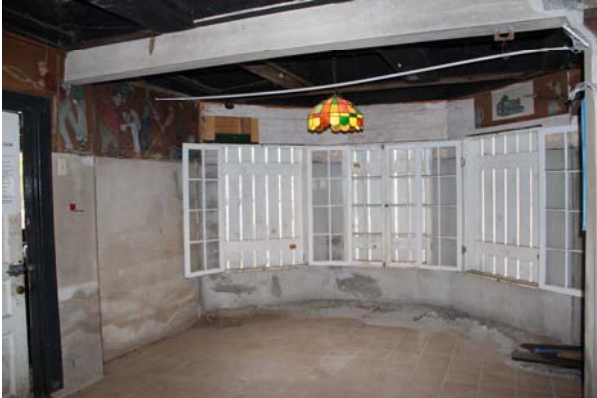
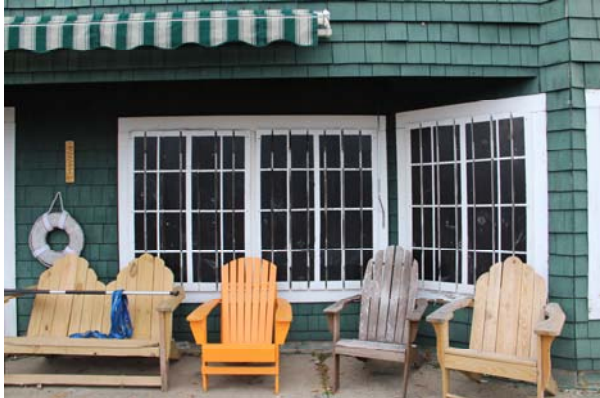
| <p>Interior view of Grill Room with panels and windows in open position.</p> | <p>Exterior view of Grill Room with painted mothball panels attached.</p> | |

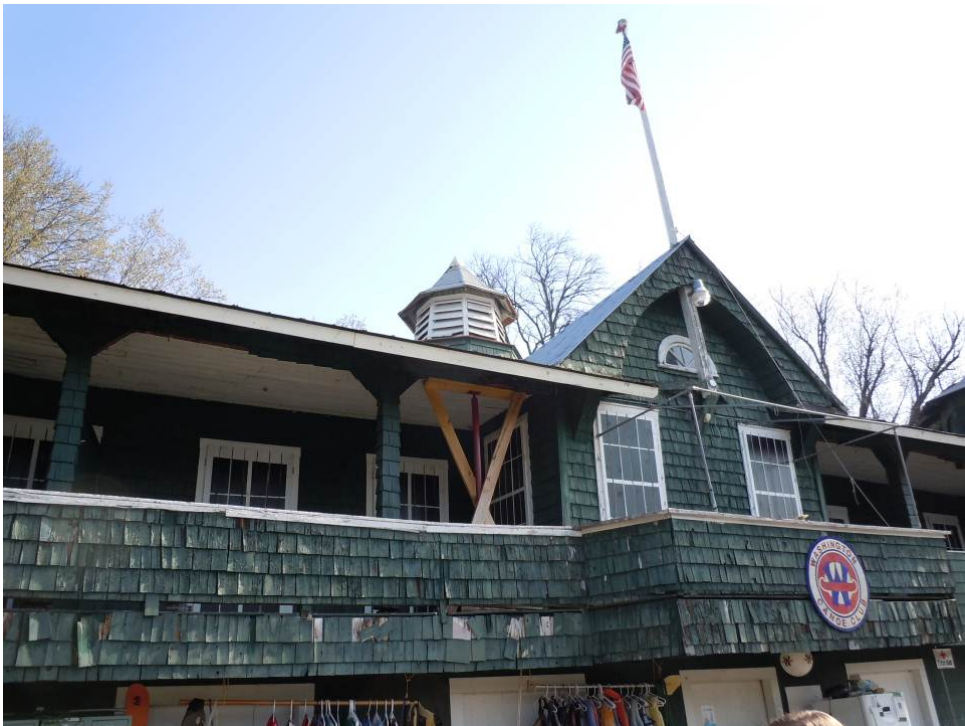
| | | | <b>B201007</b> | <b>Balcony Walls &amp; Handrails</b> |
|--|--|--|---|---|
| <p>The siding on the west and center section of the Balcony (Room 212) is in poor condition.</p> | | | | |

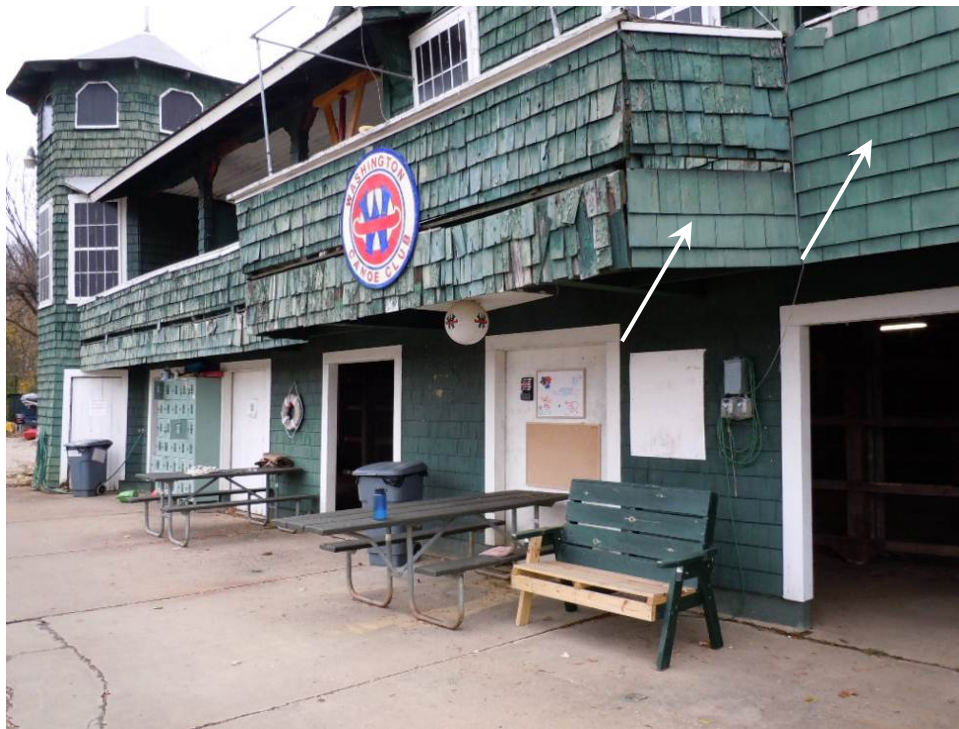
The shingle siding on the eastern section of the balcony (*arrows*) is newer and in good condition.
