1200 Architectural Engineers PLLC

EHT Traceries Historic Preservation

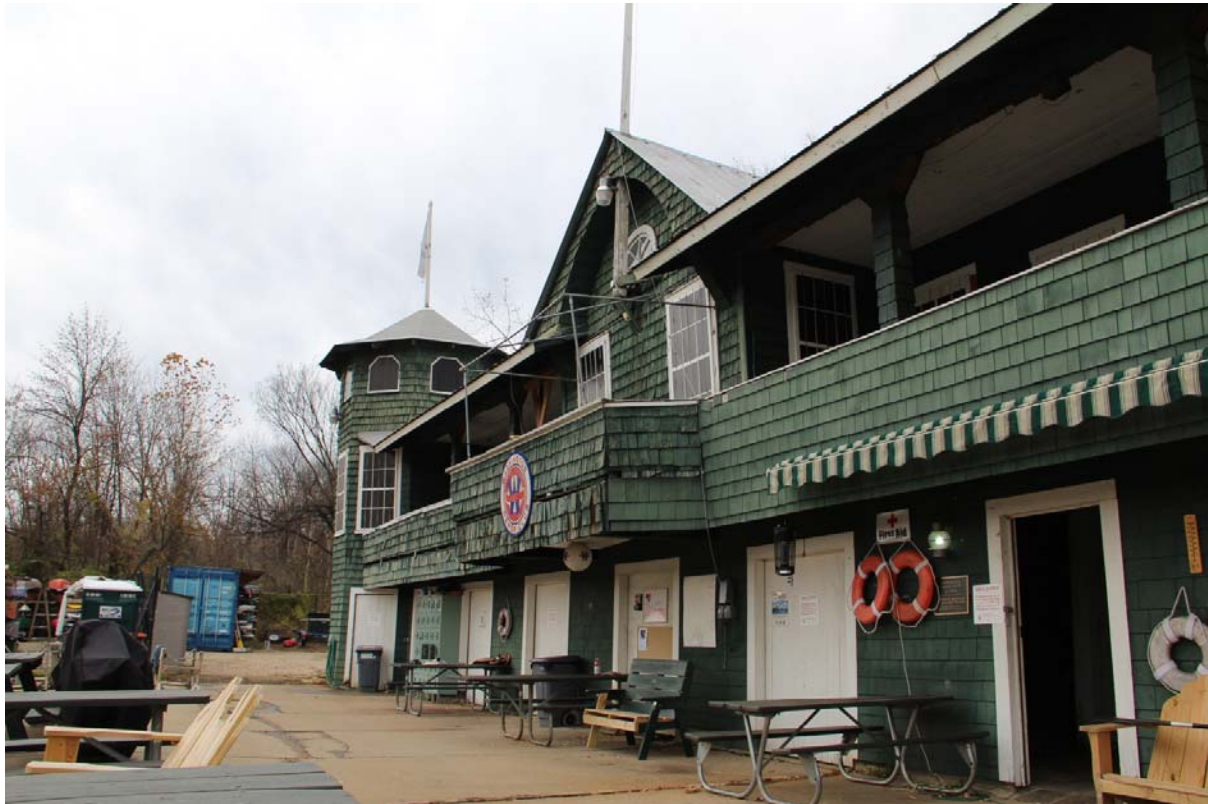
The south elevation (principal façade) of the Washington Canoe Club Building features a complex roof with many overhanging and recessed soffit areas including: the overhang of the balcony roofs (part of the main hipped roof), the east and west tower and cupola overhanging roofs and the overhanging eaves of the other roof systems. This is a feature of the American Shingle Style as it reinforces the horizontality of the building on the landscape. The overhang at the balcony was extended using supplemental rafters to protect the balcony deck from the weather. The recessed arch feature in the central gable is not considered a soffit. This feature is generally in fair condition requiring attention within one to three years. There are many localized areas with deteriorated base materials, leaking flashings, unpainted or paint in poor condition.

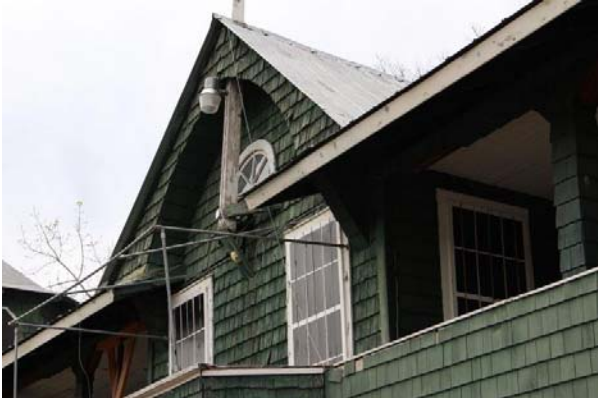
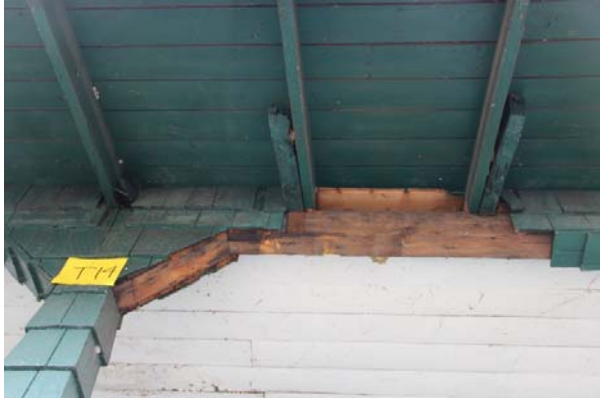
| | | | |

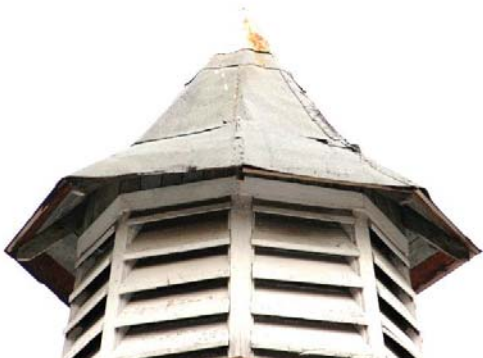
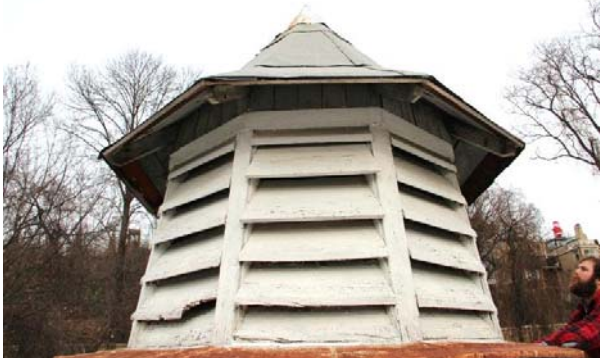
| | | | |

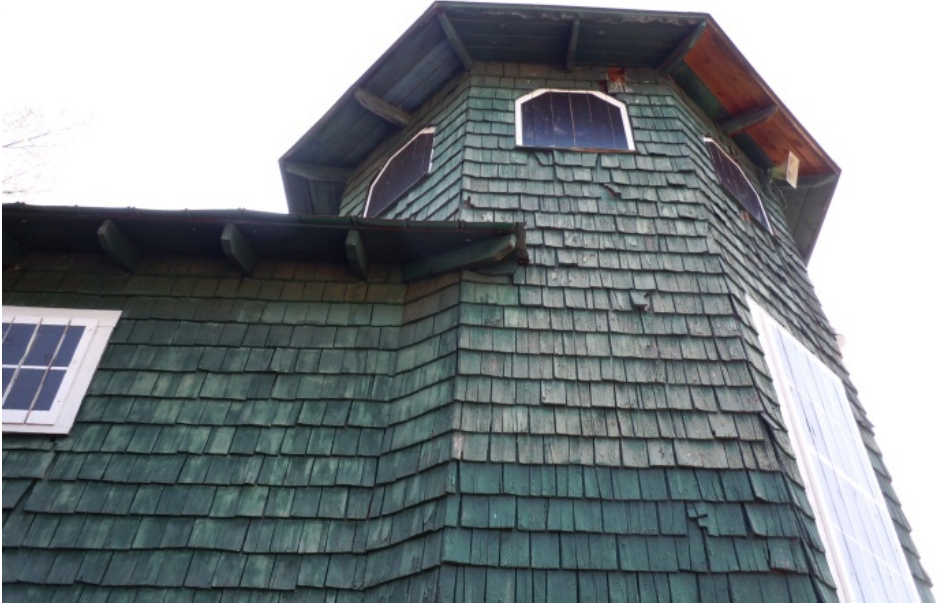
| | <b>B201008-3</b> | <b>West Tower Roof Soffit</b> |
|---|---|---|
| | | |

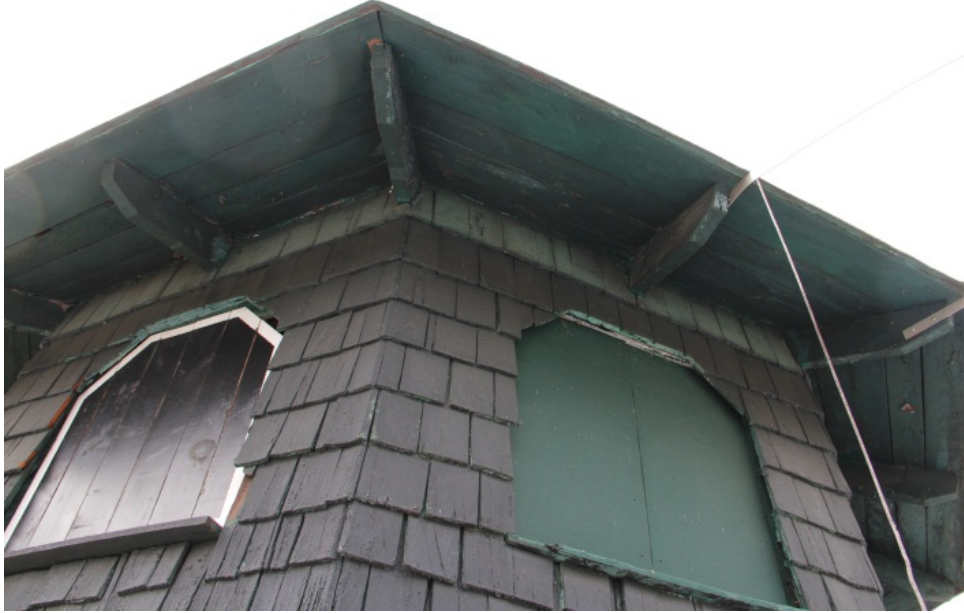
| <p data-bbox="344 940 1302 1033">The construction conditions and detailing of the east tower is similar to the west tower. Most materials are painted, not deteriorated and generally keeping water out of the building.</p> | | | |

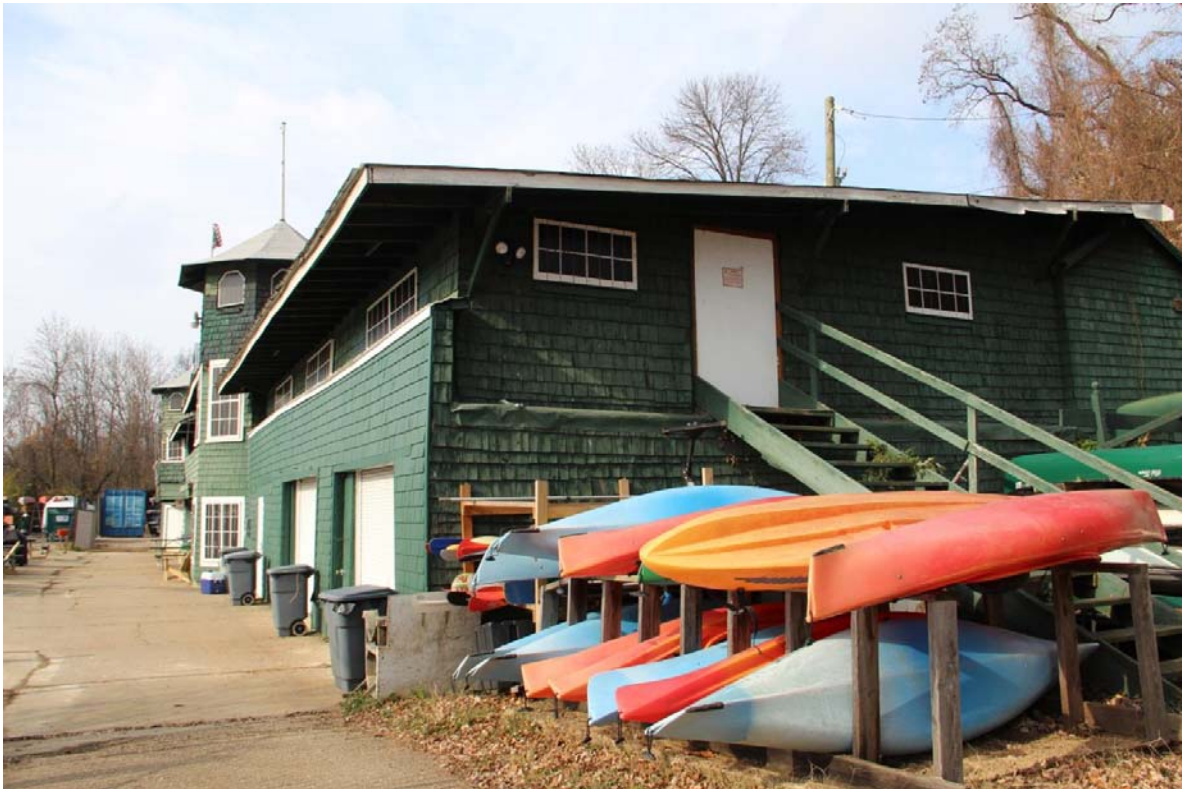
This roof overhangs the exterior walls on the south and east elevations. It is supported by the lightweight roof frame and plywood roof deck. There is a vertical fascia board on both elevations. Materials in generally fair condition.

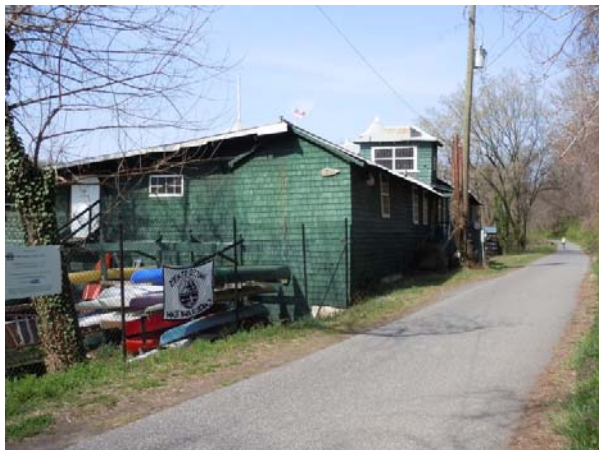
View from bike trail of the northeast corner showing the overlapping roofs of the Women's Locker Room and the Workshop.

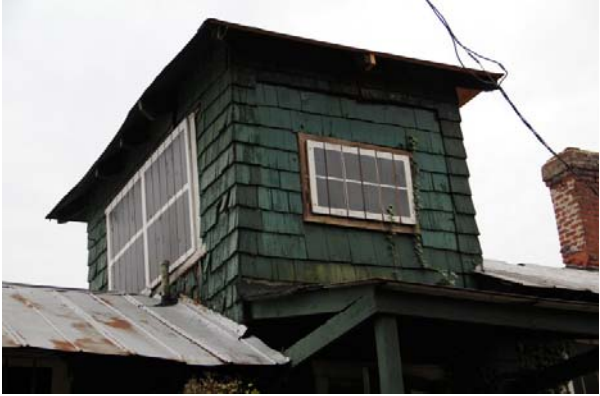
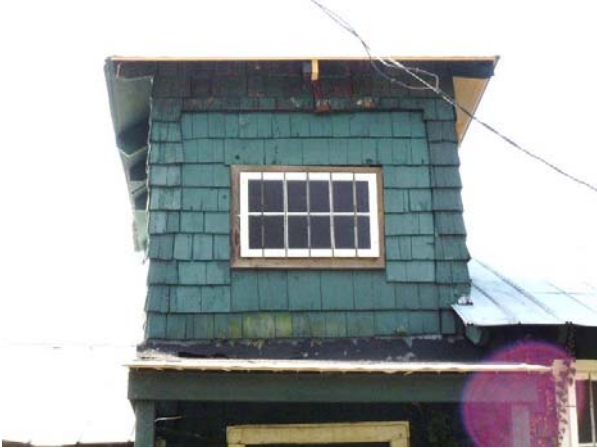
| | | | |

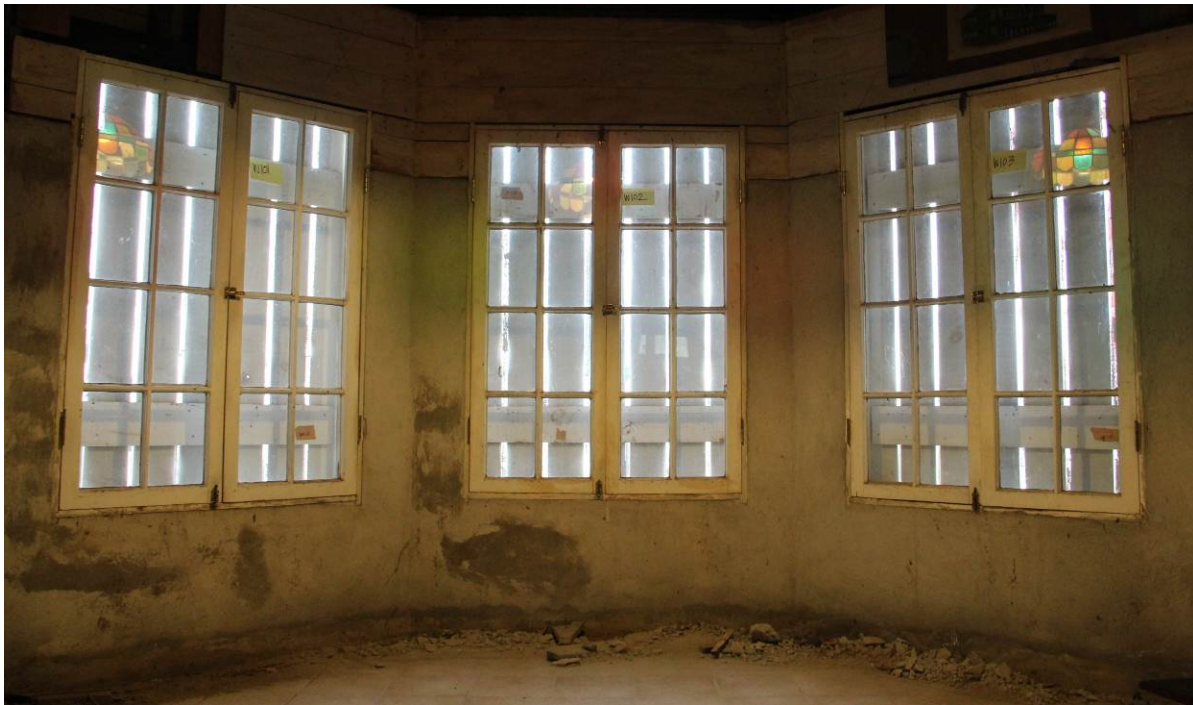
Interior view of windows W101-W103 on the south wall of the Grill Room (Room 105) on the first floor of the main block.

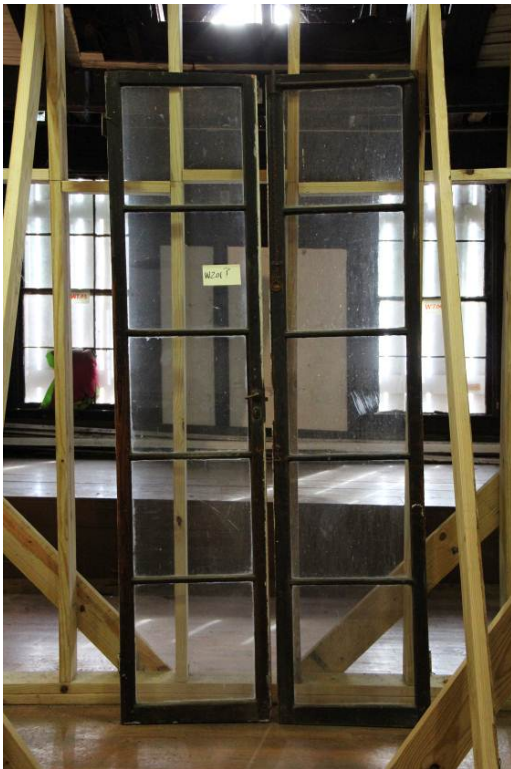
Interior side of typical full-length double casement windows in the Ballroom.

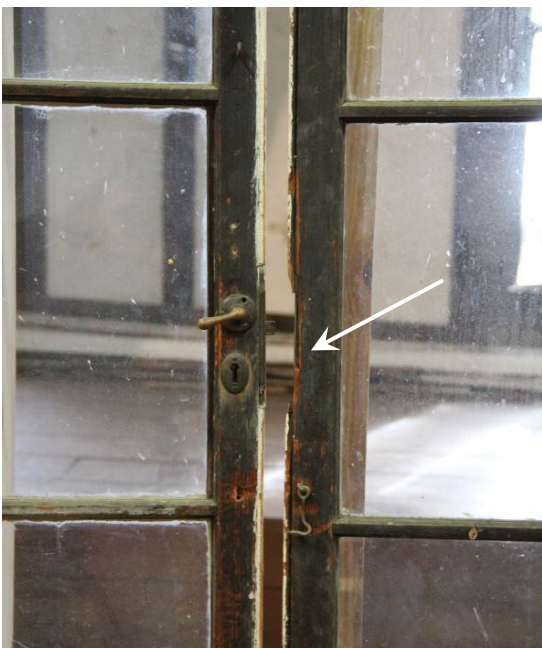
Detail of interior hardware on double casement windows. Note wood damage on stile (arrow).

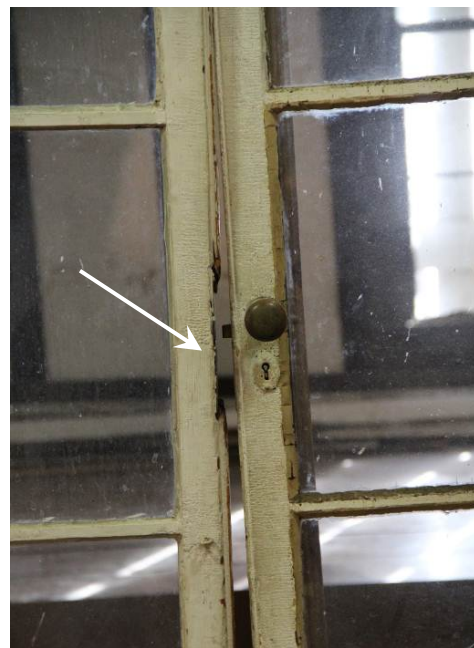
Detail of exterior hardware on double casement windows. Note wood damage on stile (arrow).

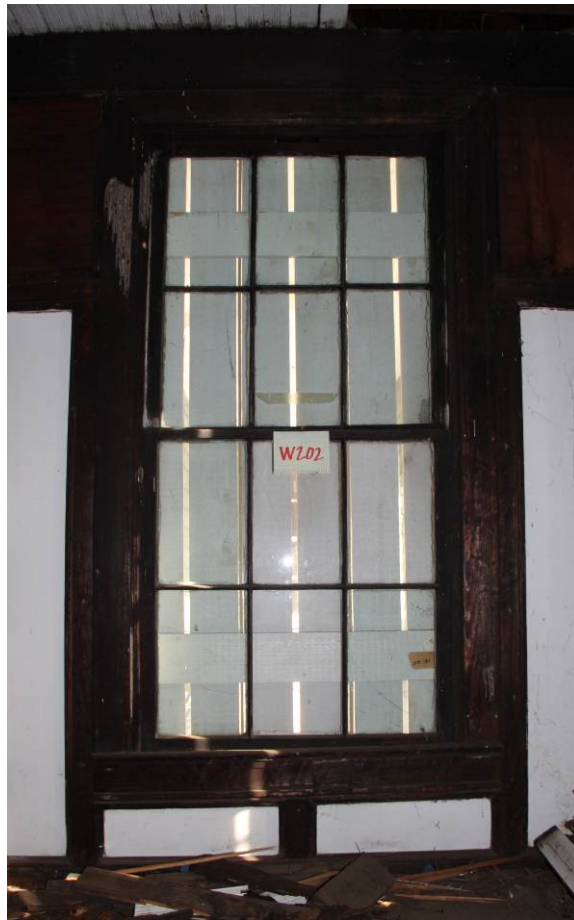
Typical double-hung wood window located in the Ballroom (Room 201).

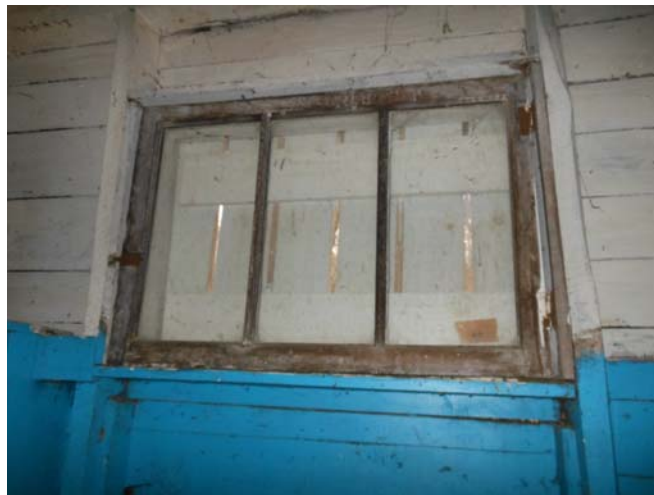
| <b>B202001-2a</b> | <b>Second-Floor Windows<br/>(Main Block – Phase 1)</b> |

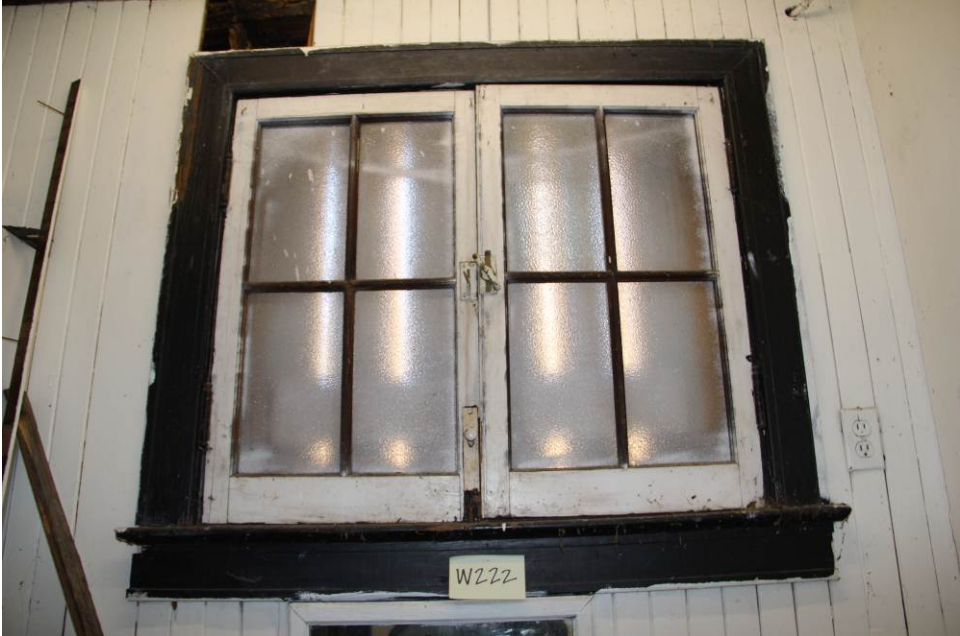
| | <b>B202001-2b</b> | <b>Second-Floor Windows<br/>(Main Block – Phase 2)</b> |
|--|---|--|
| <div style="text-align: center;"> </div> <p data-bbox="334 1192 1287 1262">Double 4-light casement window (W222) with obscure glass located in the Men’s Toilet Room (Room 205).</p> | | |

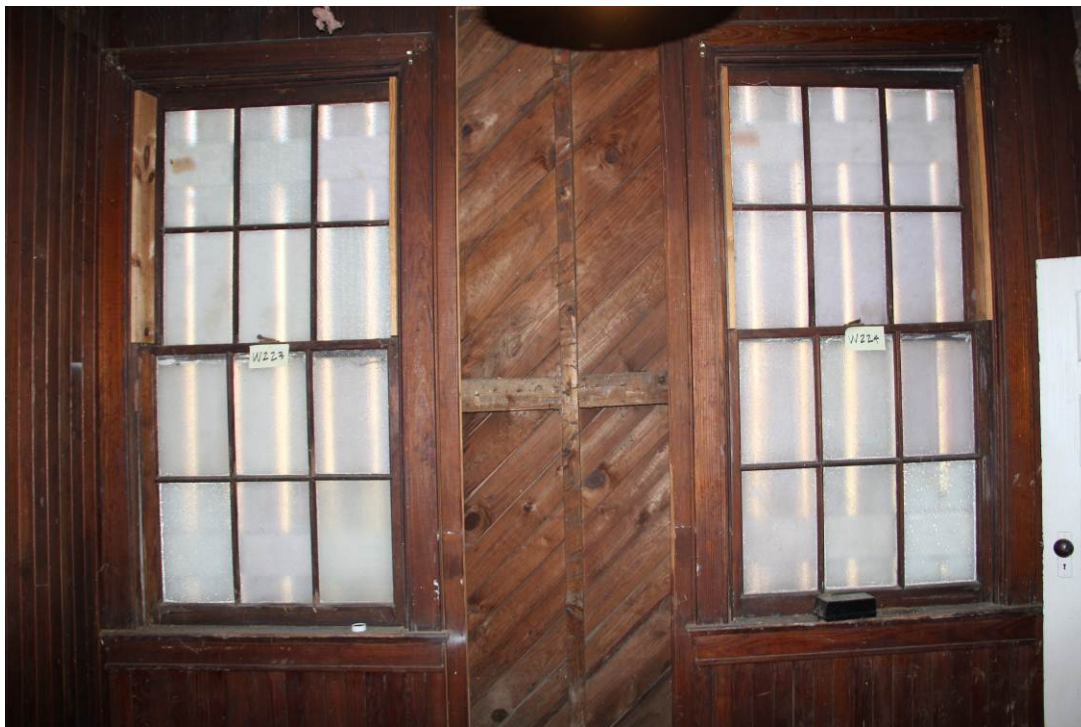
Double-hung wood windows (W223-W224) located on the north wall of the Women's Lounge (Room 206).

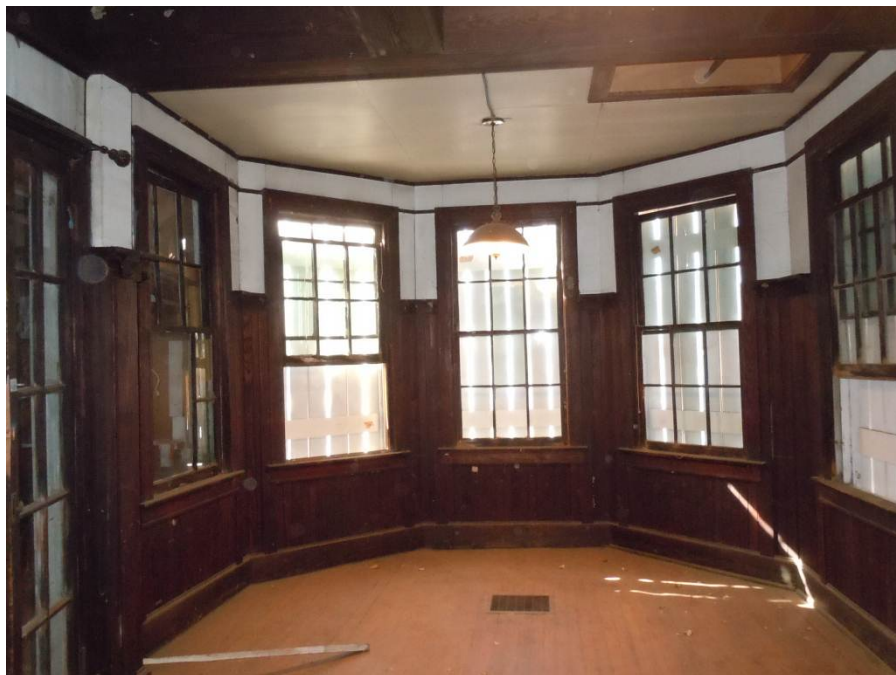
Double-hung windows (W236-W239, W248) located in the tower portion of the Board Room (Room 208).

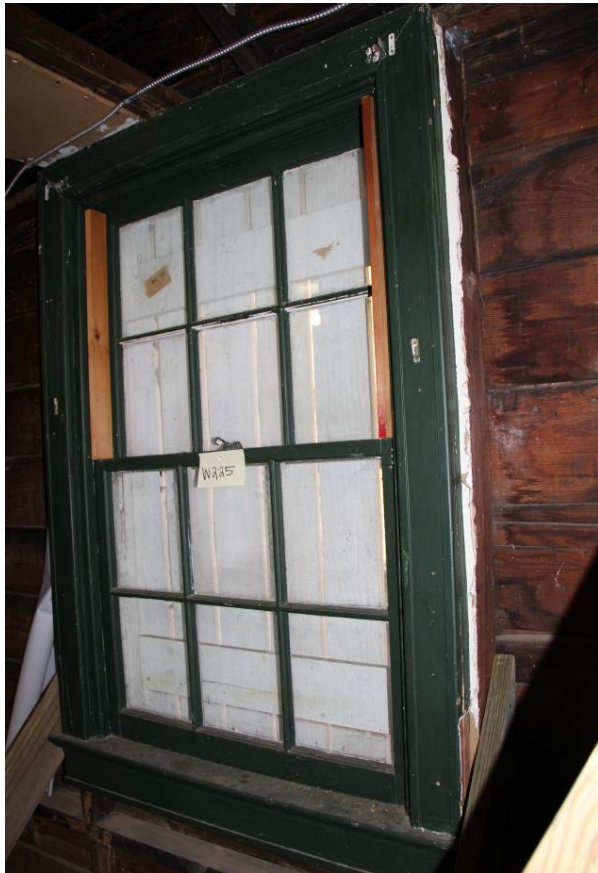
Window W225 in the north wall of the Women’s Locker Room (Room 210).

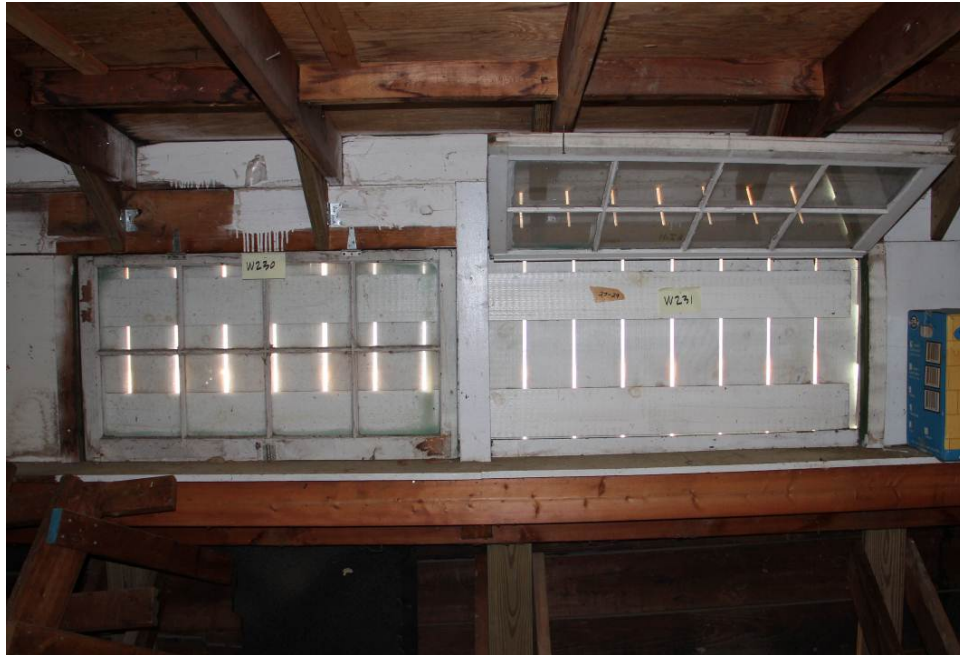
Typical 8-light hopper windows in the Workshop (Room 211).

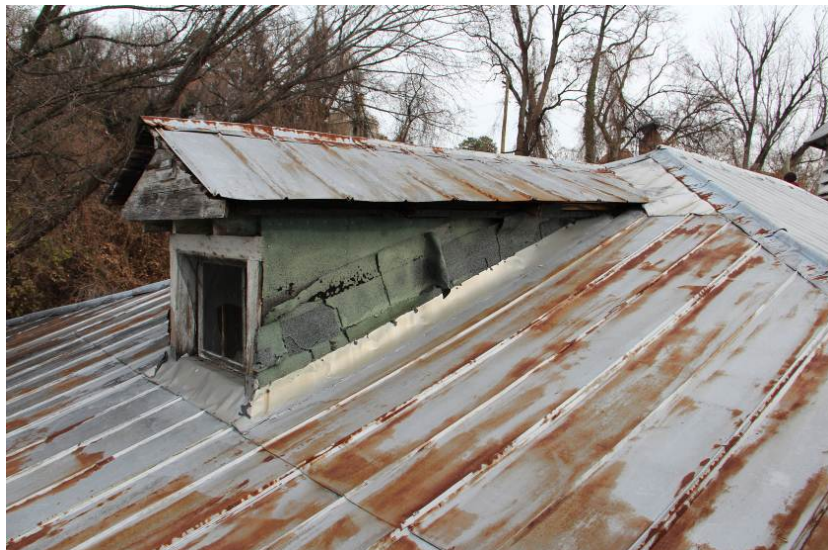
Dormer on the west slope of the main roof.

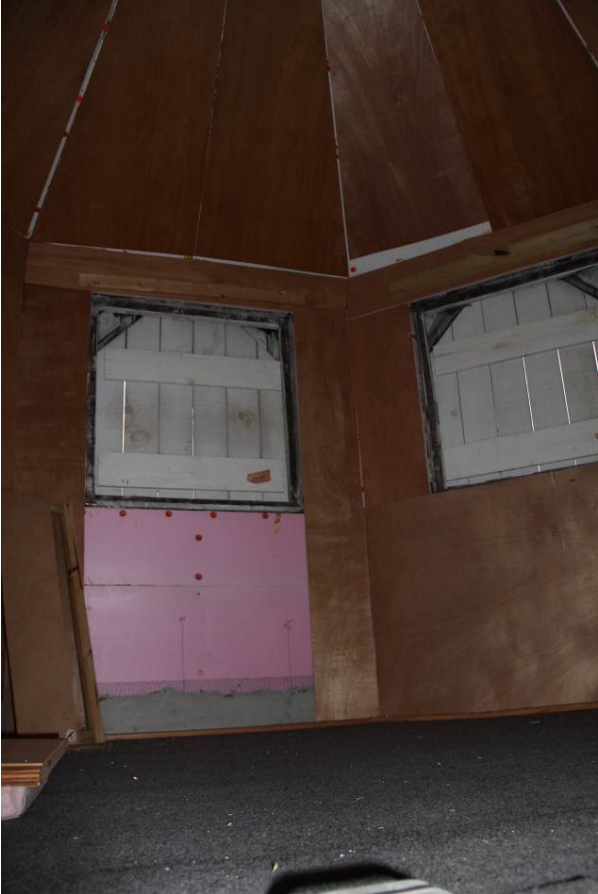
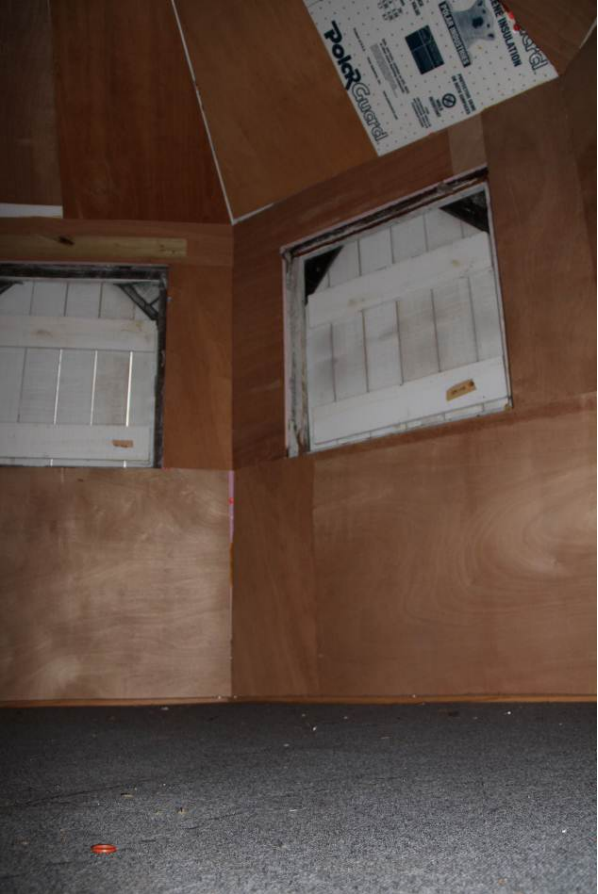
| <p>Window openings (W309-W316) in the East Tower Chamber (Room 303).</p> | | |

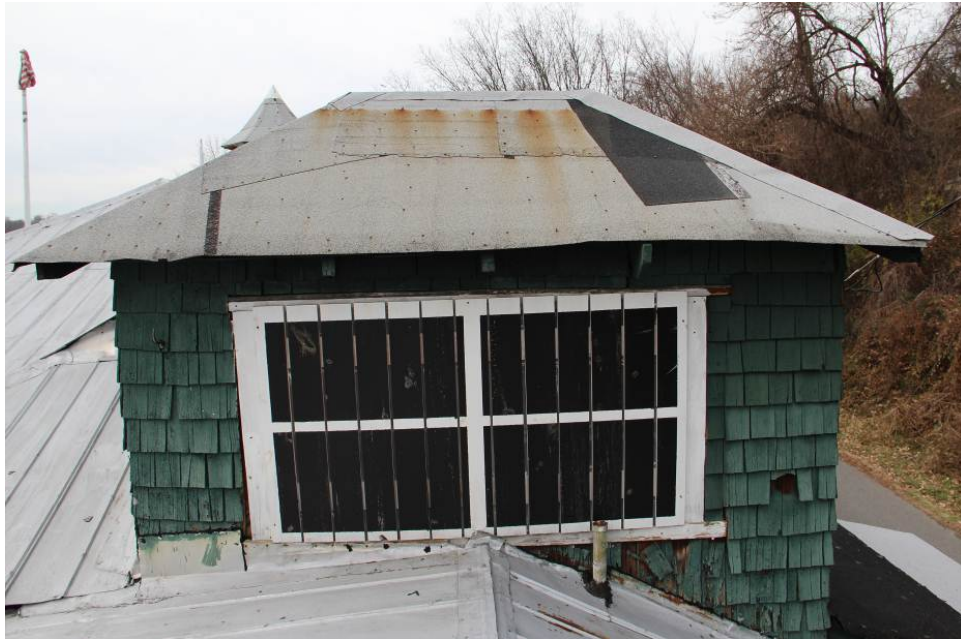
Exterior view of windows (W317, W318) on the east elevation of the North Tower (Room 304).

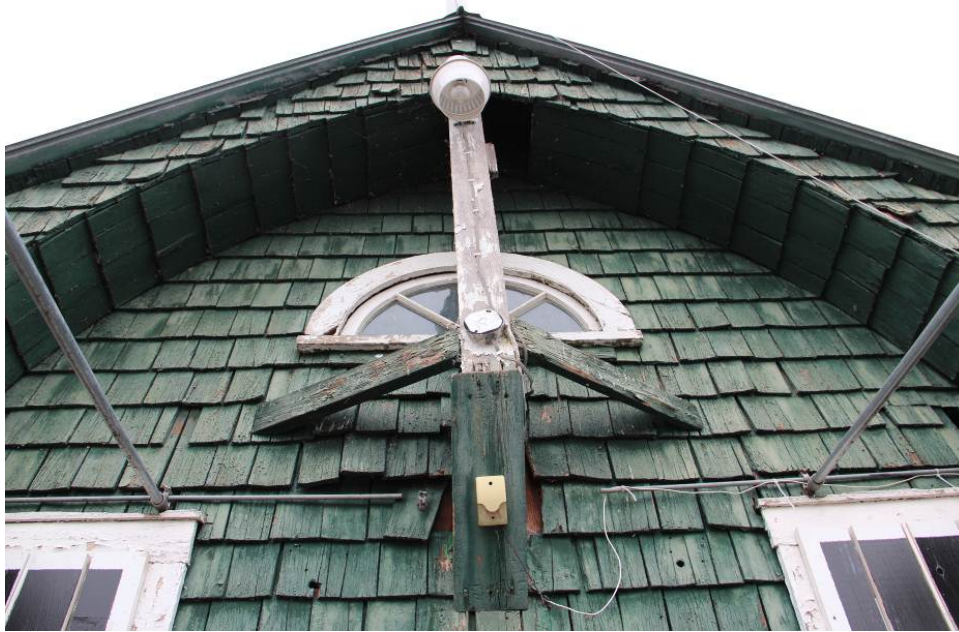
Exterior view of the fan window (W321) in the south gable.

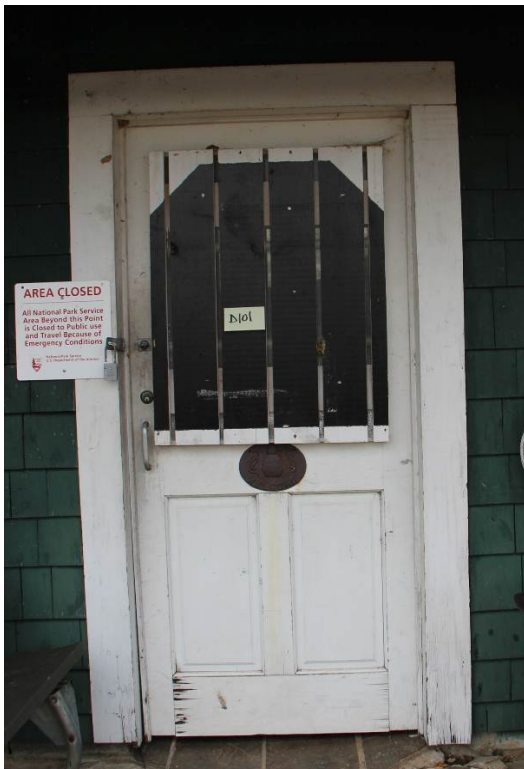
Exterior view of glazed door (D101) on the south elevation. Painted wood planks are installed over the glass panes.

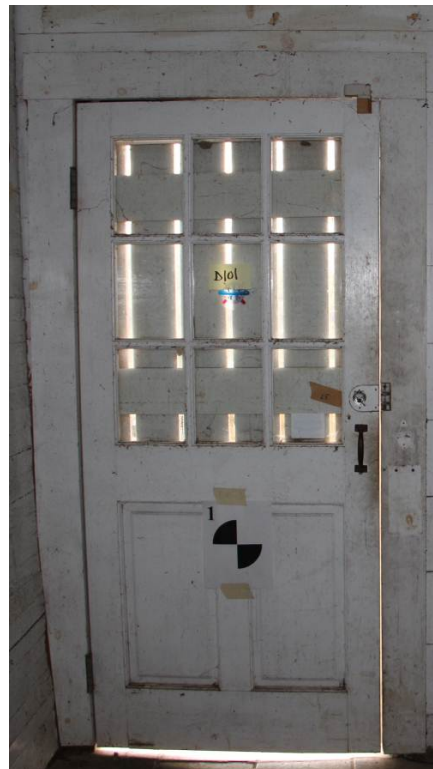
Interior view of door (D101).

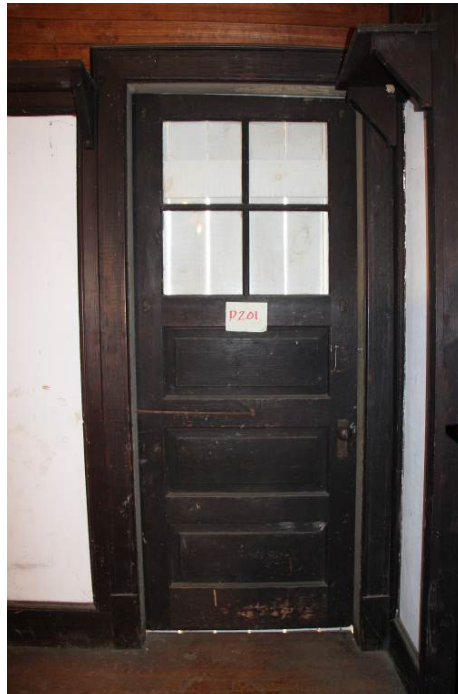
Original 3-panel, 4-light wood door (D201) leading from the Ballroom (Room 201) to the Balcony (Room 212).

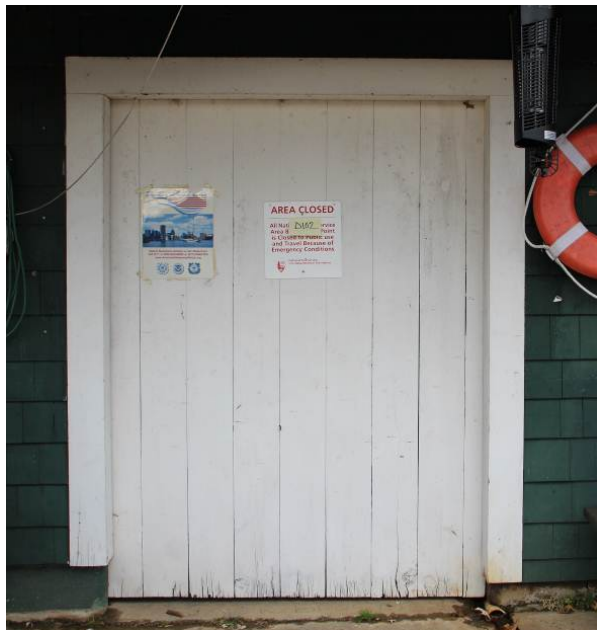
Exterior of swinging door (D102) in the south wall of the West Boat Storage Area (Room 101).

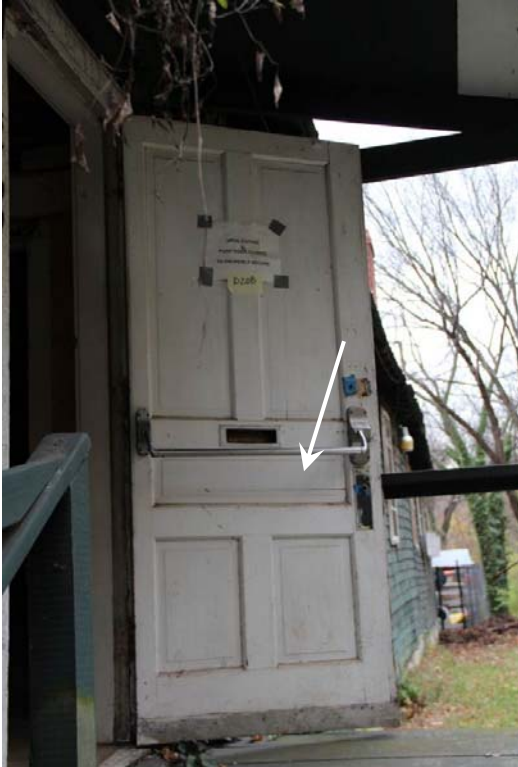
Interior view of Door (D208). The original door hardware has been removed and replaced with panic hardware (arrow).

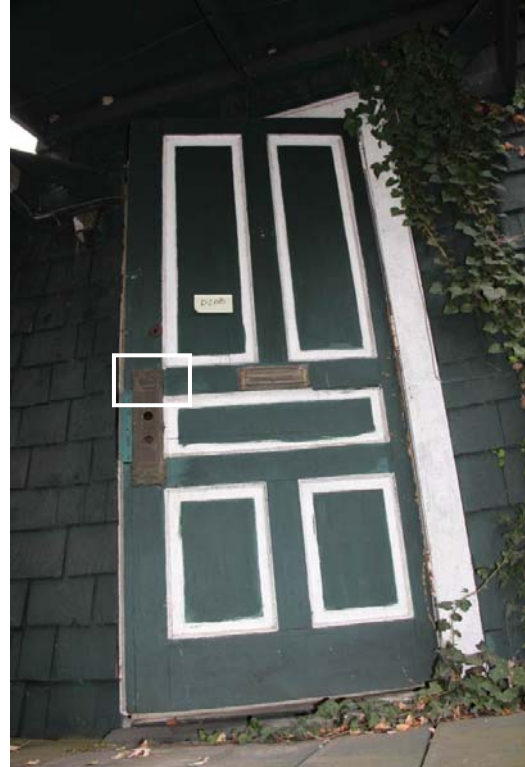
Exterior view of (D208). See inset photo below.

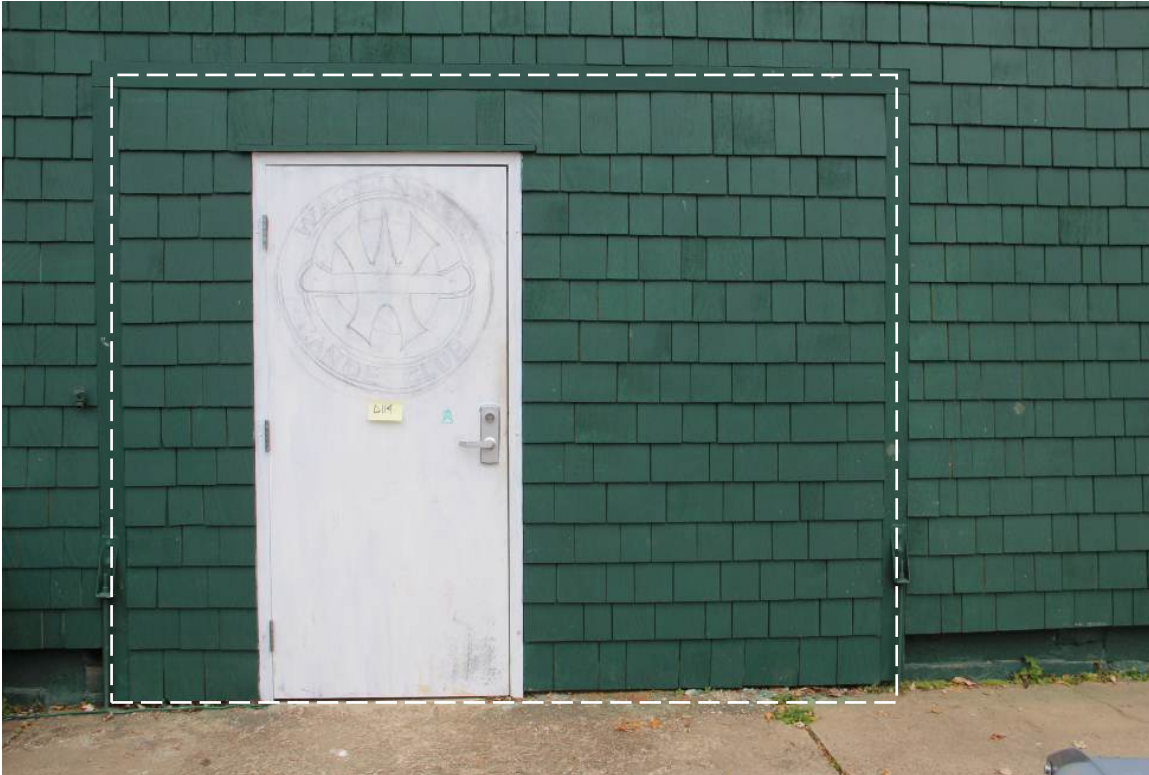
The original door opening of door (D114) in East Boat Storage Area (Room 106) has been in-filled and a modern metal man-door has been installed. The original door opening is indicated by the dashed line. No historic materials are extant.

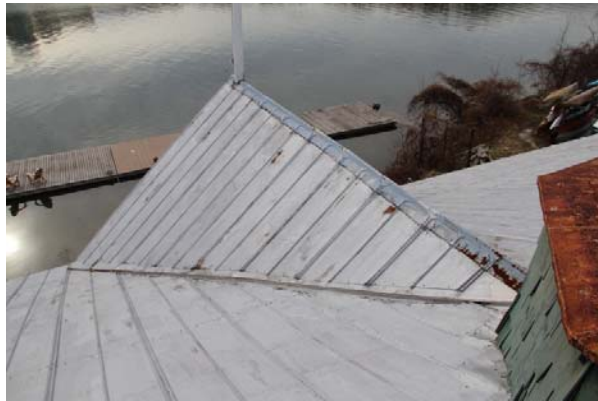
East roof slope of south cross gable with open valley and ridge cap. Note wooden mast at south end of ridge.

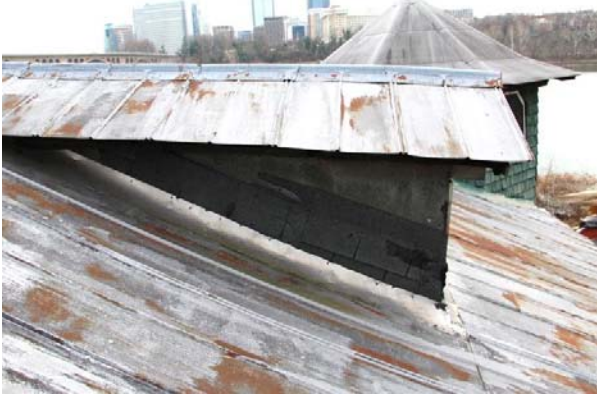
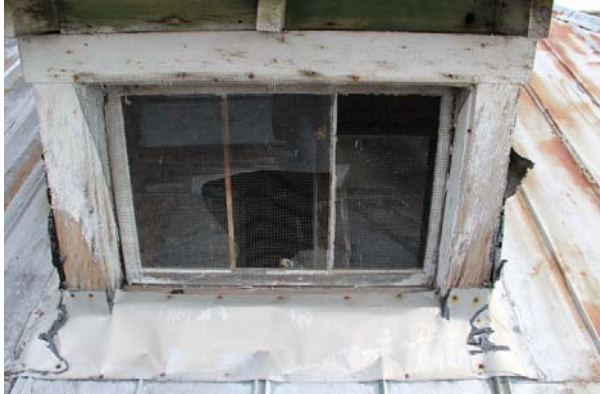
| <p>North elevation and roof slope of west gable dormer.</p> | | <p>West elevation of west gable dormer with patched sill flashing condition.</p> | |

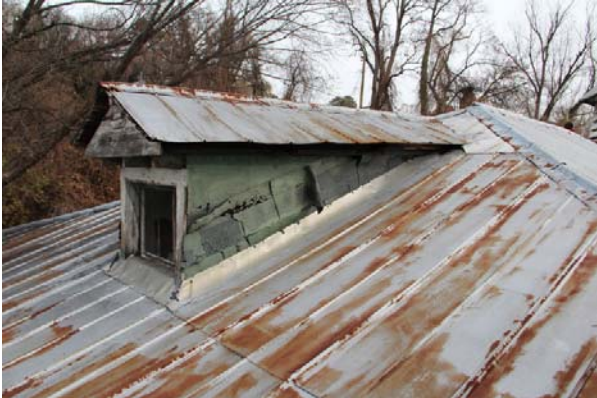
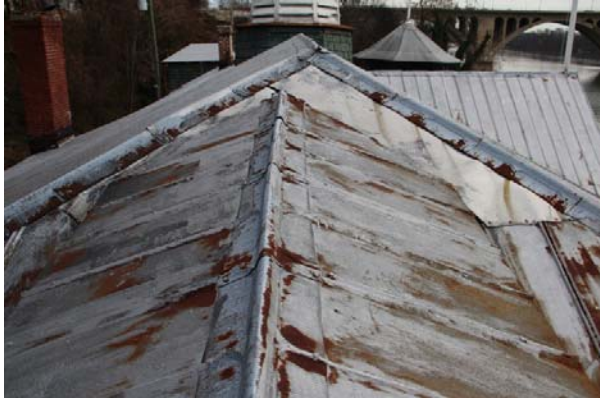
| <p>South and west elevations and roof slope of west gable dormer showing off-centered intersection with hip ridges of main block roof.</p> | | <p>Off-centered placement of west gable dormer with main ridge line of main block roof and sheet metal flashing laid over roof surface.</p> | |

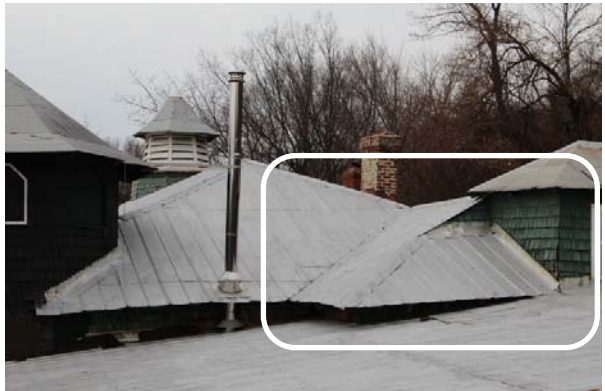
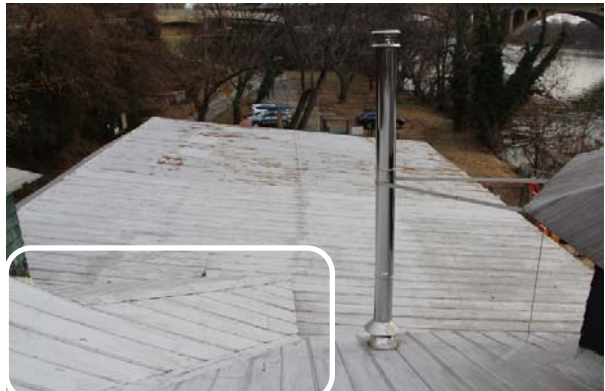
| | | | |

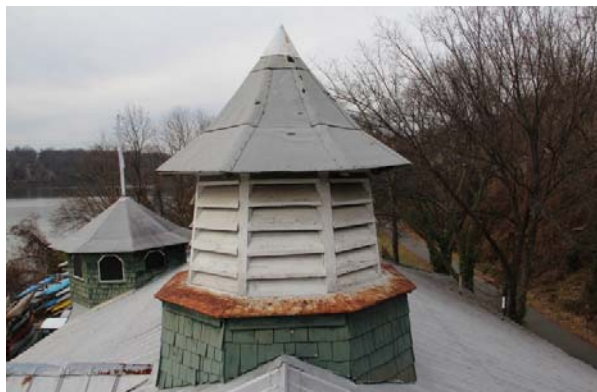
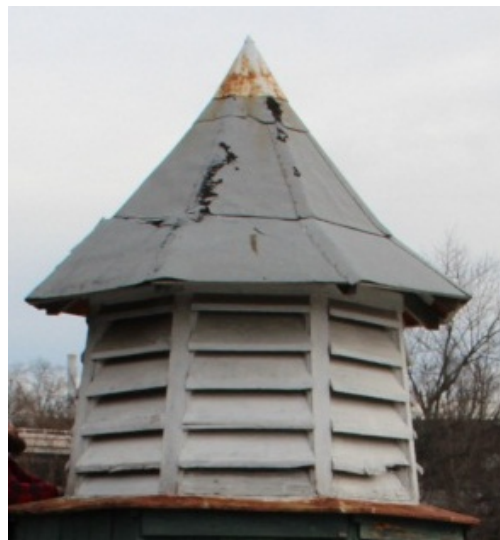
| | | | |

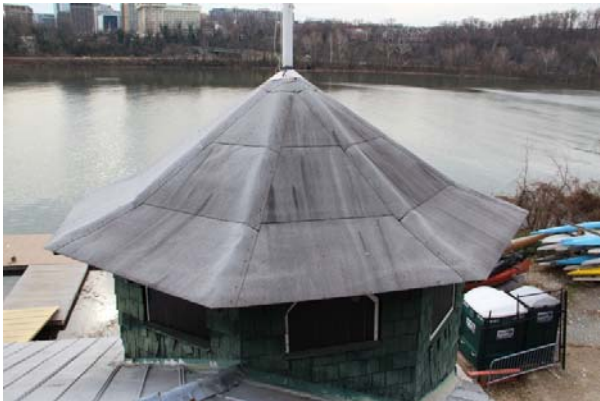
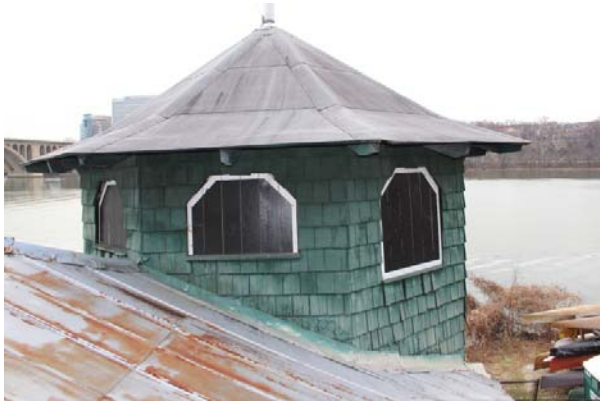
| <p>North roof slopes of the west tower with a mast at the pinnacle of the conical roof form. Mineral surface roofs are considered in Poor condition due to installation methodology not according to industry standards.</p> | | <p>View of north elevation of the west tower. Mineral surface roofs are considered in Poor condition due to installation methodology not according to industry standards.</p> | |

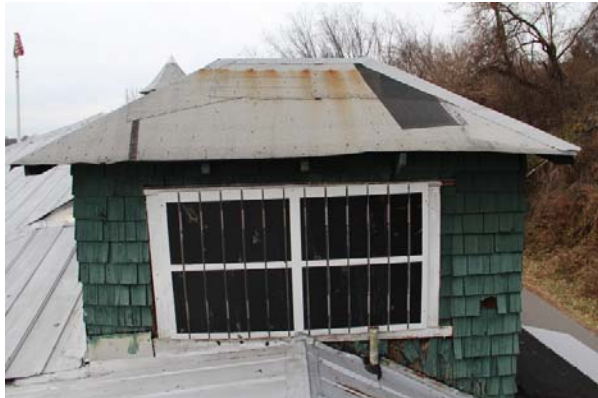
East elevation of North Tower hipped roof with non-standard installation of roof materials.

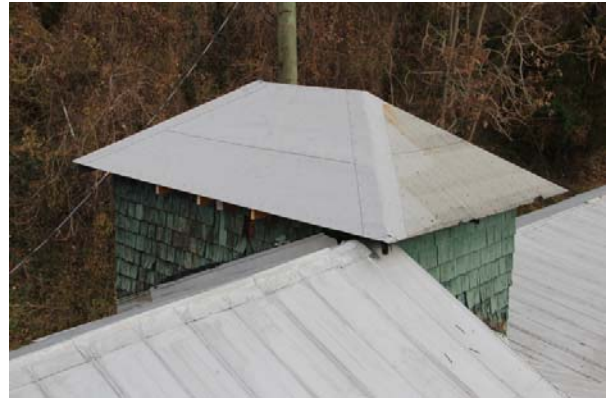
Repaired west slope and older south slope of North Tower hipped roof.

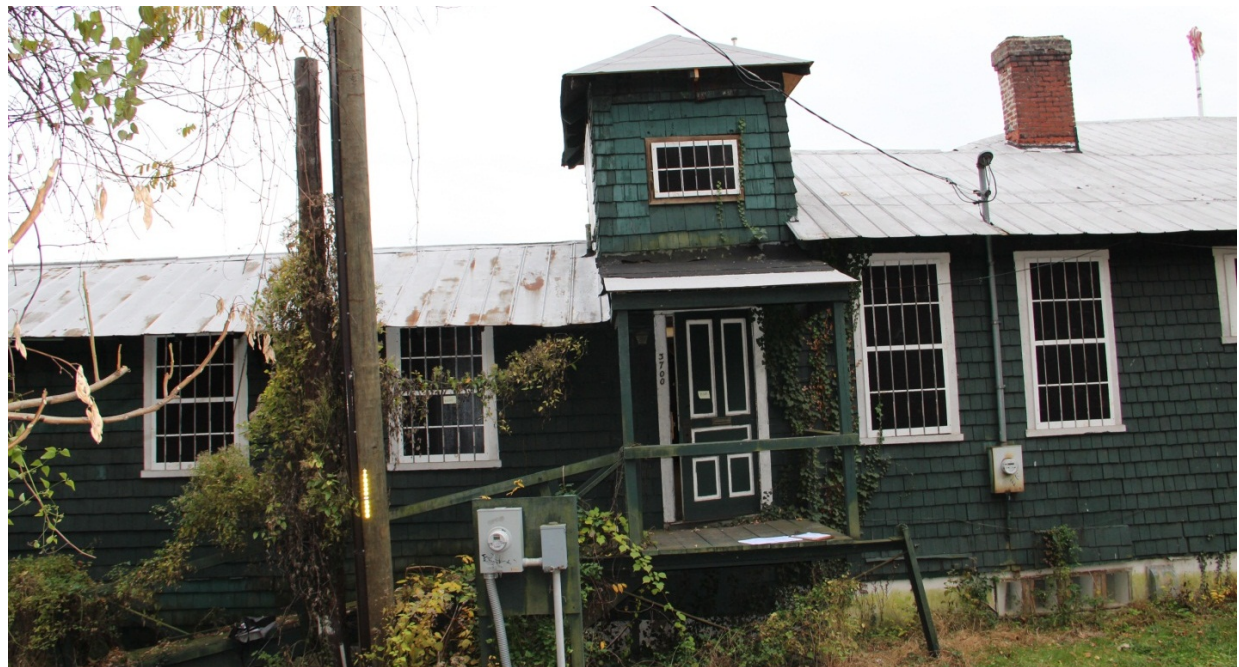
North elevation of the North Tower and shed roof over the north entrance below.

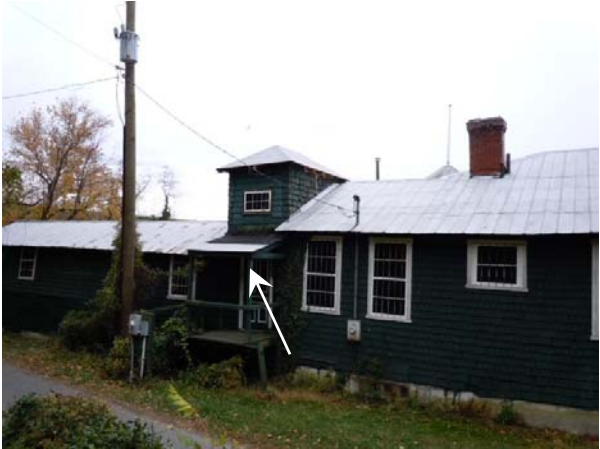
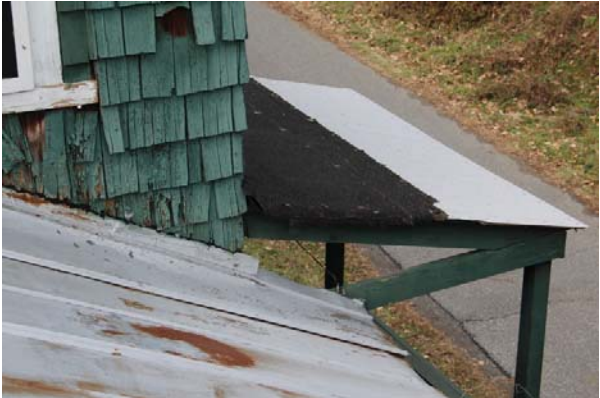
| <p>View of north porch shed roof (<i>arrow</i>) from the Capital Crescent Trail.</p> | | | <p>View of shed roof over north porch. Note recent repairs to roof finish at lower half of roof.</p> |

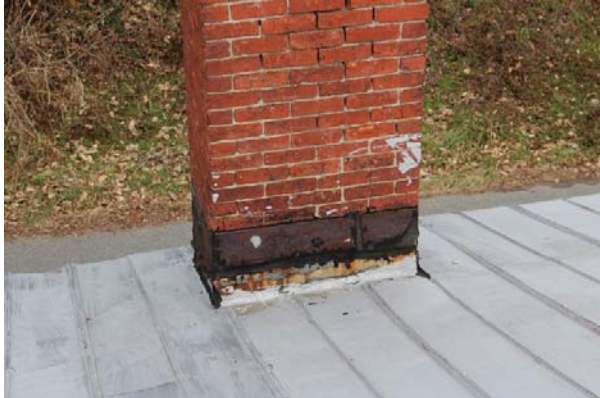
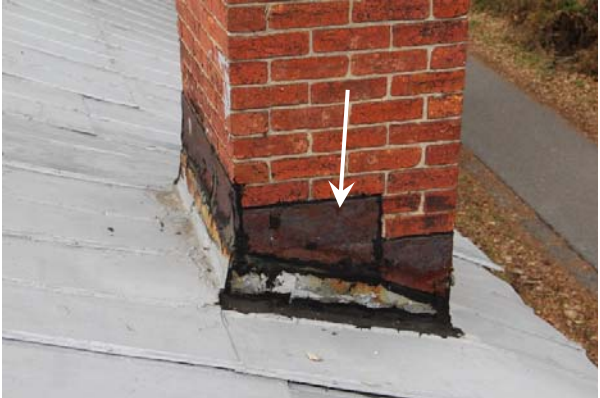
| | | | |
