1200 Architectural Engineers PLLC

EHT Traceries Historic Preservation

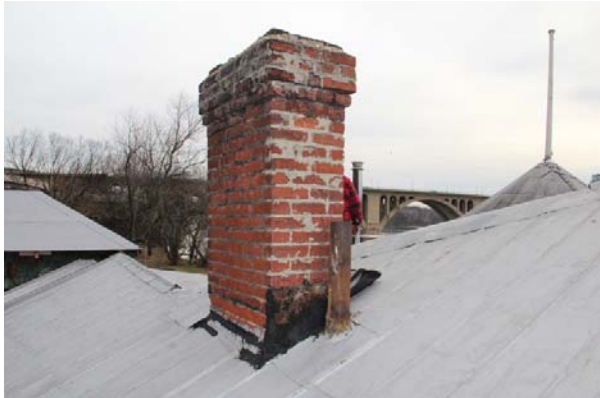
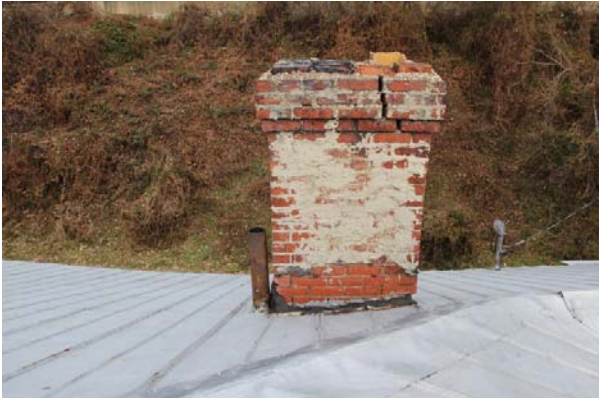
| | | | |

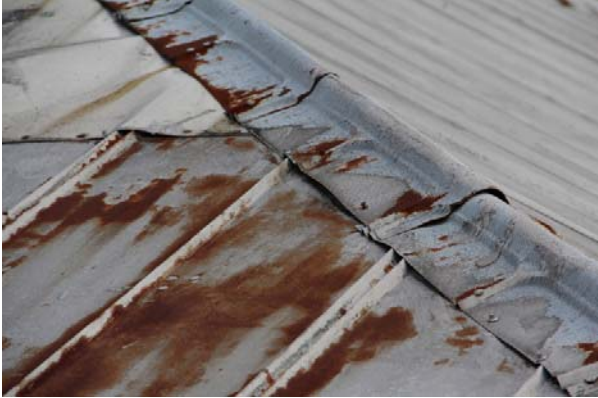
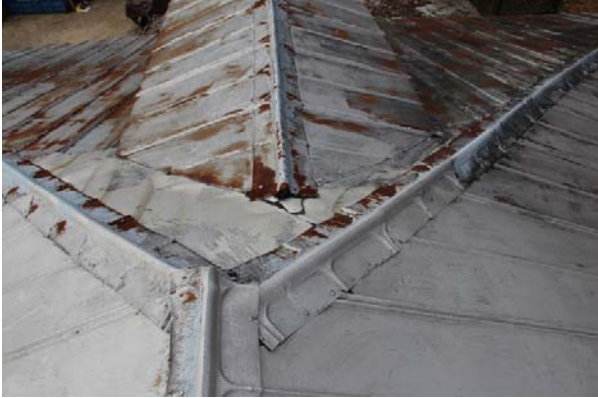
| | | <b>B301004-2</b> | <b>Main Block Hipped Roof Flashing</b> |
|---|--|---|---|
| <p data-bbox="185 758 805 888">Detail of sectional ribbed rolled ridge cap flashing suggesting smaller panelized (or metal shingle) roof in the past (possible second generation roof).</p> | | | <p data-bbox="797 233 1425 327">Includes subsidiary roof features: South Cross Gable, West Gable Dormer, East Gable Cricket Extension.</p> <p data-bbox="824 758 1445 888">View of ridge and hip flashing using same components. Installation is non-standardized and would not meet industry warranty requirements.</p> |

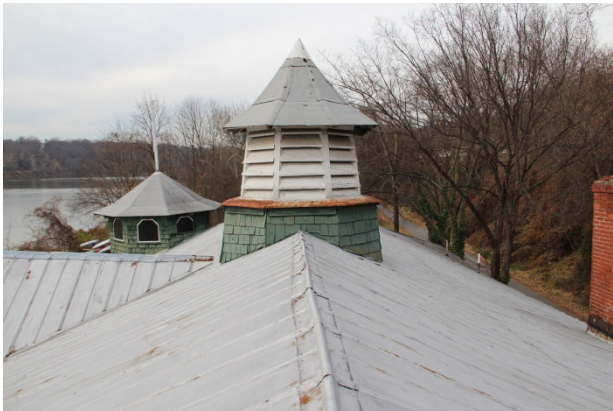
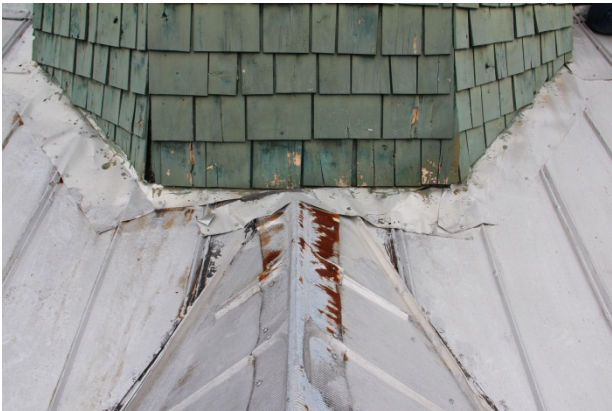
| | | |

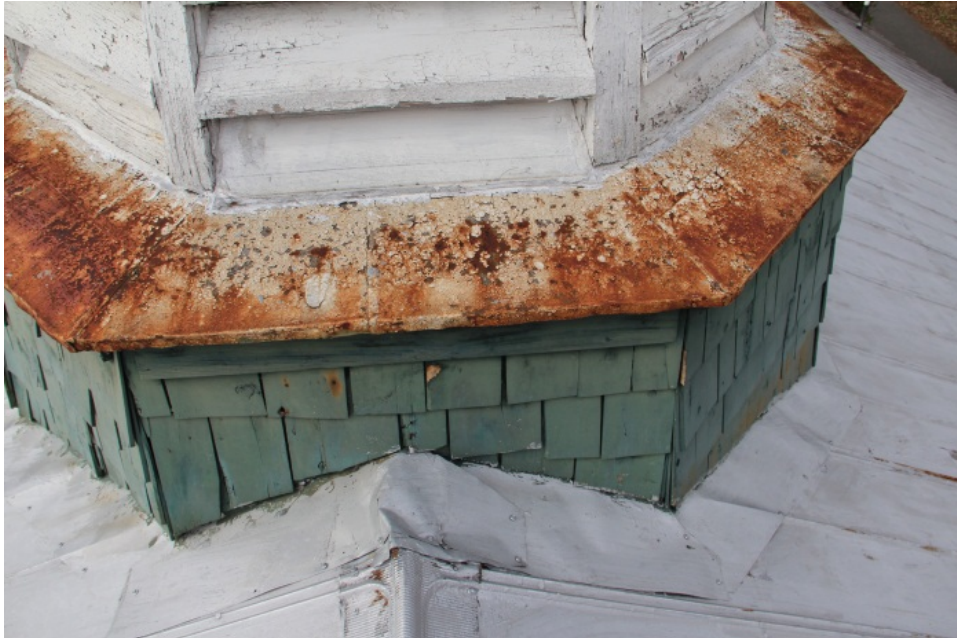
West elevation of cupola base and shelf flashing between base and louvered panels (possibly original) at intersection with primary ridge line. Typical of all base flashing conditions.

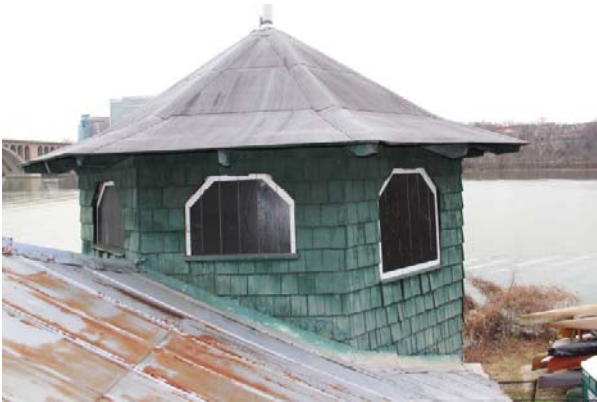
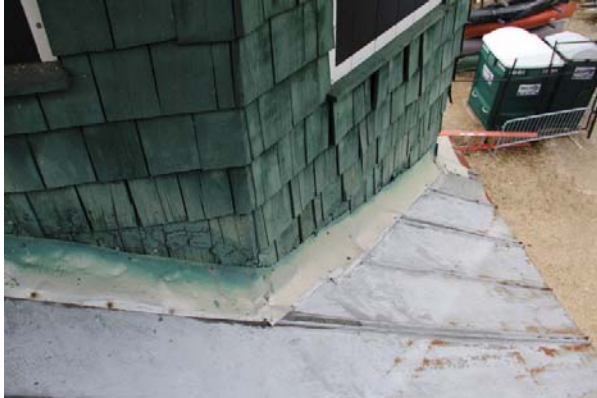
| | | |

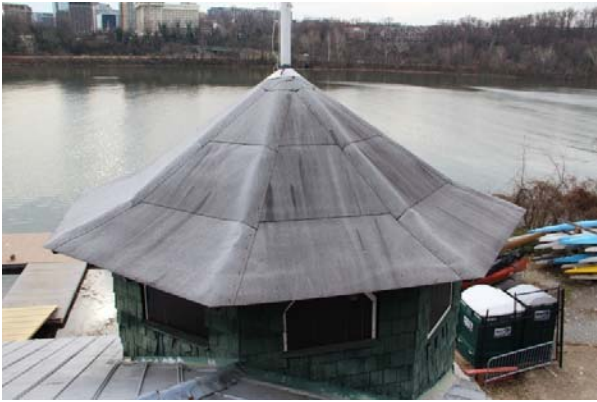
| | | <p>Sub-standard base flashing at the west tower is typical of most extant flashing installations: non-standardized, will not meet current industry standards, uses sub-par materials and is not properly executed with typical base and counter flashing systems. Note deterioration of base wood shingles adjacent to flashing strips.</p> |

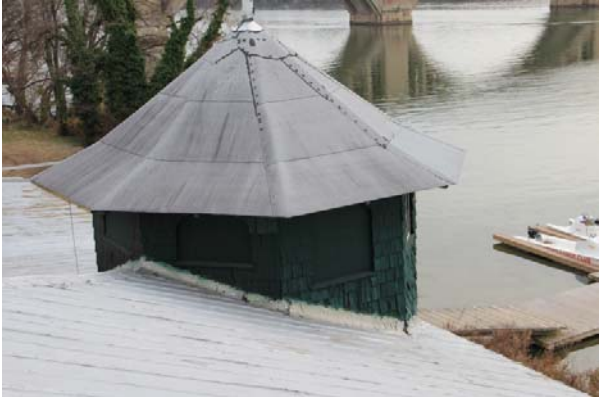
| <p>Northwest elevations of East Tower showing extant non-standard "flashing".</p> | <p>Base conditions on northeast section of East Tower are typical of non-standard details.</p> | |

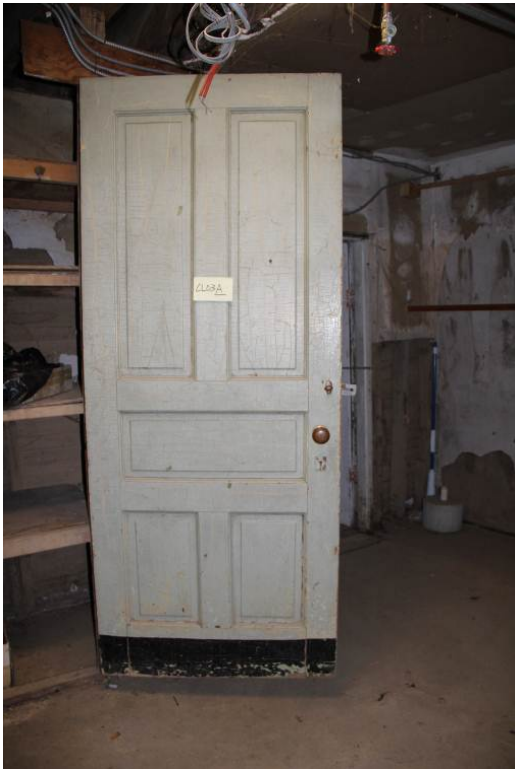
Original door (CL03A)

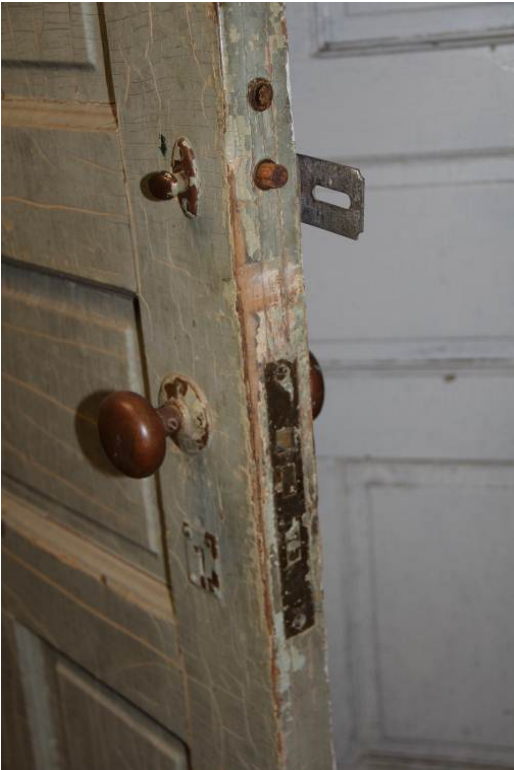
Detail of original hardware on found on doors (CL03A and CL03B).

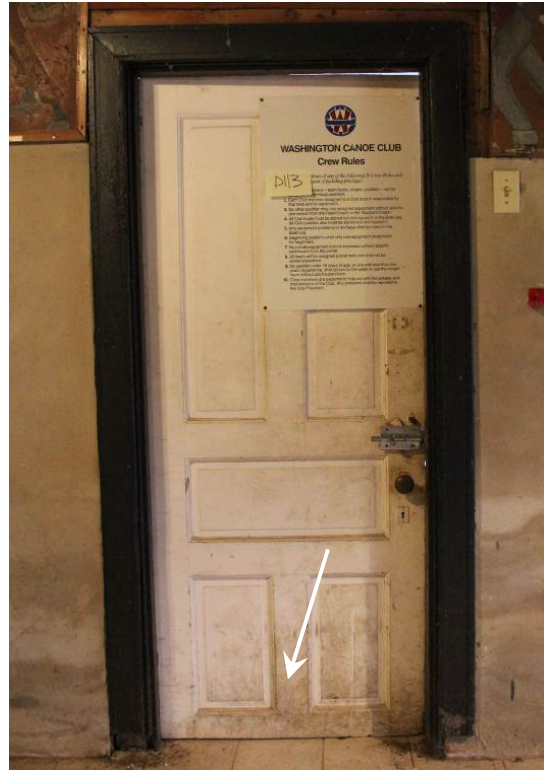
Door (D113) is similar to doors (D109, CL03A, and CL03B). The bottom rail (arrow) has also been trimmed.

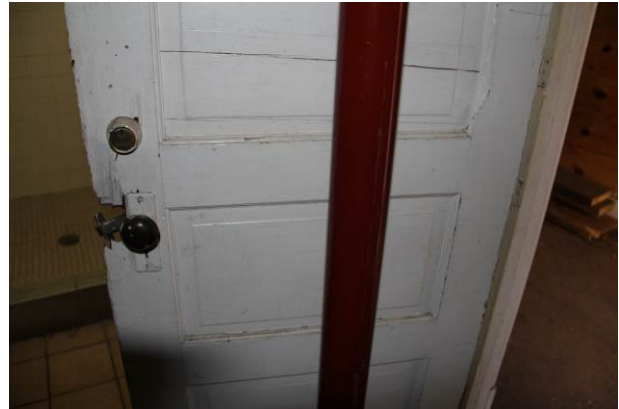
The panels of door (D210) are cracked and the door is broken at the latch.

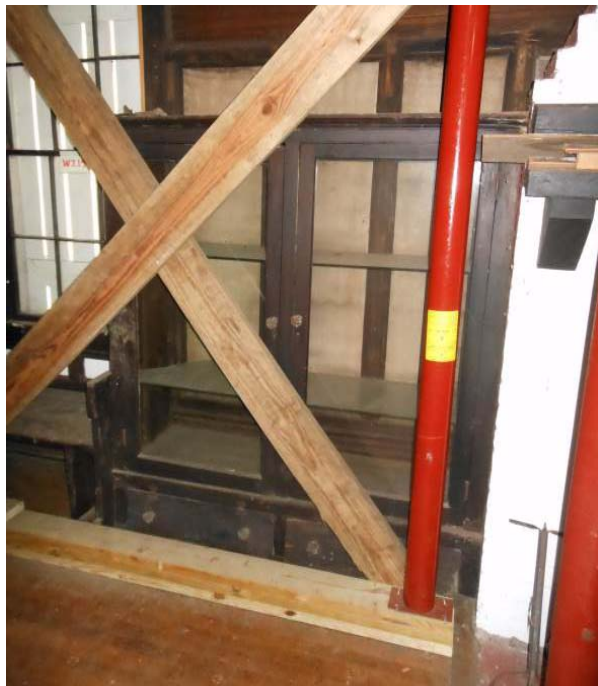
West built-in cabinet to the left of the fireplace in the Ballroom (Room 201).

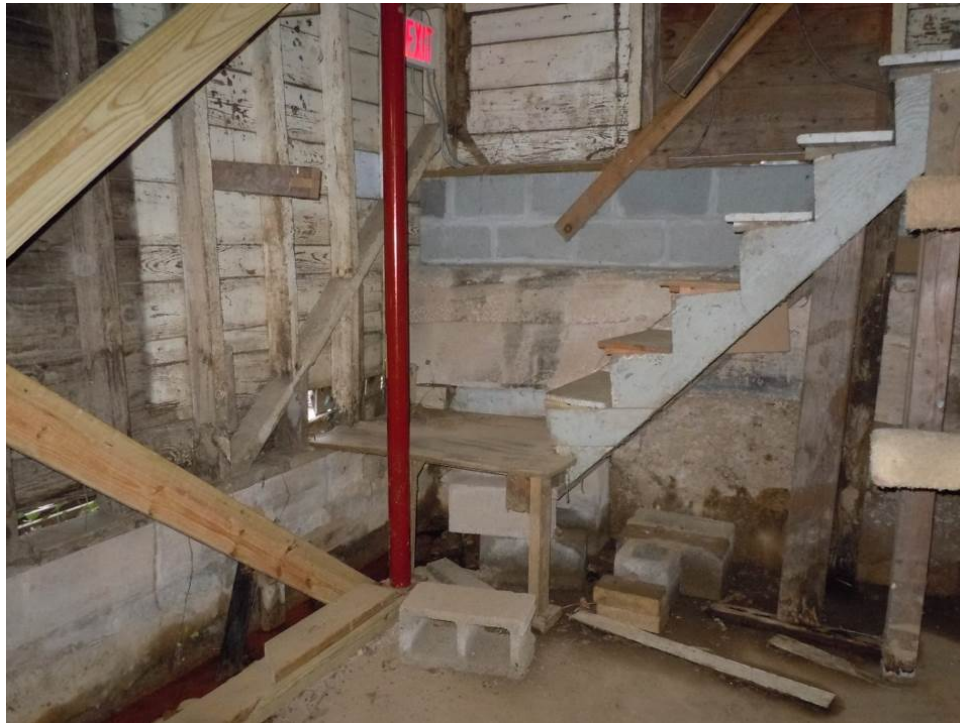
Stairs (ST01) in the northeast corner of West Boat Storage (Room 101) leading to the Men’s Locker Room (Room 203).

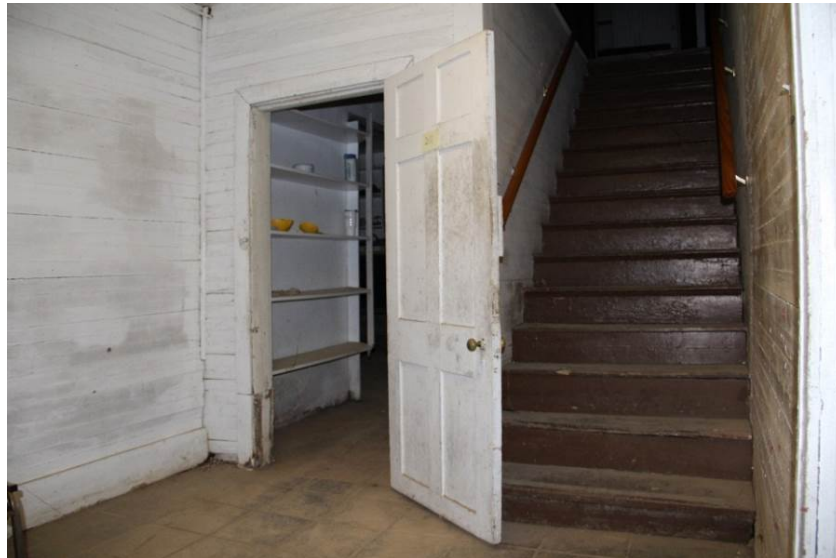
Stairs (ST02) in the first floor hall (Room 104) leading to the second floor hall (Room 207).

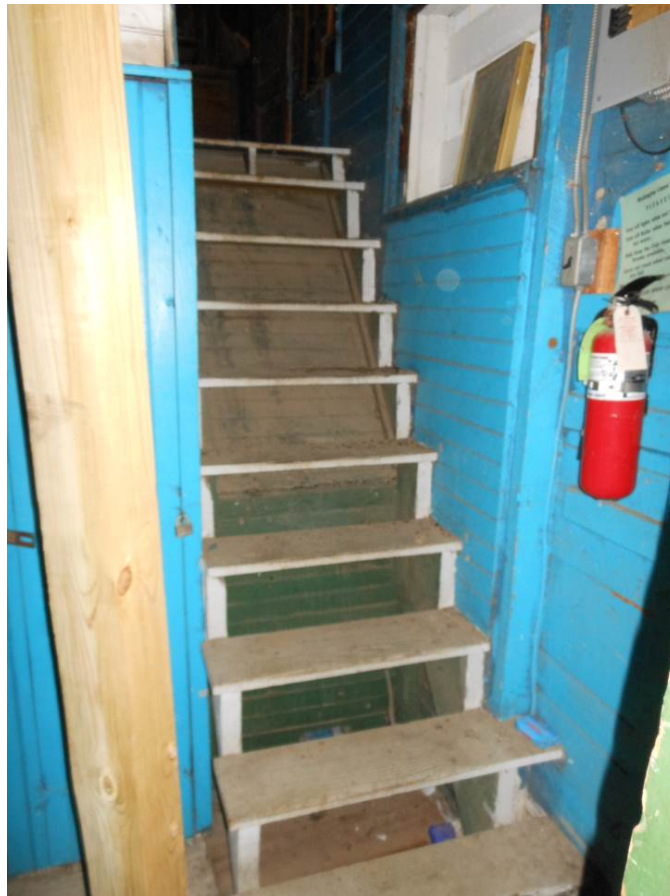
Wood stairs (ST05) lead from the Men’s Locker Room (Room 203) the mezzanine of the locker room.

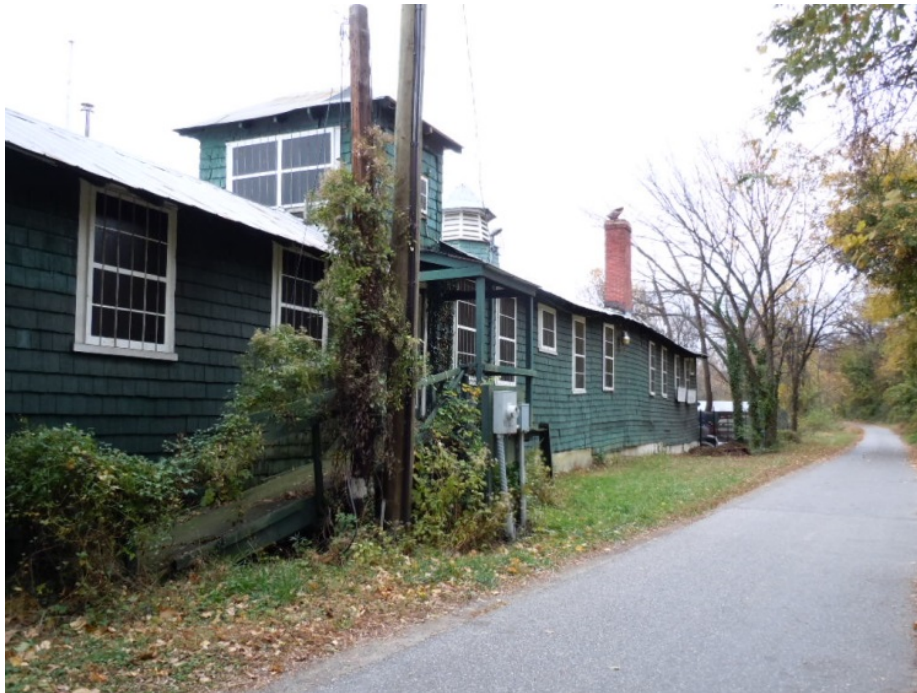
A wood ramp is installed over the stairs (ST03) leading to the north entrance door (D208) on the north elevation.

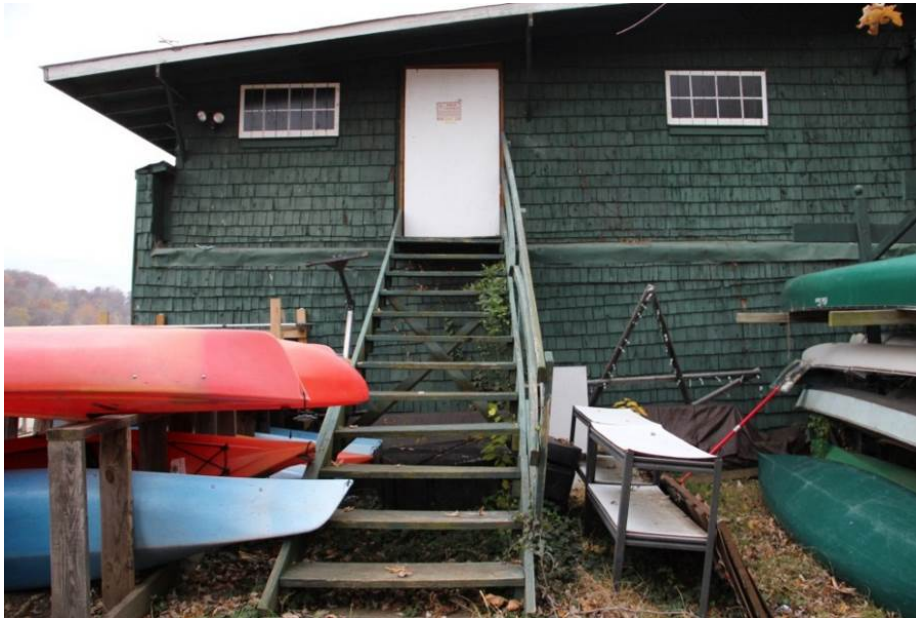
Stairs (ST04) at the east entrance.

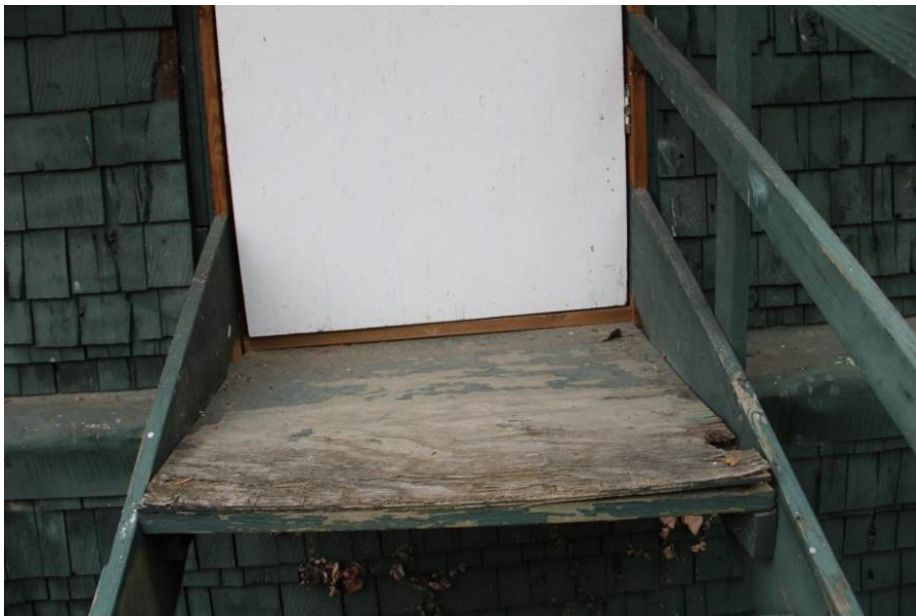
Deteriorated plywood landing at the top of the east entrance stairs (ST04).

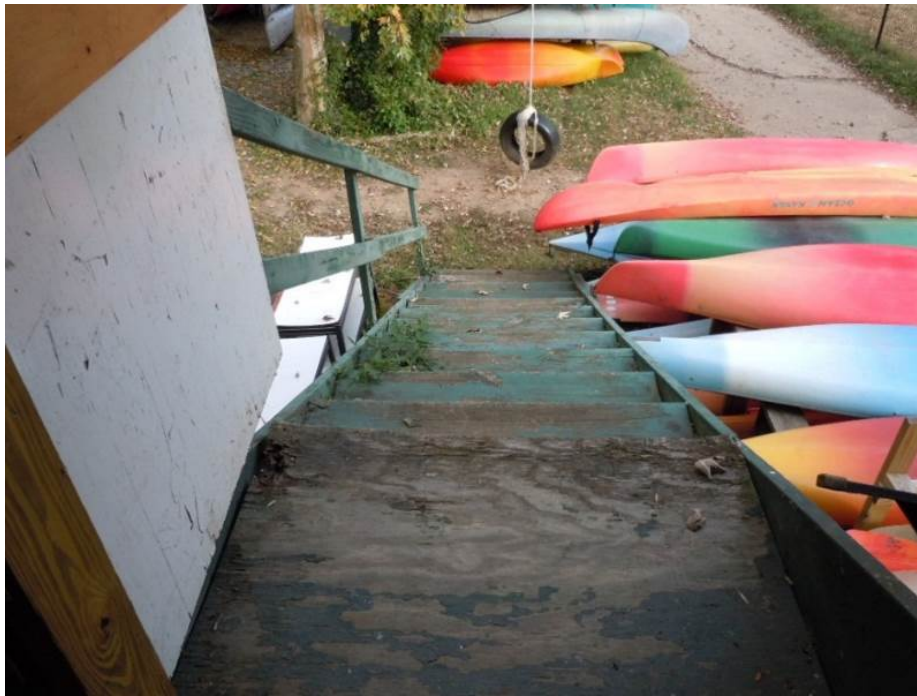
View looking down the east entrance stairs (ST04) from the Workshop (Room 211).

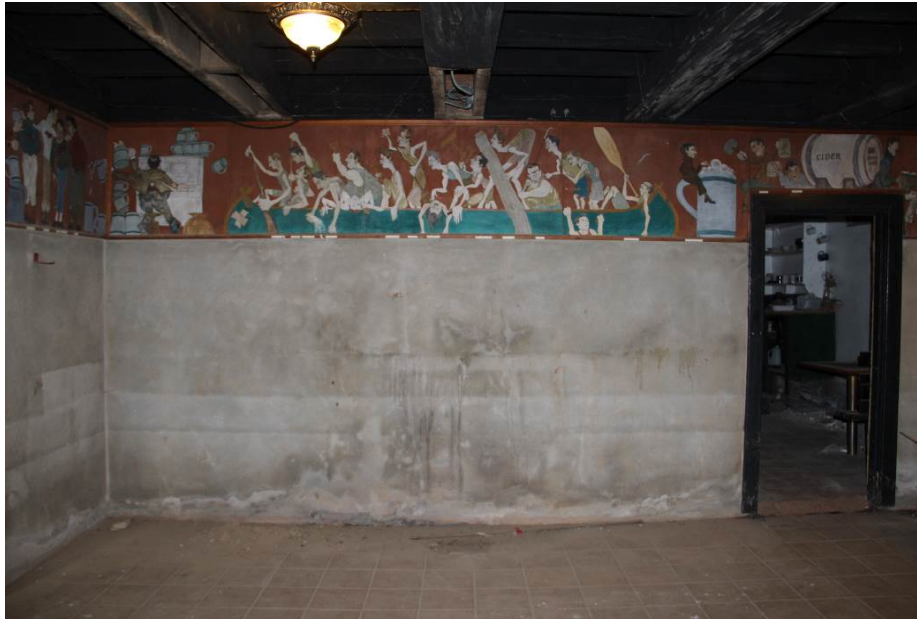
Plaster wall finish in the Grill Room (Room 105). Does not include mural area.

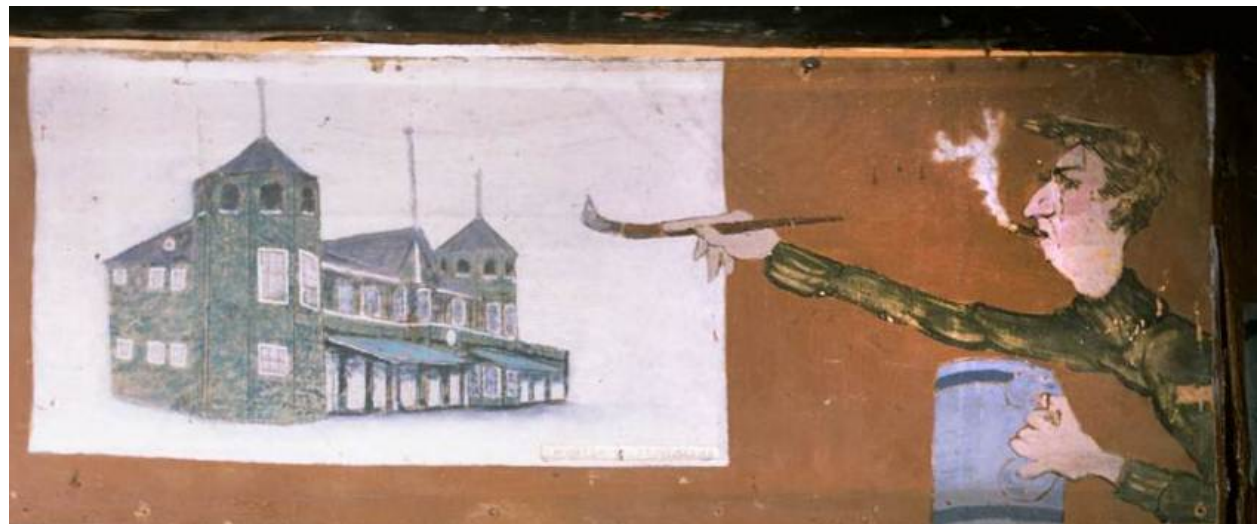
An example of one panel of the cartoon wall frieze mural. As the panel was determined to not be included as a character-defining feature (as it is not part of the building fabric) or initially included in the condition assessment, it was neither measured nor inventoried. The substrate is a type of early Masonite-like wallboard (or perhaps a painting substrate – an artist’s medium) but it was not analyzed, nor was the paint analyzed. It is known (Note in the NR) that it was “touched-up” in 1981-82 by Charles W. Lundmark.

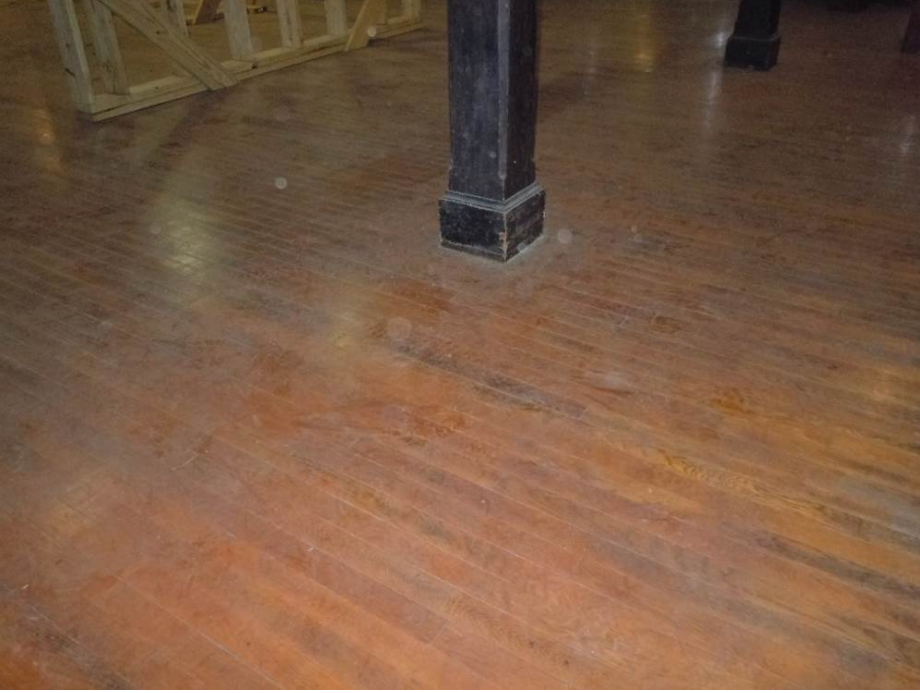
| | <b>C3020</b> | <b>Floor Finishes</b> |
|---|---|---|
| <p>Typical wood flooring in the Ballroom (Room 201) on the second floor.</p> | | |

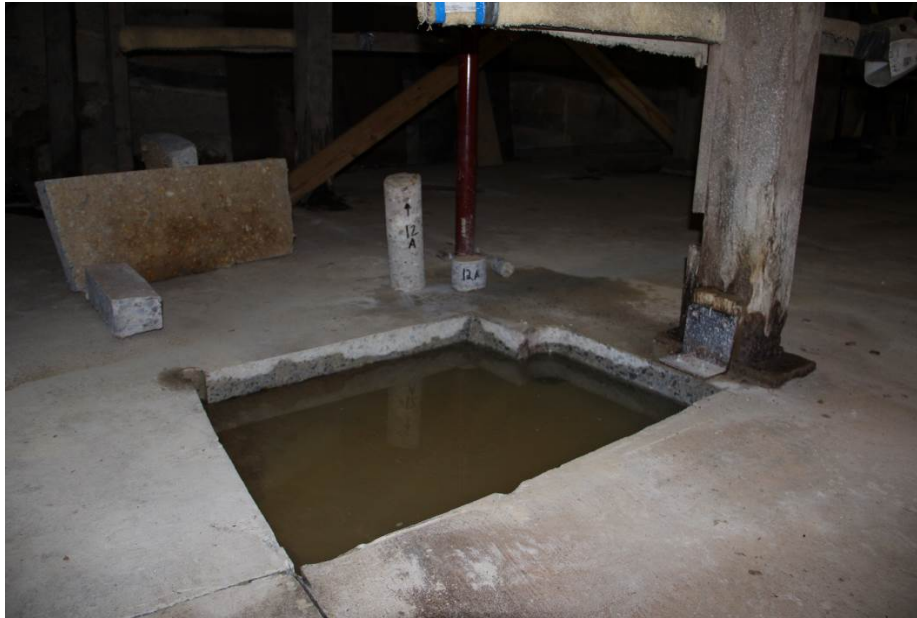
A section of concrete floor saw cut and removed in the West Boat Storage Area (Room 101) to investigate the subfloor and foundation conditions.

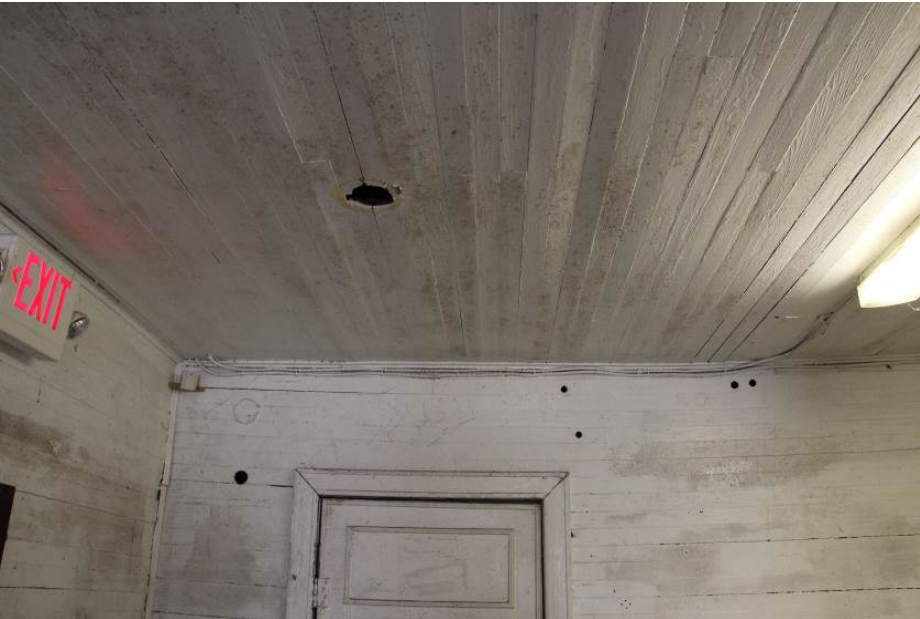
| | <b>C3030</b> | <b>Ceiling Finishes</b> |
|---|---|---|
| <p>Painted tongue-and-groove paneling on the ceiling in the Main Hall (Room 104) on the first floor (note mold and mildew).</p> | | |

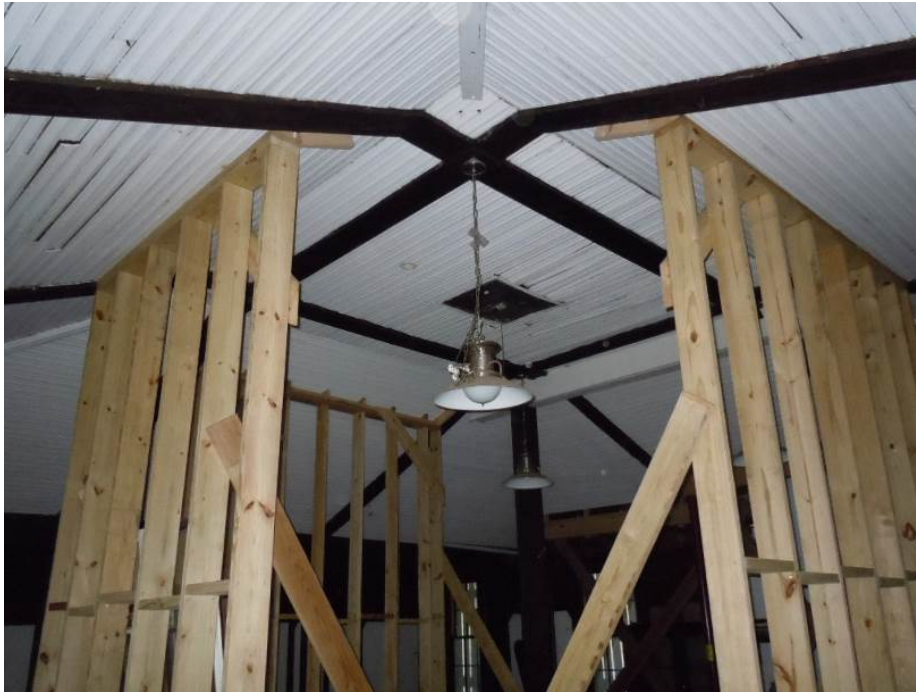
The Ballroom (Room 201) has painted beaded board paneling on the ceiling. Note loose and separating elements.

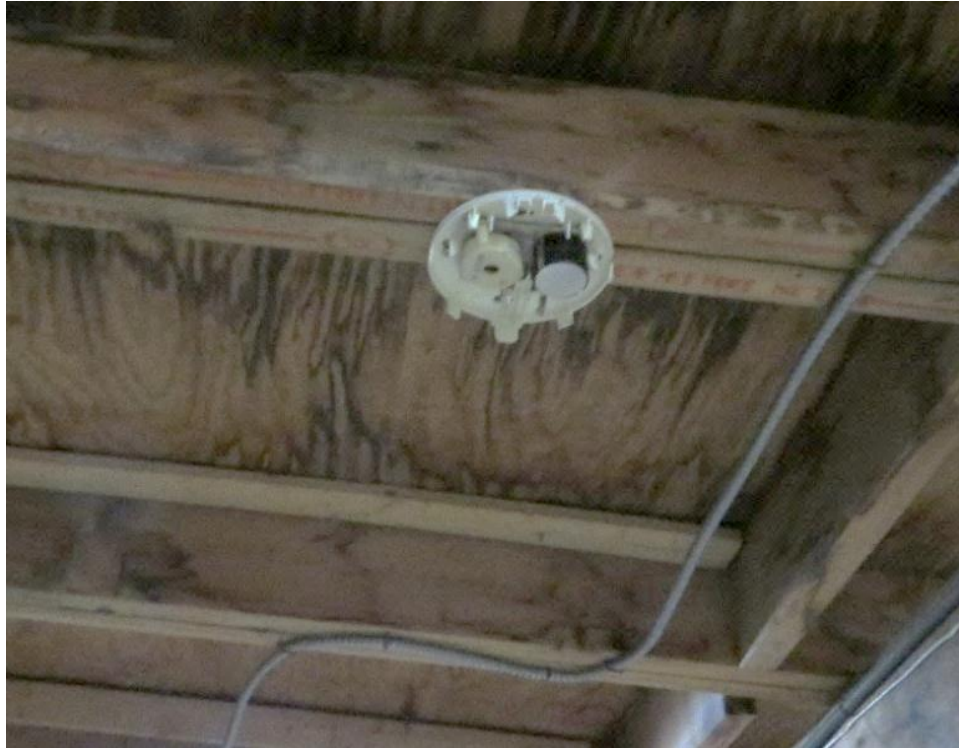
No working smoke or heat detectors are installed throughout the building.

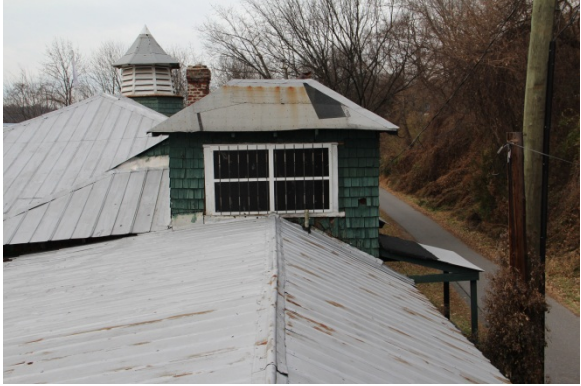
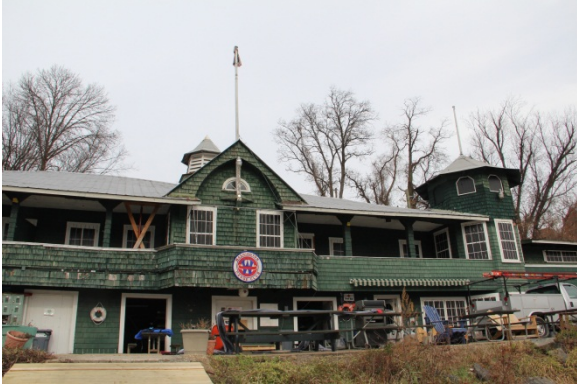
| <p>View of roof looking west with no evidence of lightning protection system.</p> | <p>View of roof looking east with no evidence of lightning protection system.</p> | |

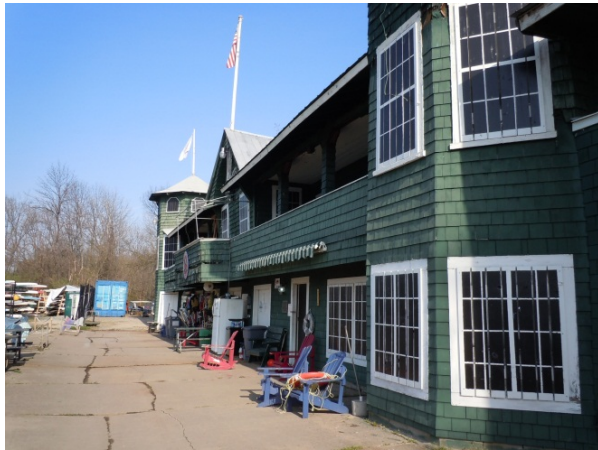
South elevation with concrete apron installed between building and river shore (4/19/13 HPTC).

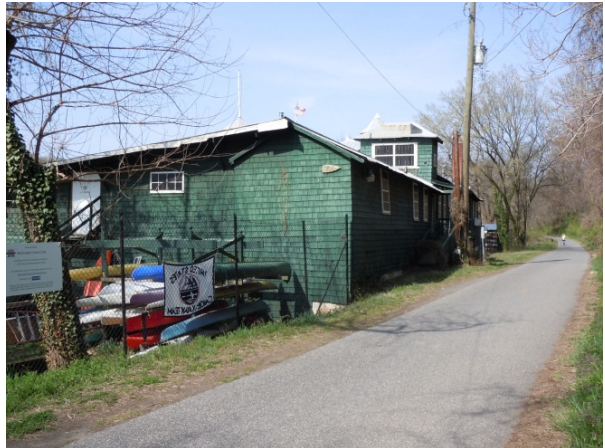
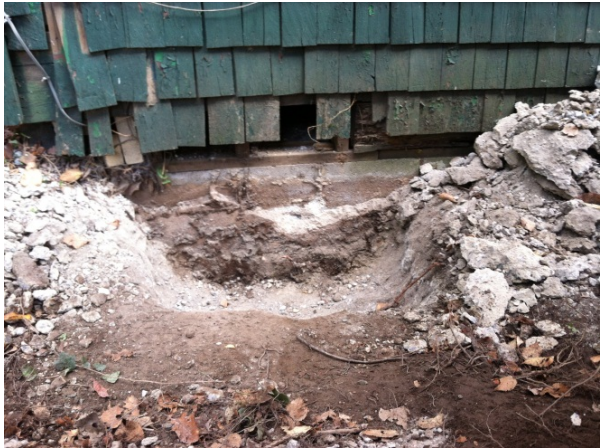
| <p>North elevation and Capital Crescent Trail adjacent to building. (4/19/13, HPTC).</p> | <p>Excavation along north elevation reveals lack of waterproofing and drainage system at this foundation area. (11/07/13, HPTC).</p> |

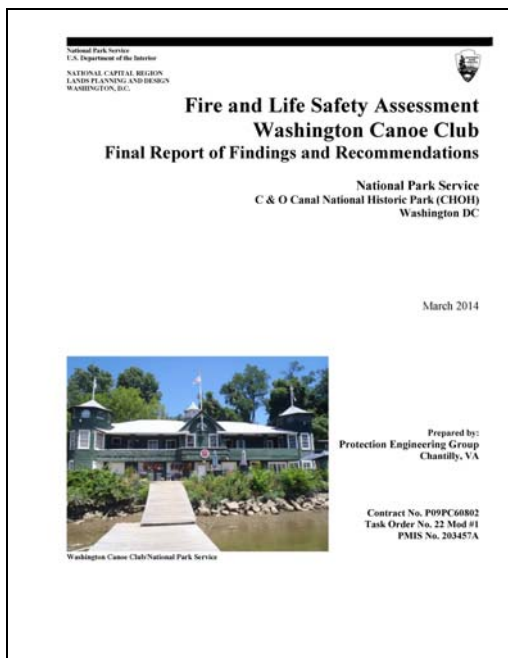
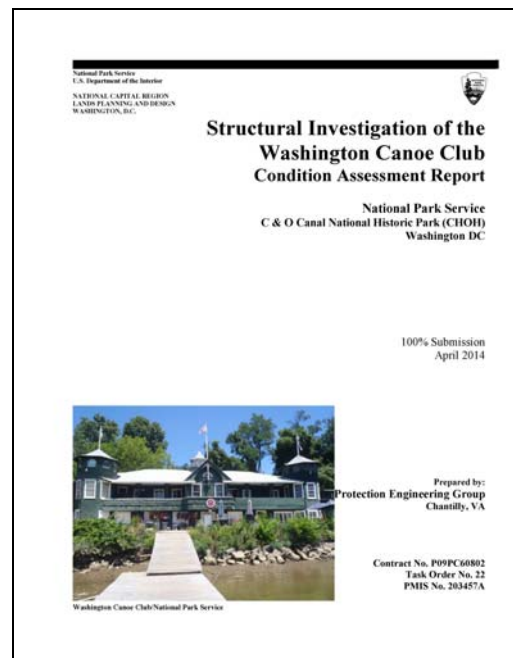
| <b>CONTINUED STABILIZATION: Prioritized Recommended Treatment List</b> | | | |
