APPLICATION AND REFERRAL TO THE US COMMISSION OF FINE ARTS FOR OLD GEORGETOWN REVIEW

Rear Window Replacement Project 1636 33rd St, NW REVISED 8.24.22

1636 33rd STREET (REAR) SUPPLEMENTAL PHOTOS REVISED 8.24.22

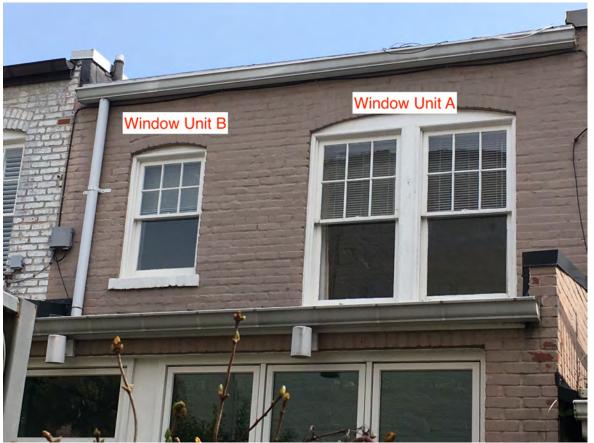
Second Floor - Window Units A, B - Original 6 over 1 wood windows. One unit is a twin unit, the other is a single window unit. Existing sashes and frames are severely rotted. One sash has failed completely. Most of the wood joints are also failing. The frames are dry rotted.

Window Units A, B to be replaced with sapele mahogany 6 over 1, all wood, Dallas Millwork, Inc full units, insulated glass, no vinyl to the exterior and brickmould to match.

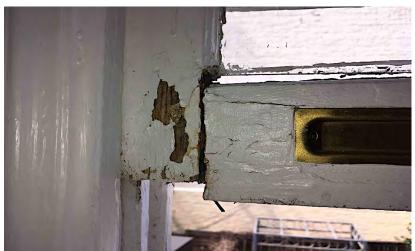
INTERIOR UNIT A (lower sash, twin window left side from INT) - Side rail is rotted and has completely separated from lower rail. Wood joinery has failed. This window sash has been pushed back together, but it previously collapsed on the owner as she attempted to open it.

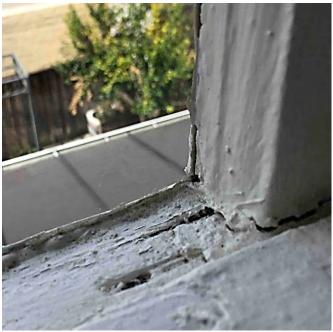
INTERIOR UNIT A (upper sash, twin window right side from INT) - Meeting rail is rotted and splitting. Attempts at repairs with bondo have failed.

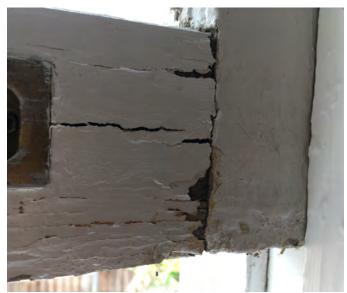
INTERIOR UNIT A (Lower sash, twin window right side from INT) - Lower rail is rotted and splitting from side rail. Failure of joinery. Both upper and lower sash have signifcant rot issues

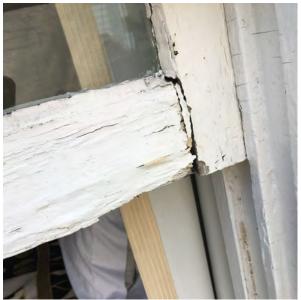
EXTERIOR UNIT A (Lower sash, twin window right side from INT) - Sash lower rail is severely rotted and has separated from side rail.

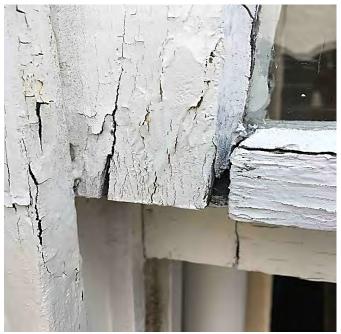
EXTERIOR UNIT B (Upper sash, bathroom window right side from INT) - Sash meeting rail is rotted and splitting and has separated from side rail. Sash is in danger of collapse.

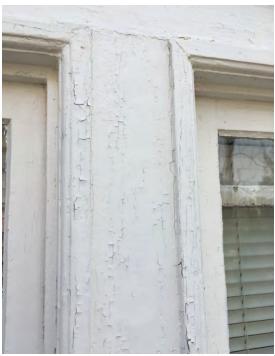
Existing mull profile to be replicated

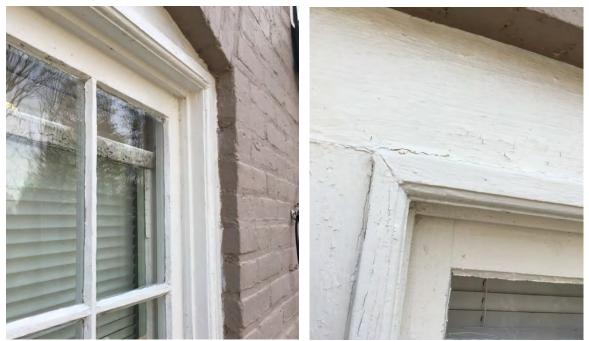
Existing brickmould to be replicated
