# THE WASHINGTON CANOE CLUB - Interior and Exterior Modifications and Repairs

3700 Water Street NW Washington, DC

Old Georgetown Board US Commission of Fine Arts • Concept Design Submission Volume 1

October 17, 2024

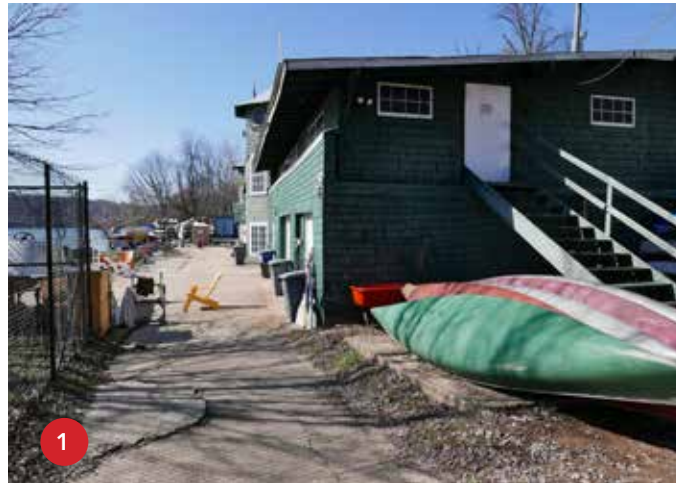
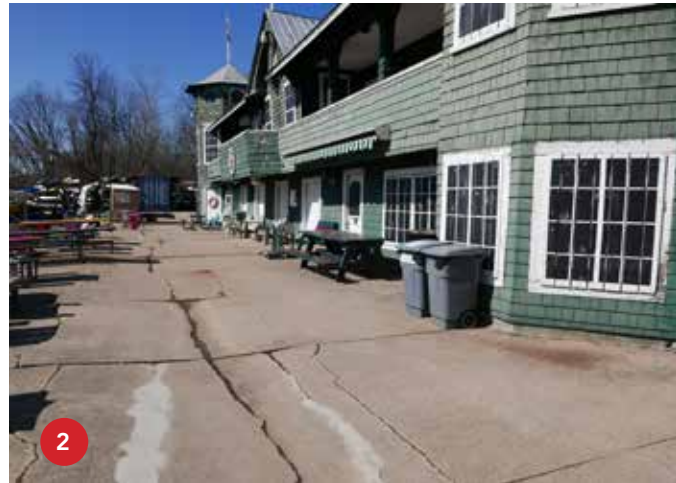
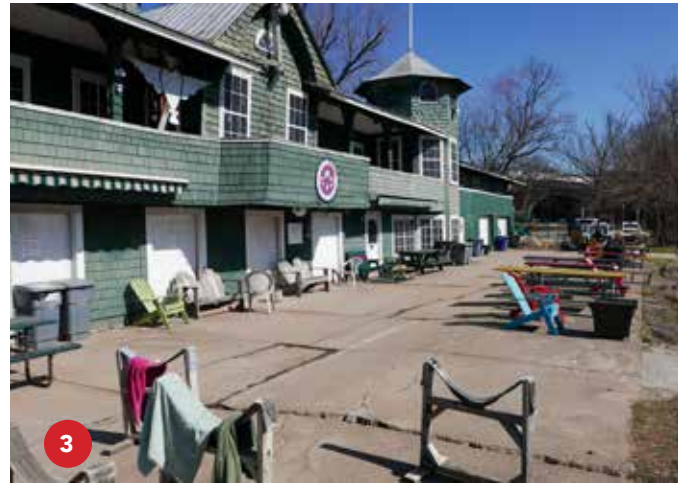
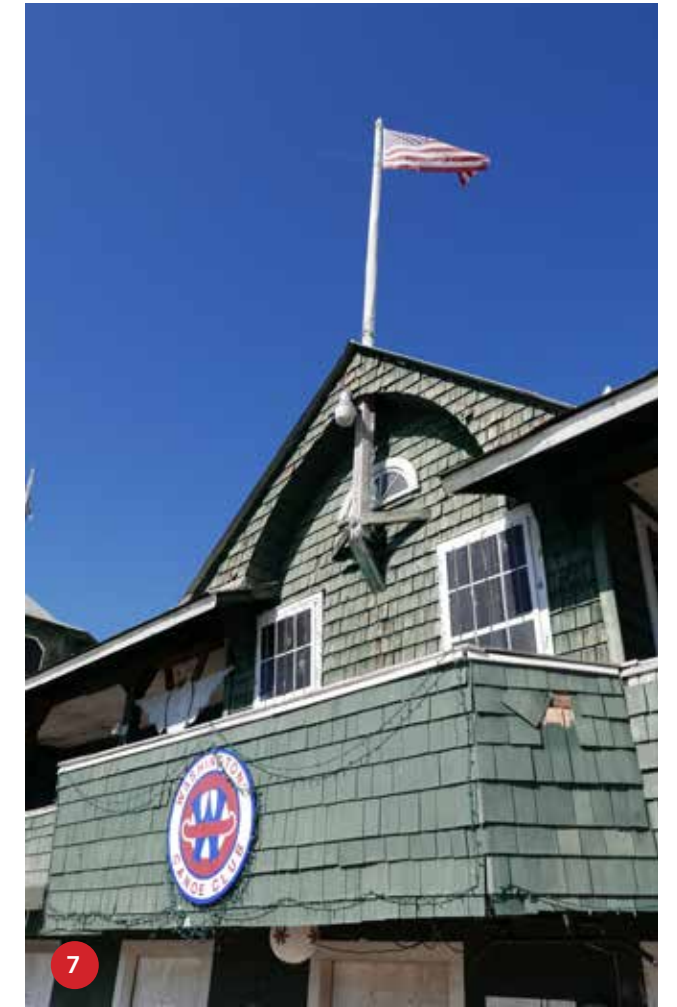
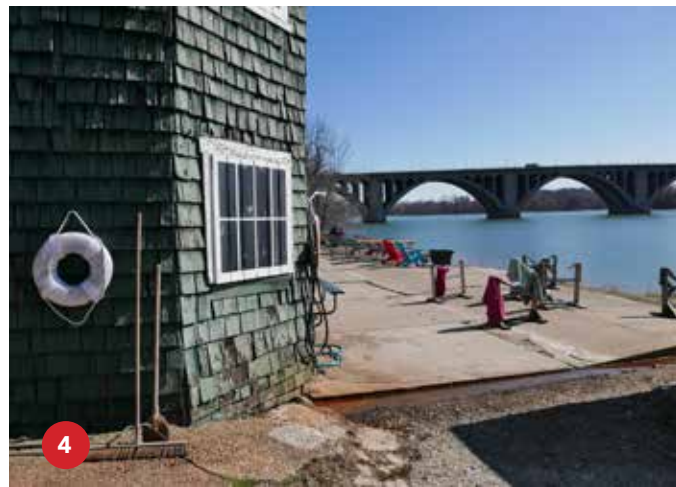
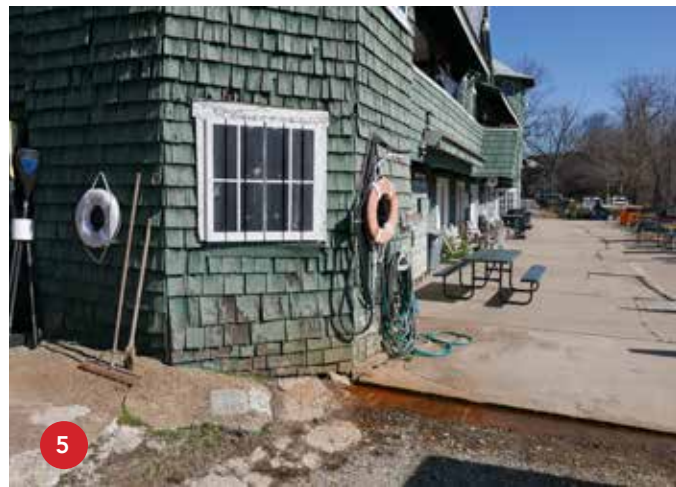
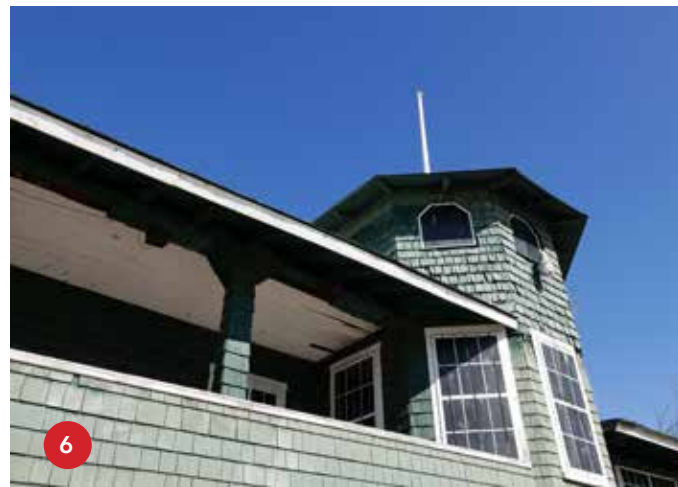
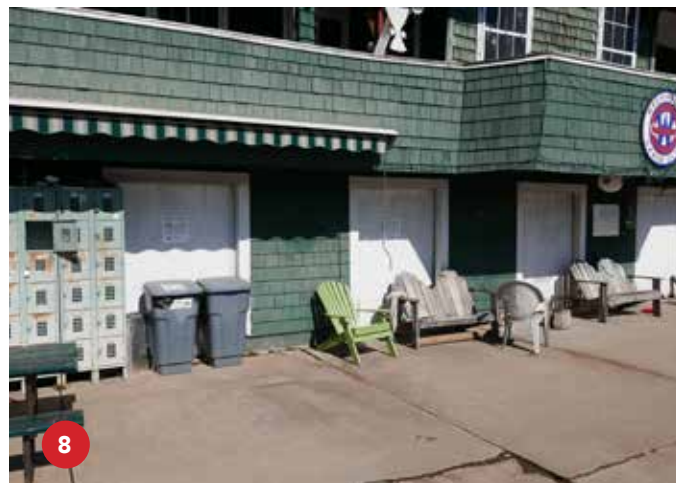
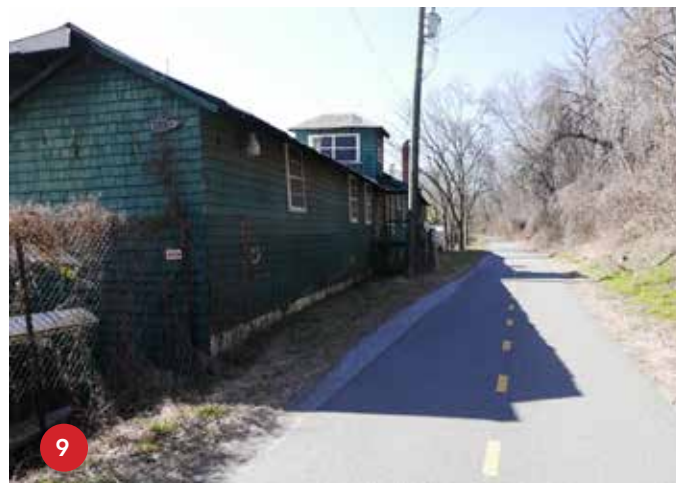
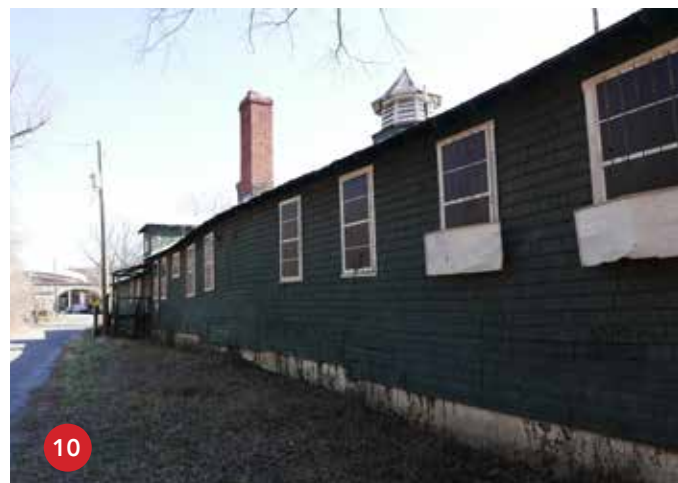
**Existing Exterior Conditions**

- 1. East entry
- 2. River elevation from east
- 3. River elevation from west
- 4. Southwest corner detail
- 5. River elevation from west
- 6. Detail at balcony and turret
- 7. Second floor detail
- 8. First floor storage bay doors
- 9. North elevation to west
- 10. North elevation to east

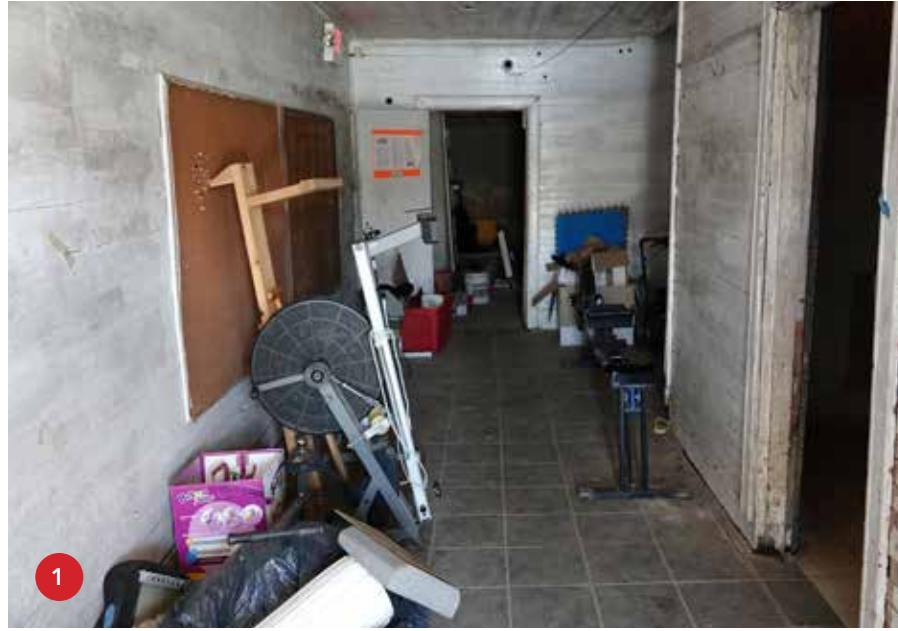
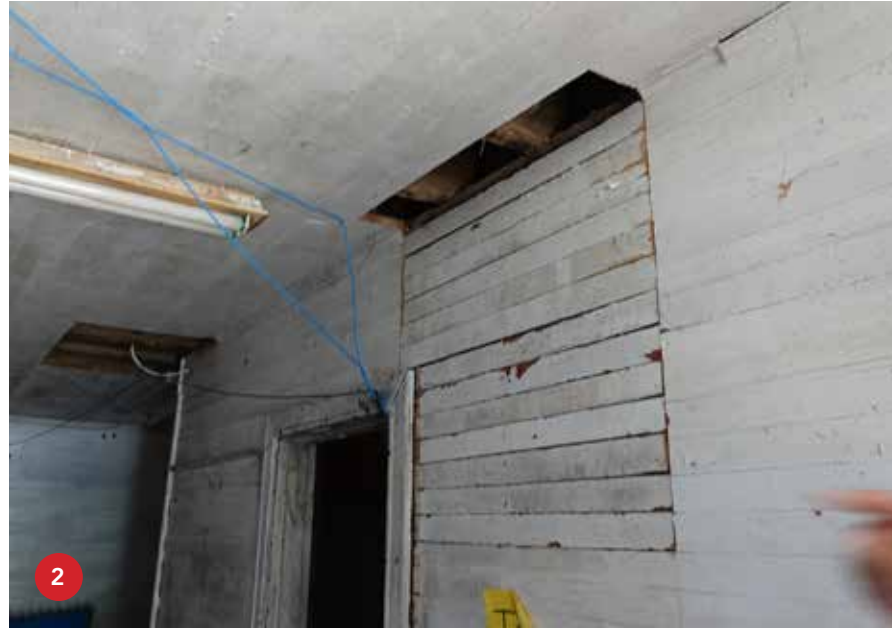
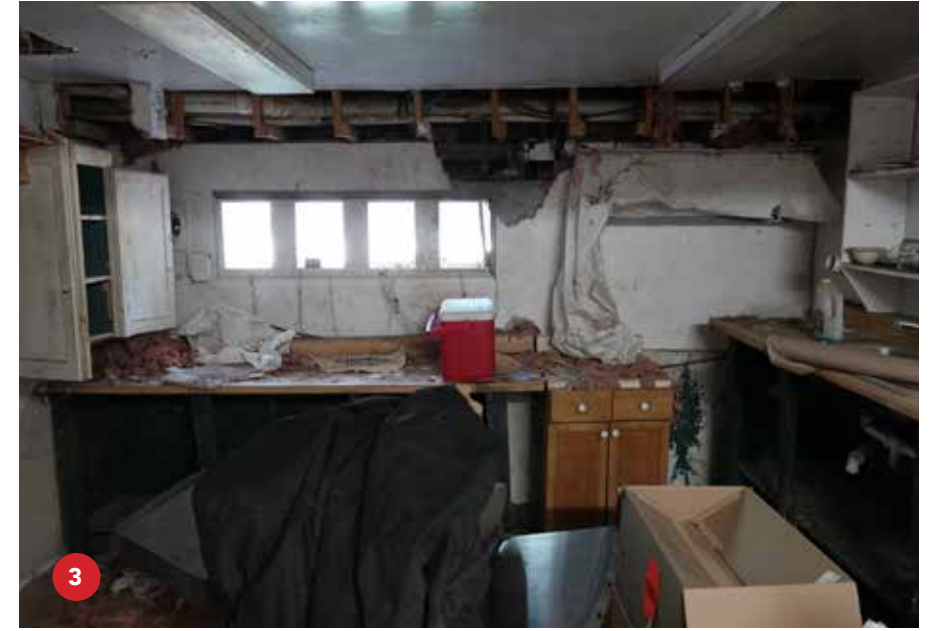
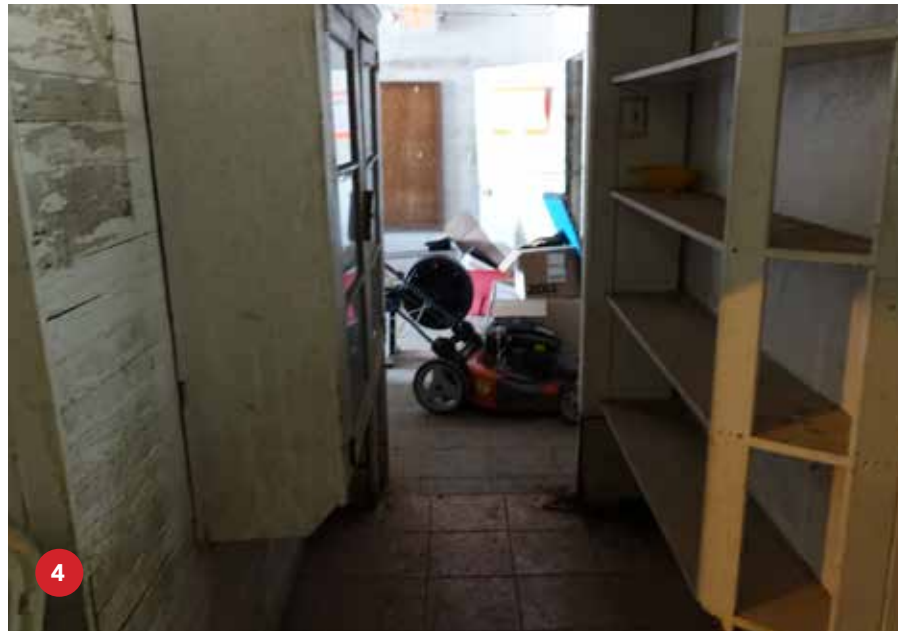
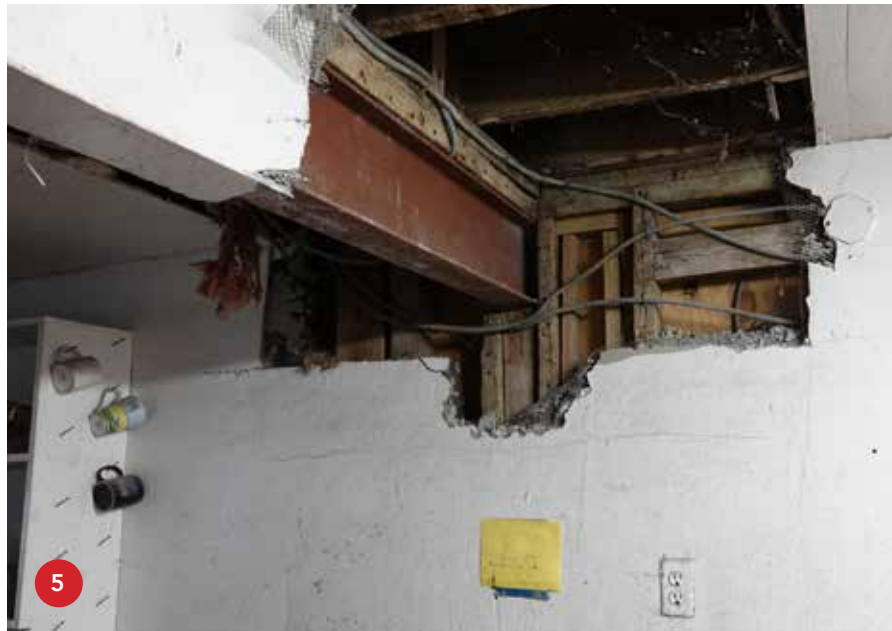
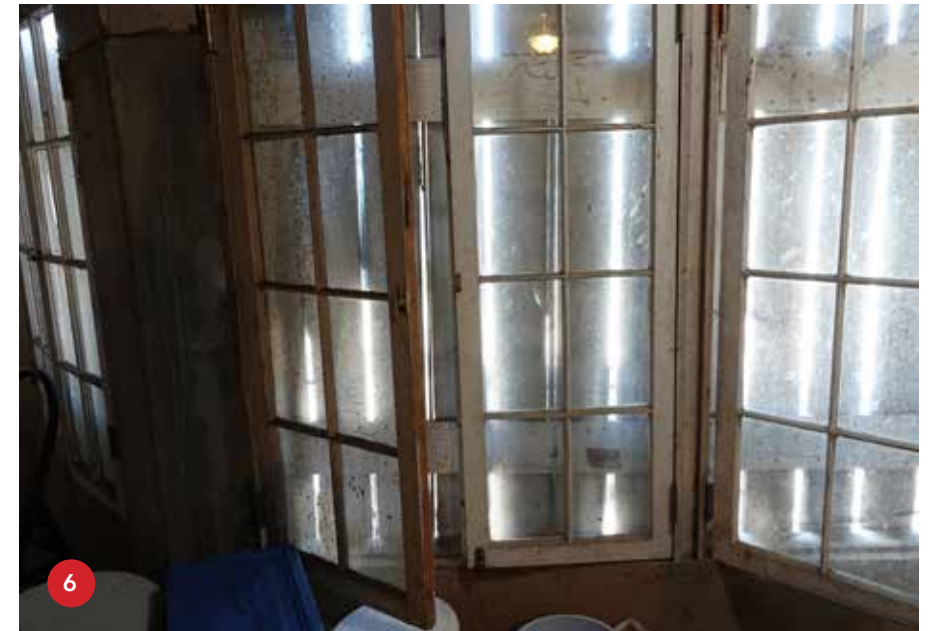
**Existing Interior Conditions**

- 1. Main entry Hall
- 2. Typical damage at entry Hall
- 3. Kitchen
- 4. Hall from Kitchen to East Bay
- 5. Typical damage at Kitchen
- 6. Grille Room Windows

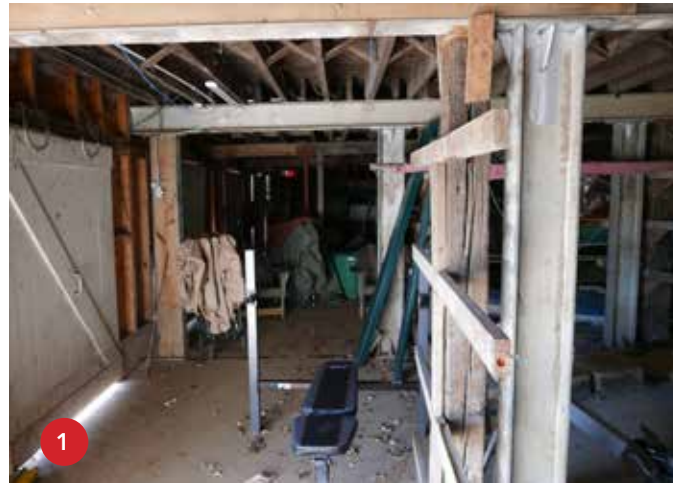
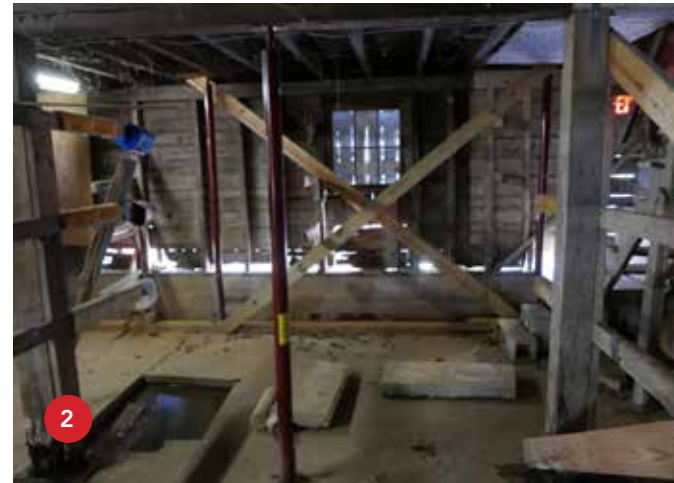
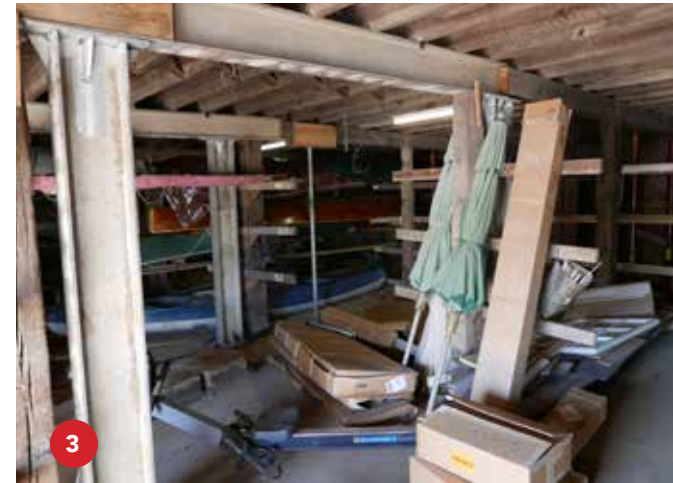
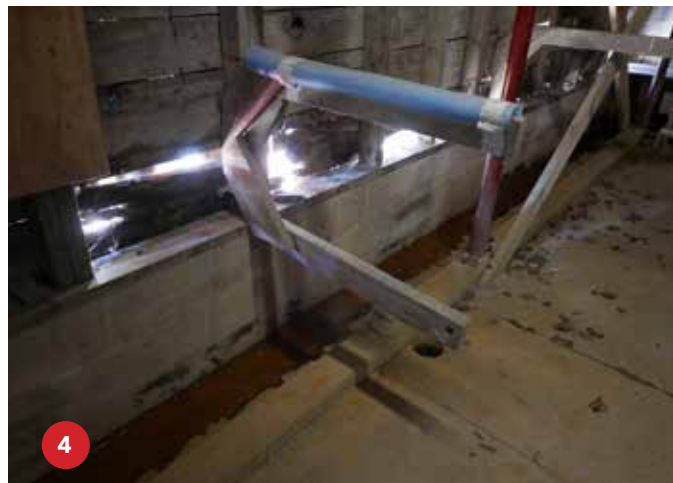
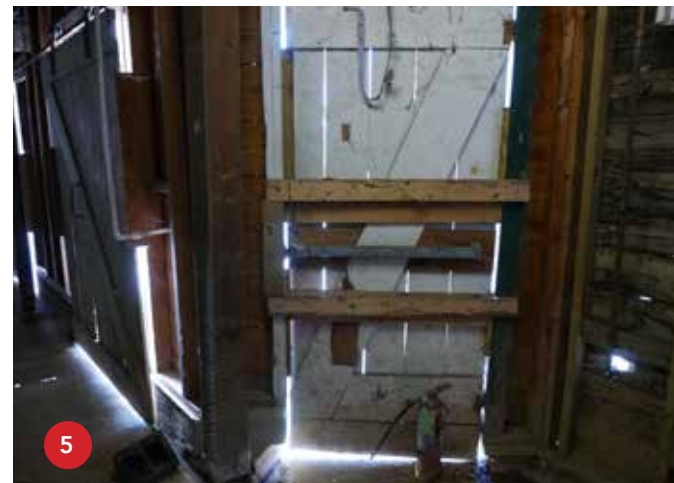
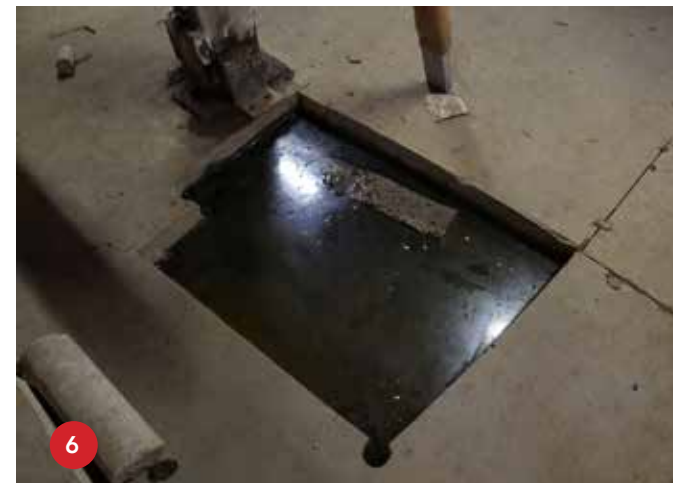
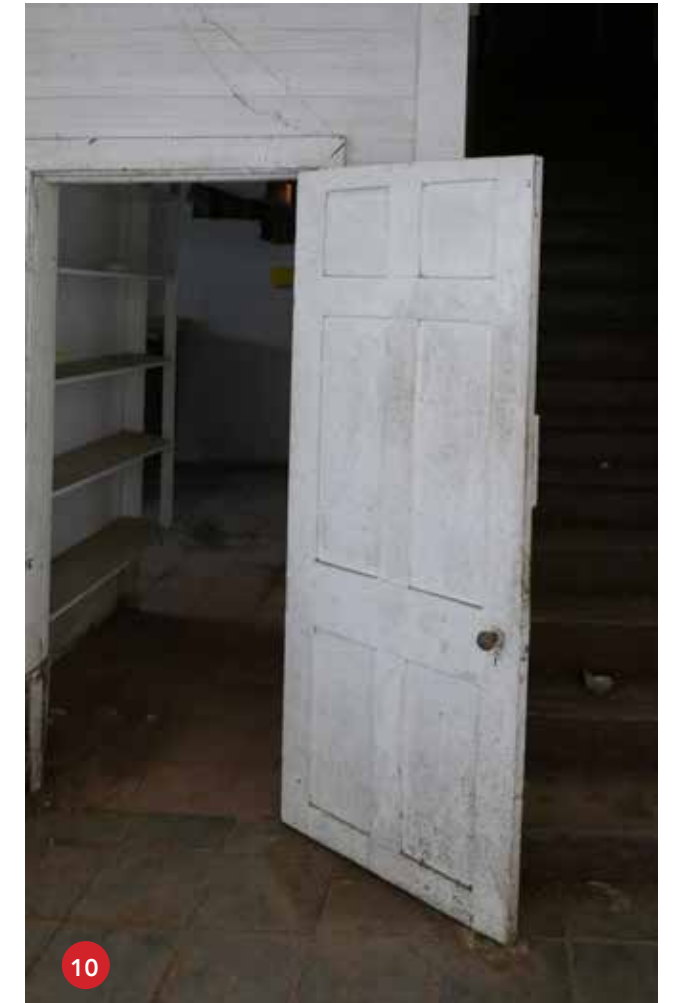
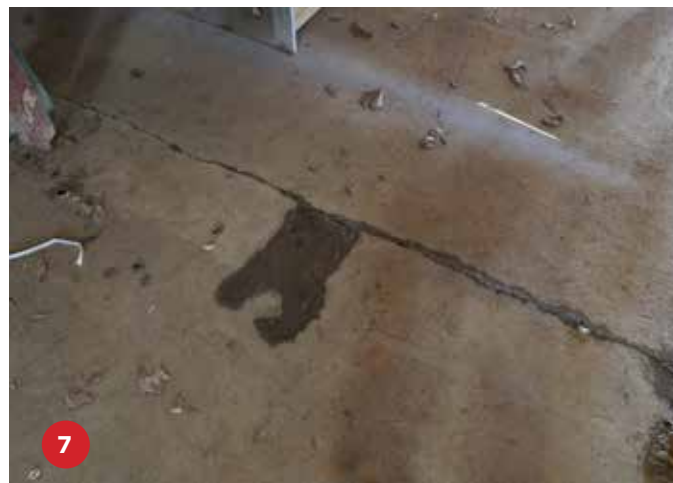
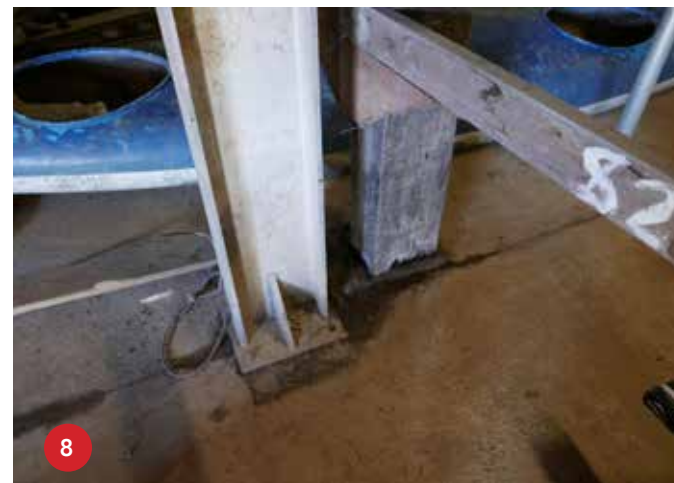
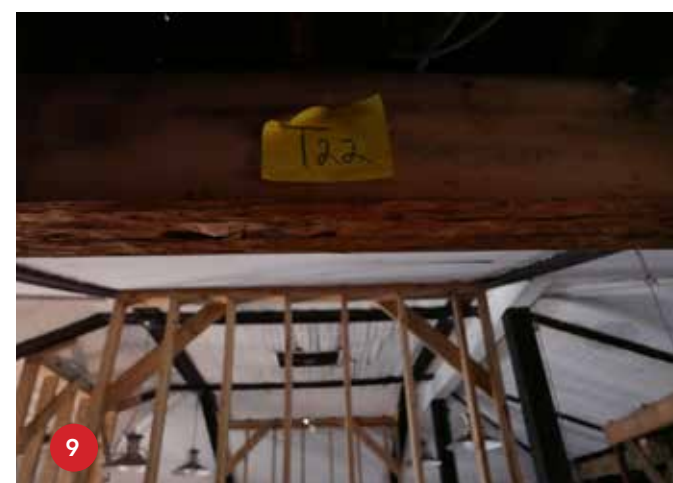
### Existing Interior Conditions

- 1. South wall West Bay
- 2. West Bay
- 3. West Bay
- 4. Deteriorated north wall
- 5. South wall exterior door
- 6. Water just below slab at West Bay
- 7. First floor water seepage at West Bay
- 8. Typical column base West Bay
- 9. Temporary shoring 2nd floor ballroom
- 10. Cut down first floor door

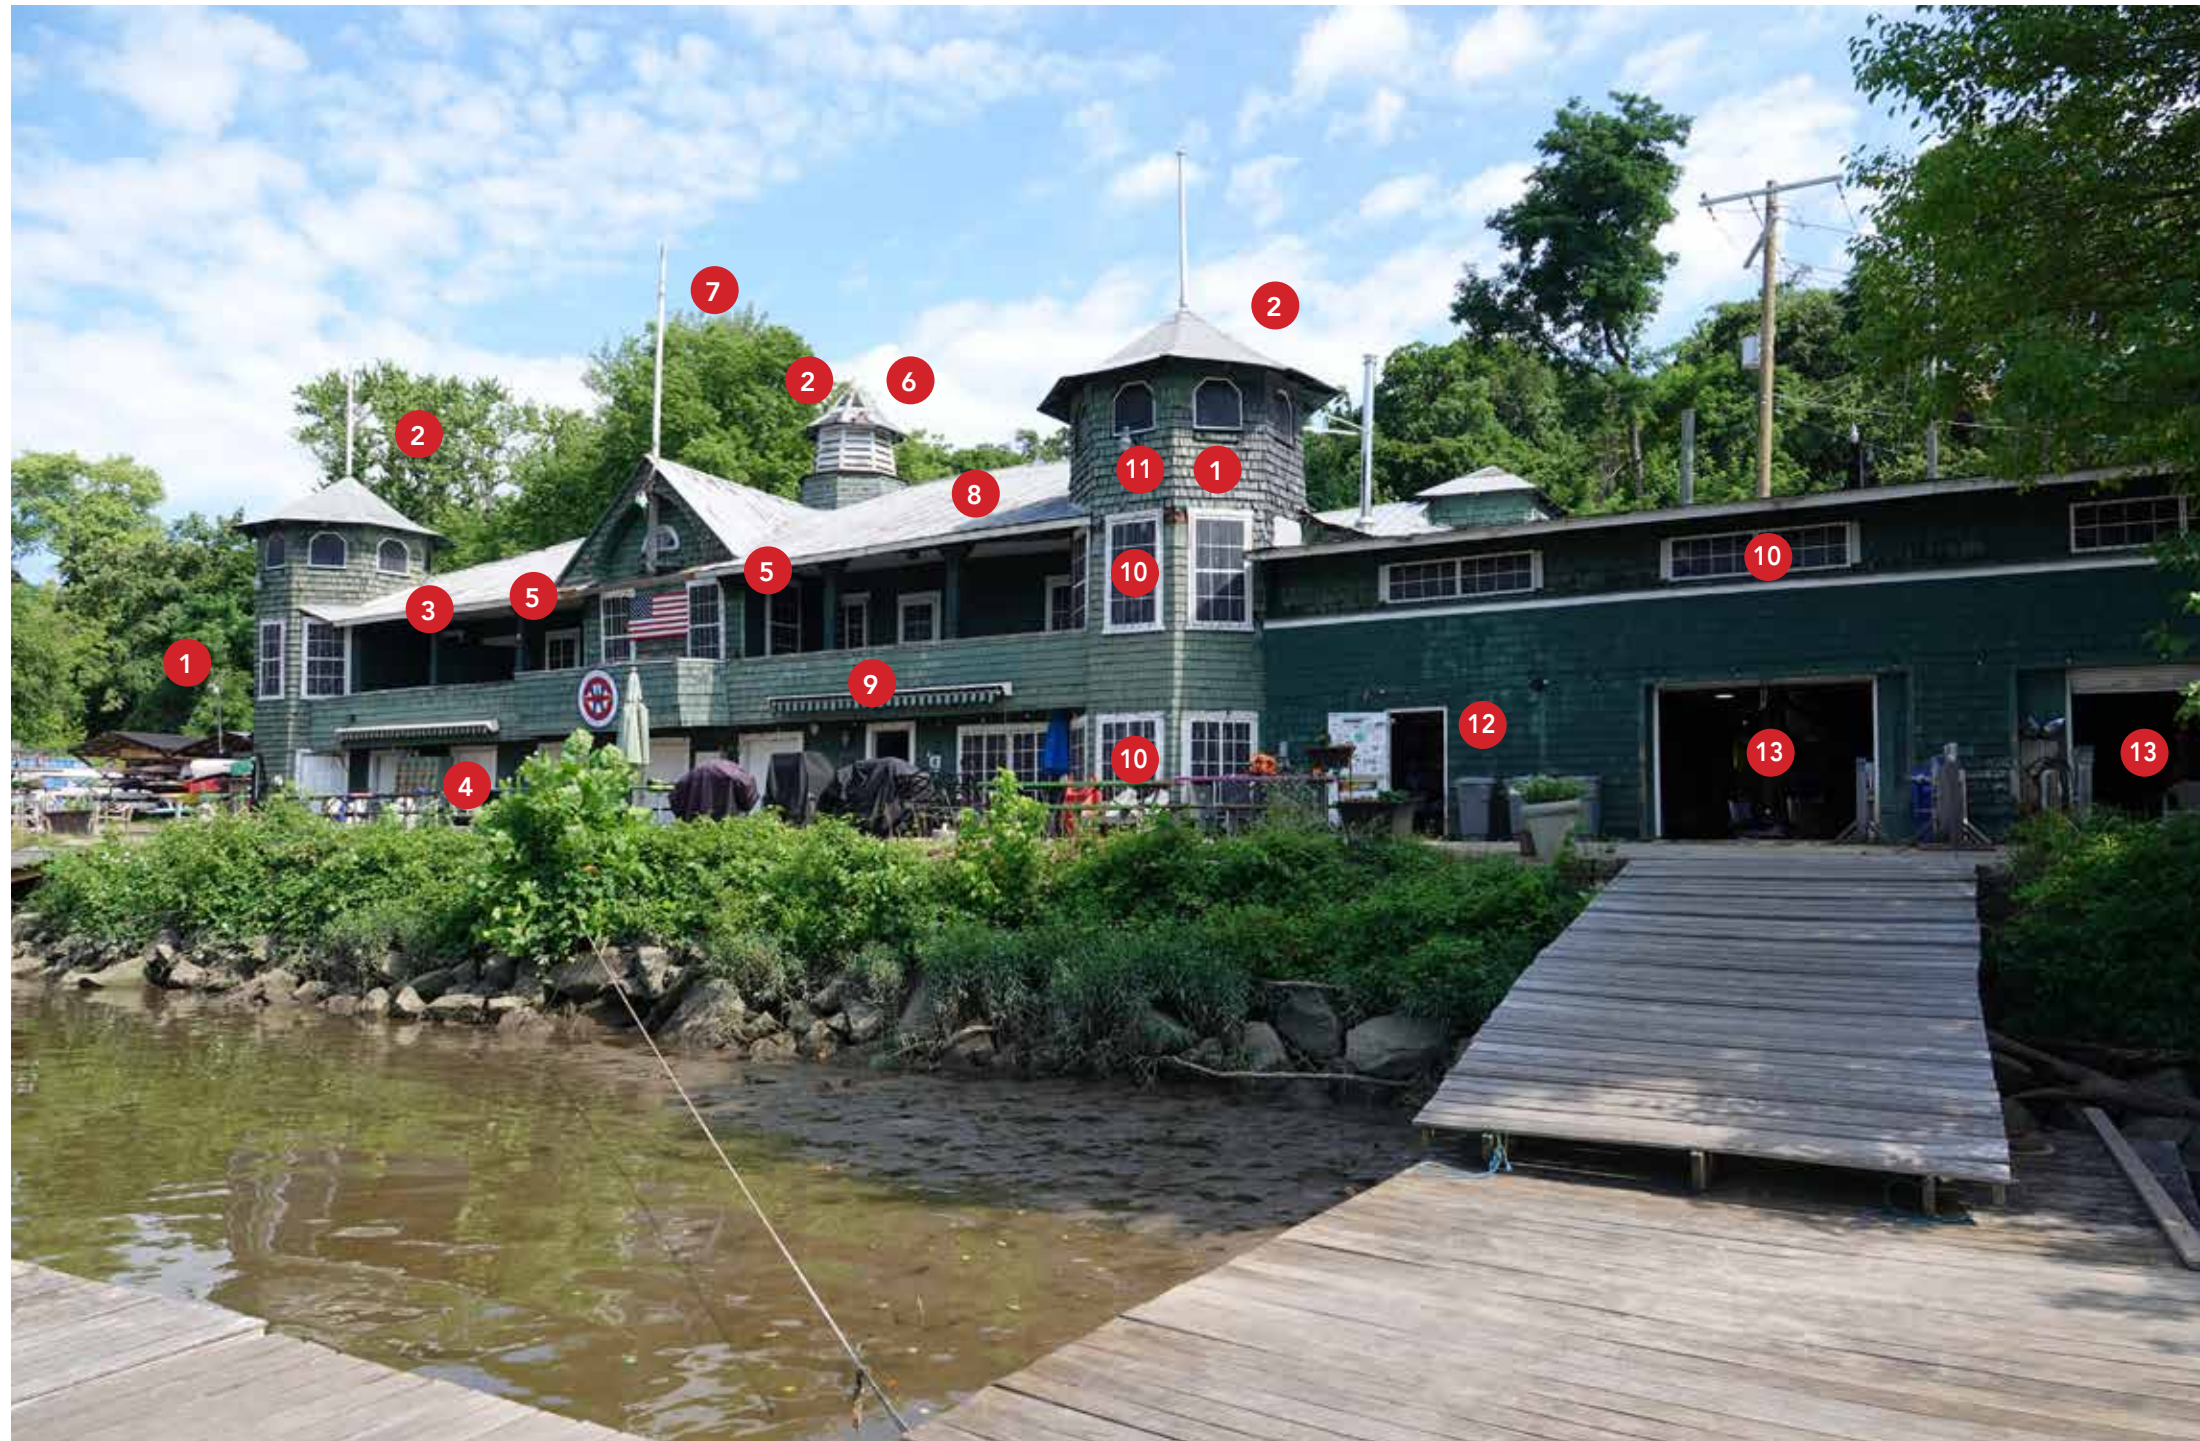
South Elevation - Observed Conditions and Repair Scope

The south elevation of the boat house is generally in poor and some cases unstable condition requiring major repair, replacement and refinish. The roofing which is not historic to the 1903 condition is in need of complete replacement. The exterior wood shingles and wood soffits and trims are deteriorated in places needing repair and or replacement. The exterior windows and some doors have been boarded over to protect historic fabric and appear to be in restorable condition. The first floor boat bay doors at the west bay are deteriorated with select replacement recommended. The historic east bay boat bay doors have been replaced with one entirely closed.

1. Severely deteriorated wood shingles to be replaced
2. Replace sheet bituminous roofing and repair flagpole
3. Install period correct gutters and downspouts as viewed in historic photos
4. Repair and or replace deteriorated wood West boat bay doors
5. Broken roof framing member
6. Restore deteriorated venting cupola
7. Repair wood flagpole
8. Replace deteriorated corrugated metal roofing and flashings
9. Repair balcony framing
10. Remove overlay door and window guards and restore historic doors and windows
11. Reopen close openings at turrets
12. Reestablished closed boat bay door
13. Replace modern metal roll up garage door with period wood

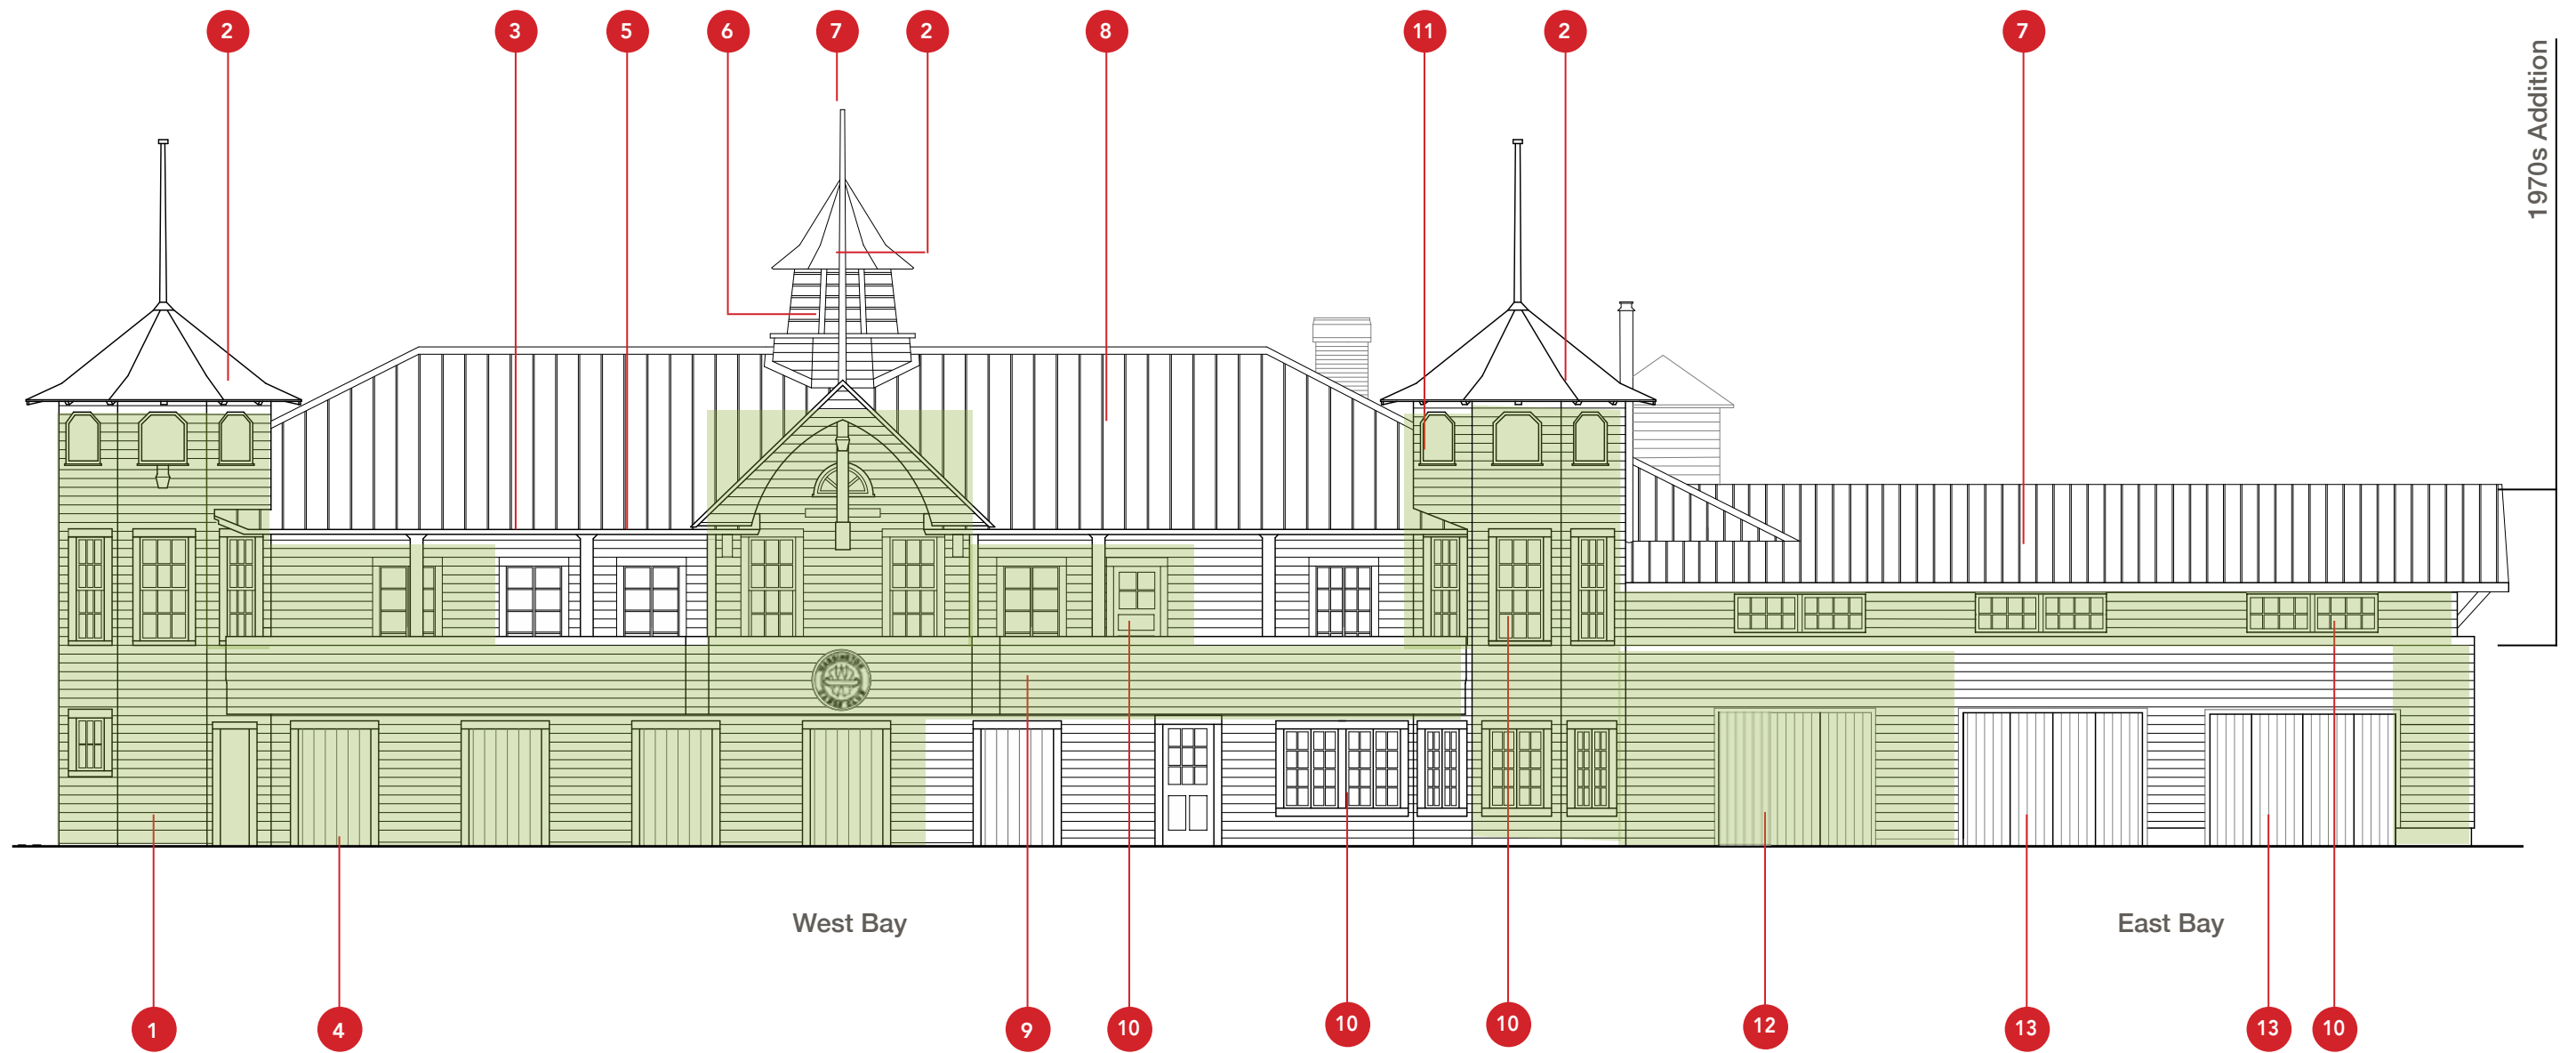
South Elevation - Observed Conditions and Repair Scope

Approximate area of deteriorated shingles to be removed and replaced

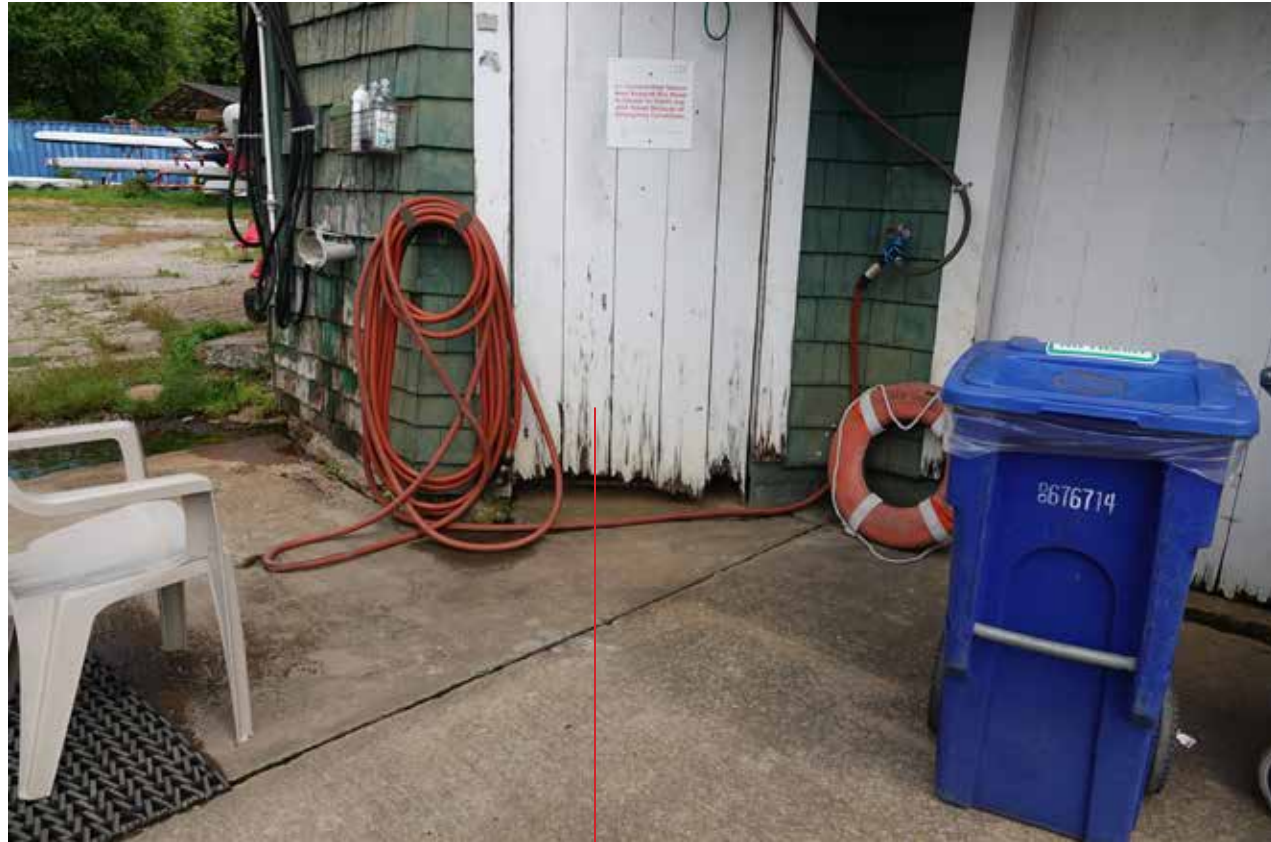
4 Repair and or replace deteriorated wood West boat bay doors

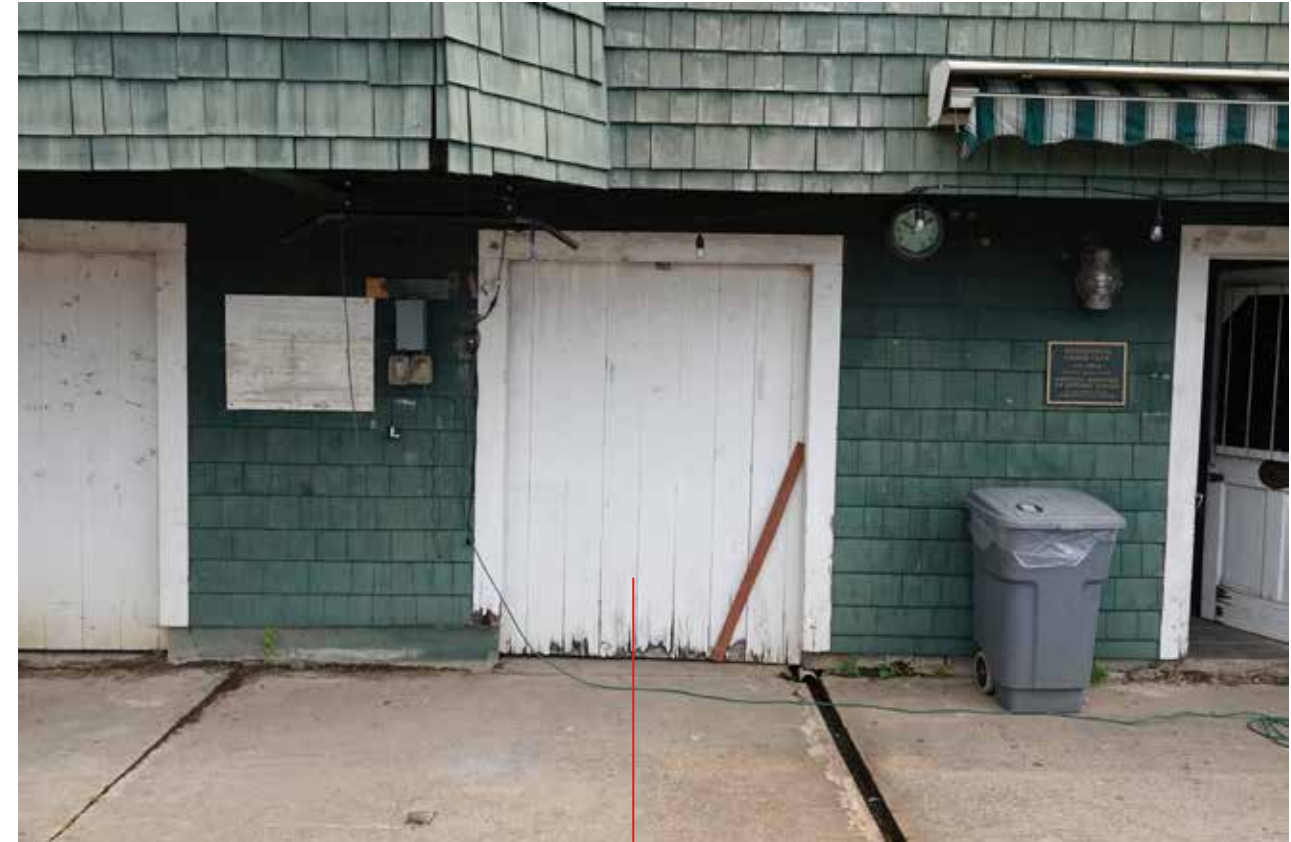
### Existing West Bay Boat Bay Door Repair

4 Repair and or replace deteriorated wood West boat bay doors

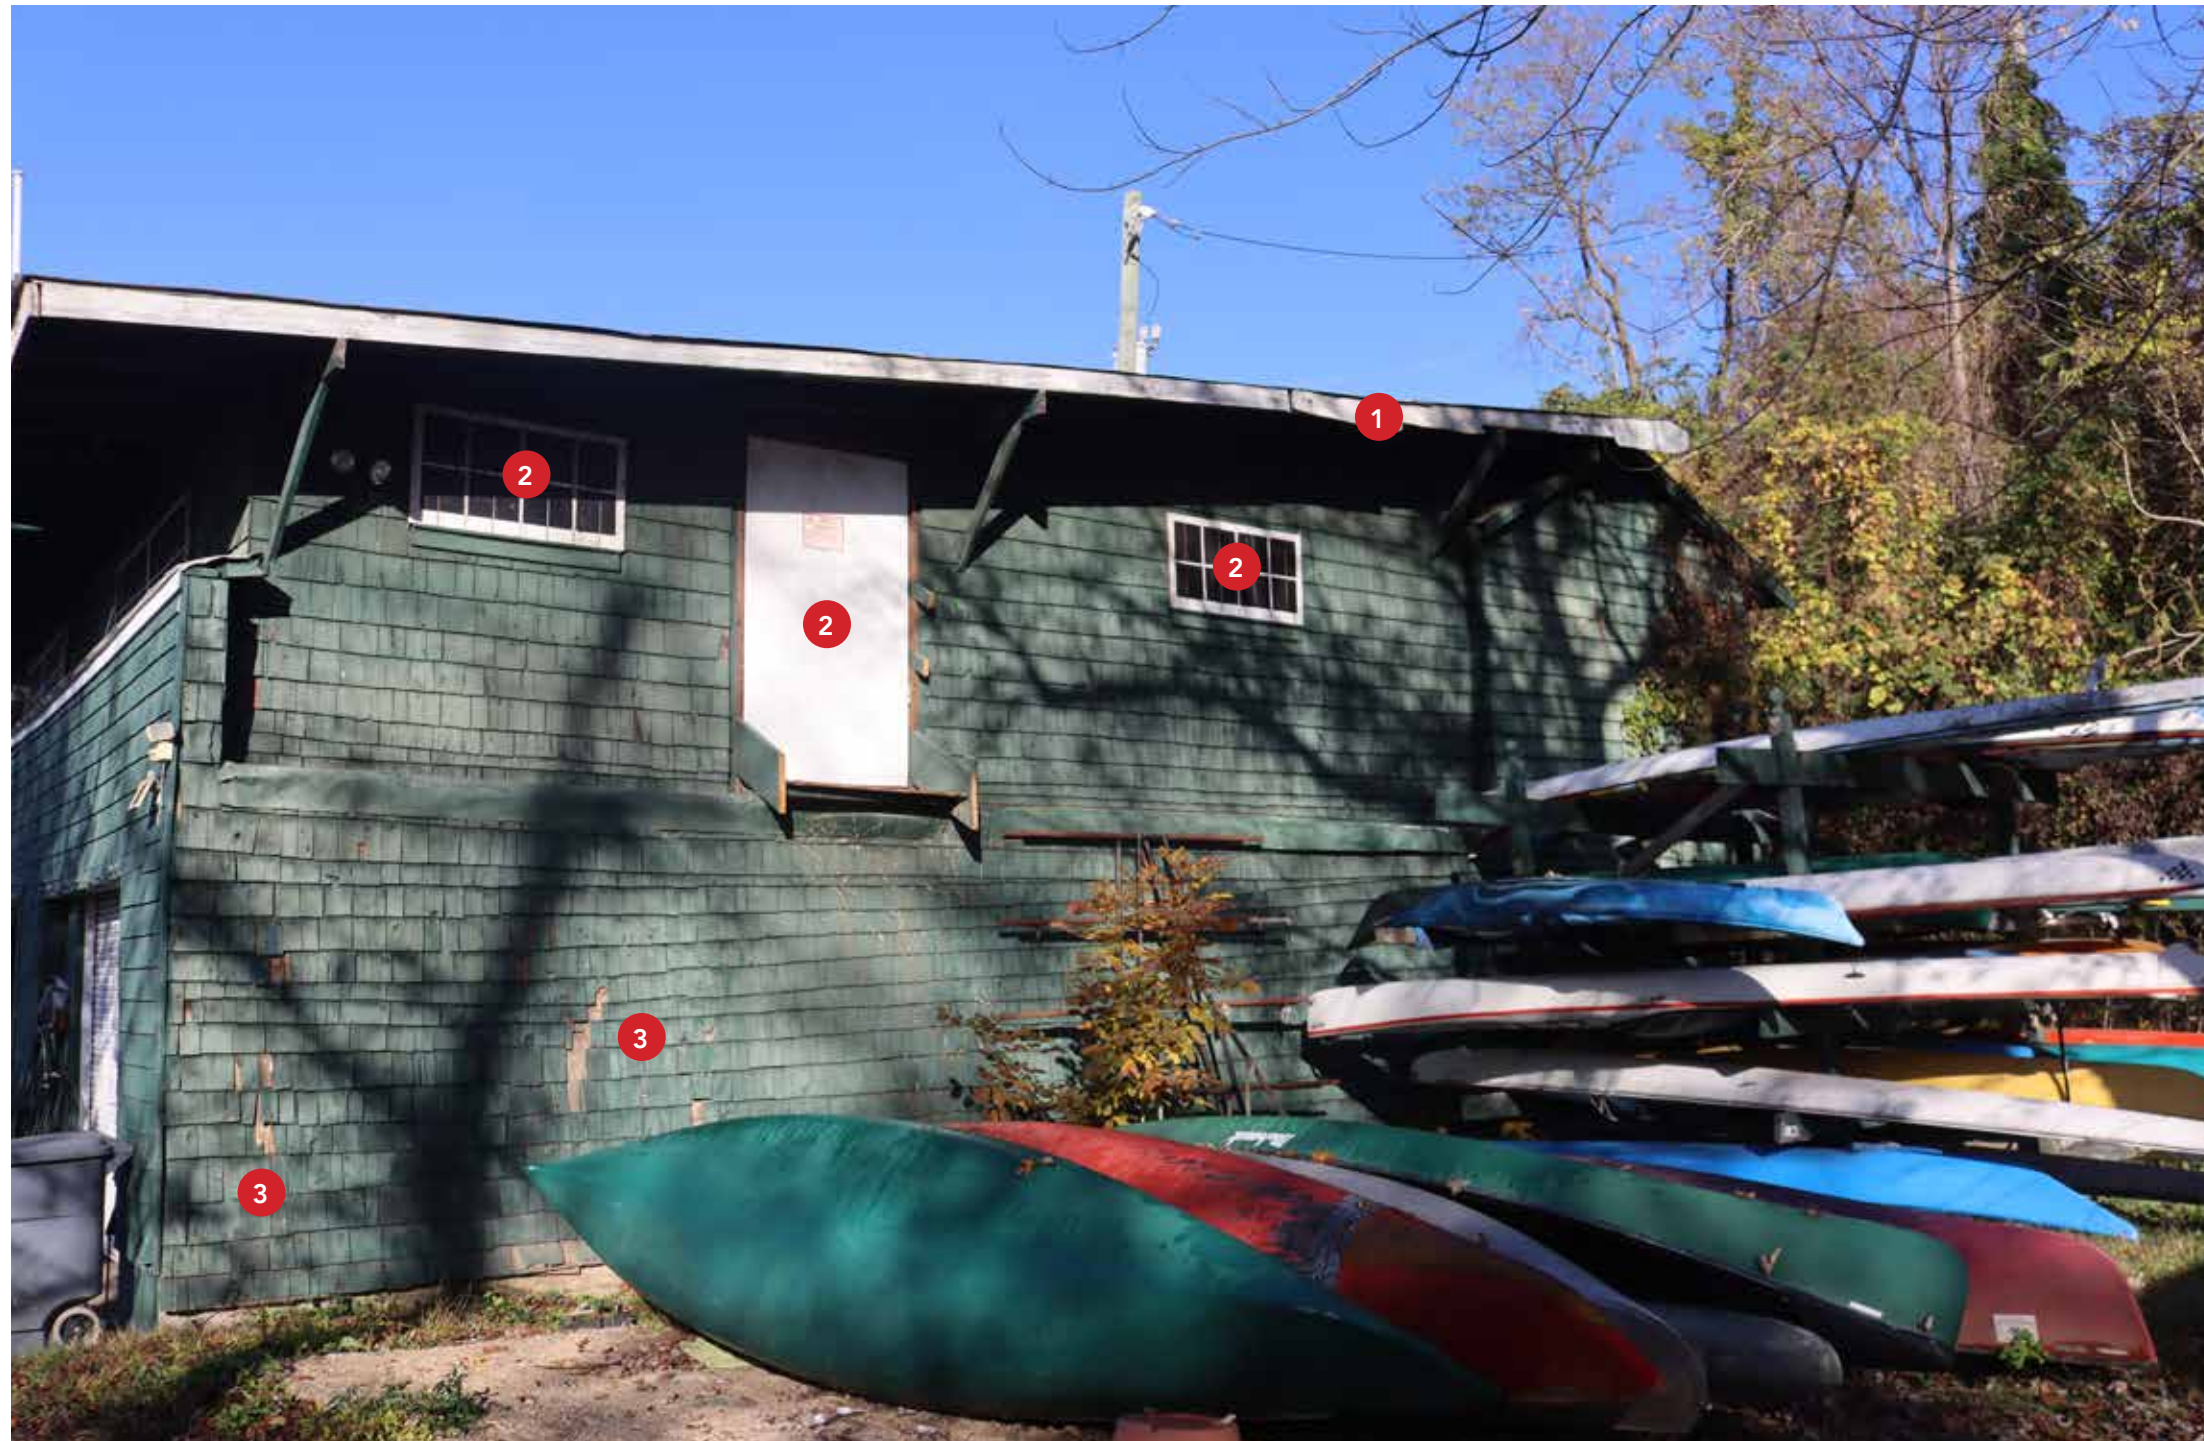
North Elevation - Observed Conditions and Repair Scope

The east elevation of the boat house is generally in poor and some cases unstable condition requiring major repair, replacement and refinish at the 1920's single story and 1970s second floor addition. The roofing which is not is in need of complete replacement. The exterior wood shingles and wood soffits and trims are deteriorated in places needing repair and or replacement. The exterior windows at the second floor have been boarded over to protect historic fabric and appear to be in restorable condition.

1. Deteriorated wood trim to be repaired, replaced and refinished
2. Remove overlay door and window guards and restore historic doors and windows
3. Severely deteriorated wood shingles to be replaced.
