# THE WASHINGTON CANOE CLUB - Interior and Exterior Modifications and Repairs

3700 Water Street NW Washington, DC

Old Georgetown Board US Commission of Fine Arts • Concept Design Submission Volume 1

October 17, 2024

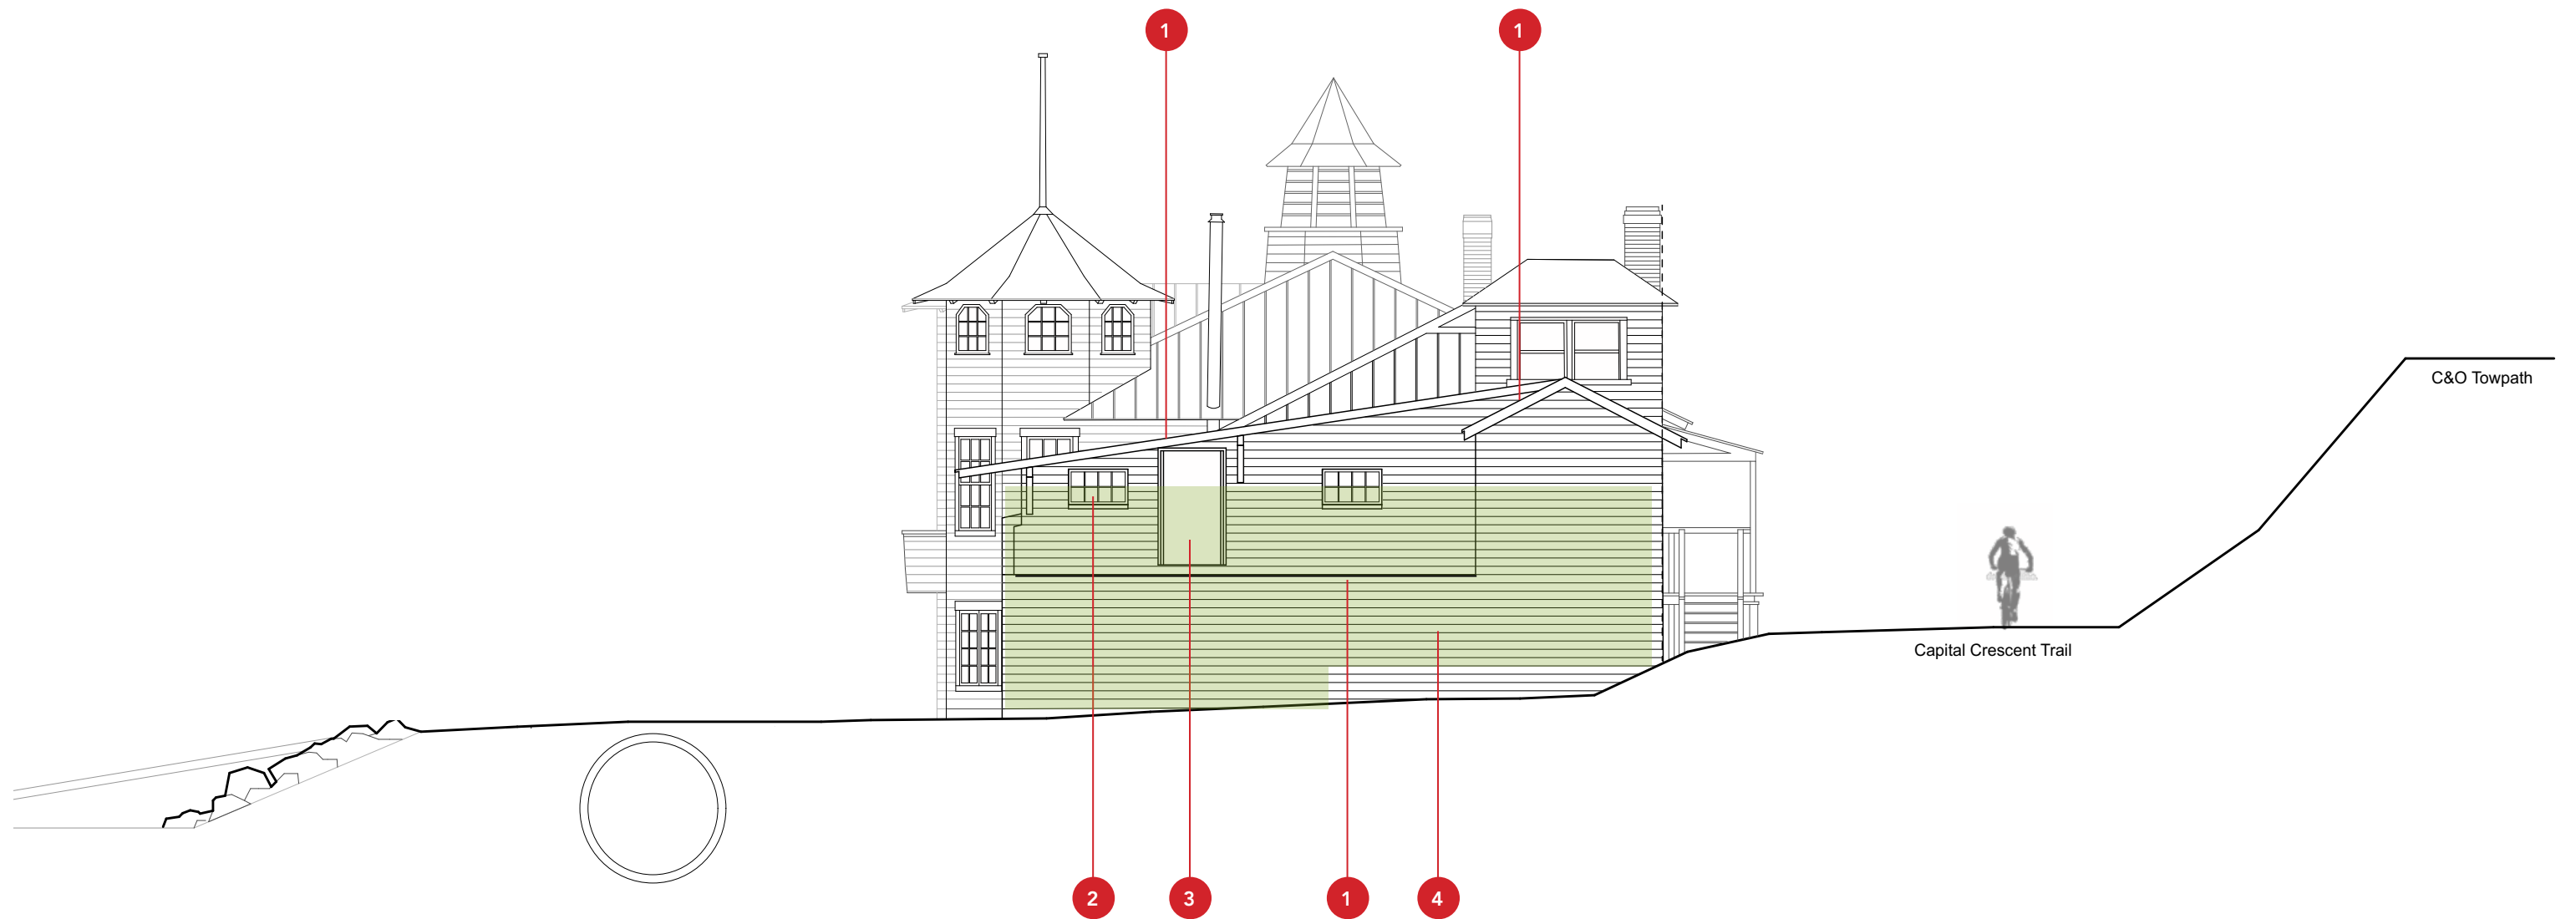
East Elevation - Observed Conditions and Repair Scope

- Approximate area of deteriorated shingles to be removed and replaced
- Photo or Note Key - see preceding pages

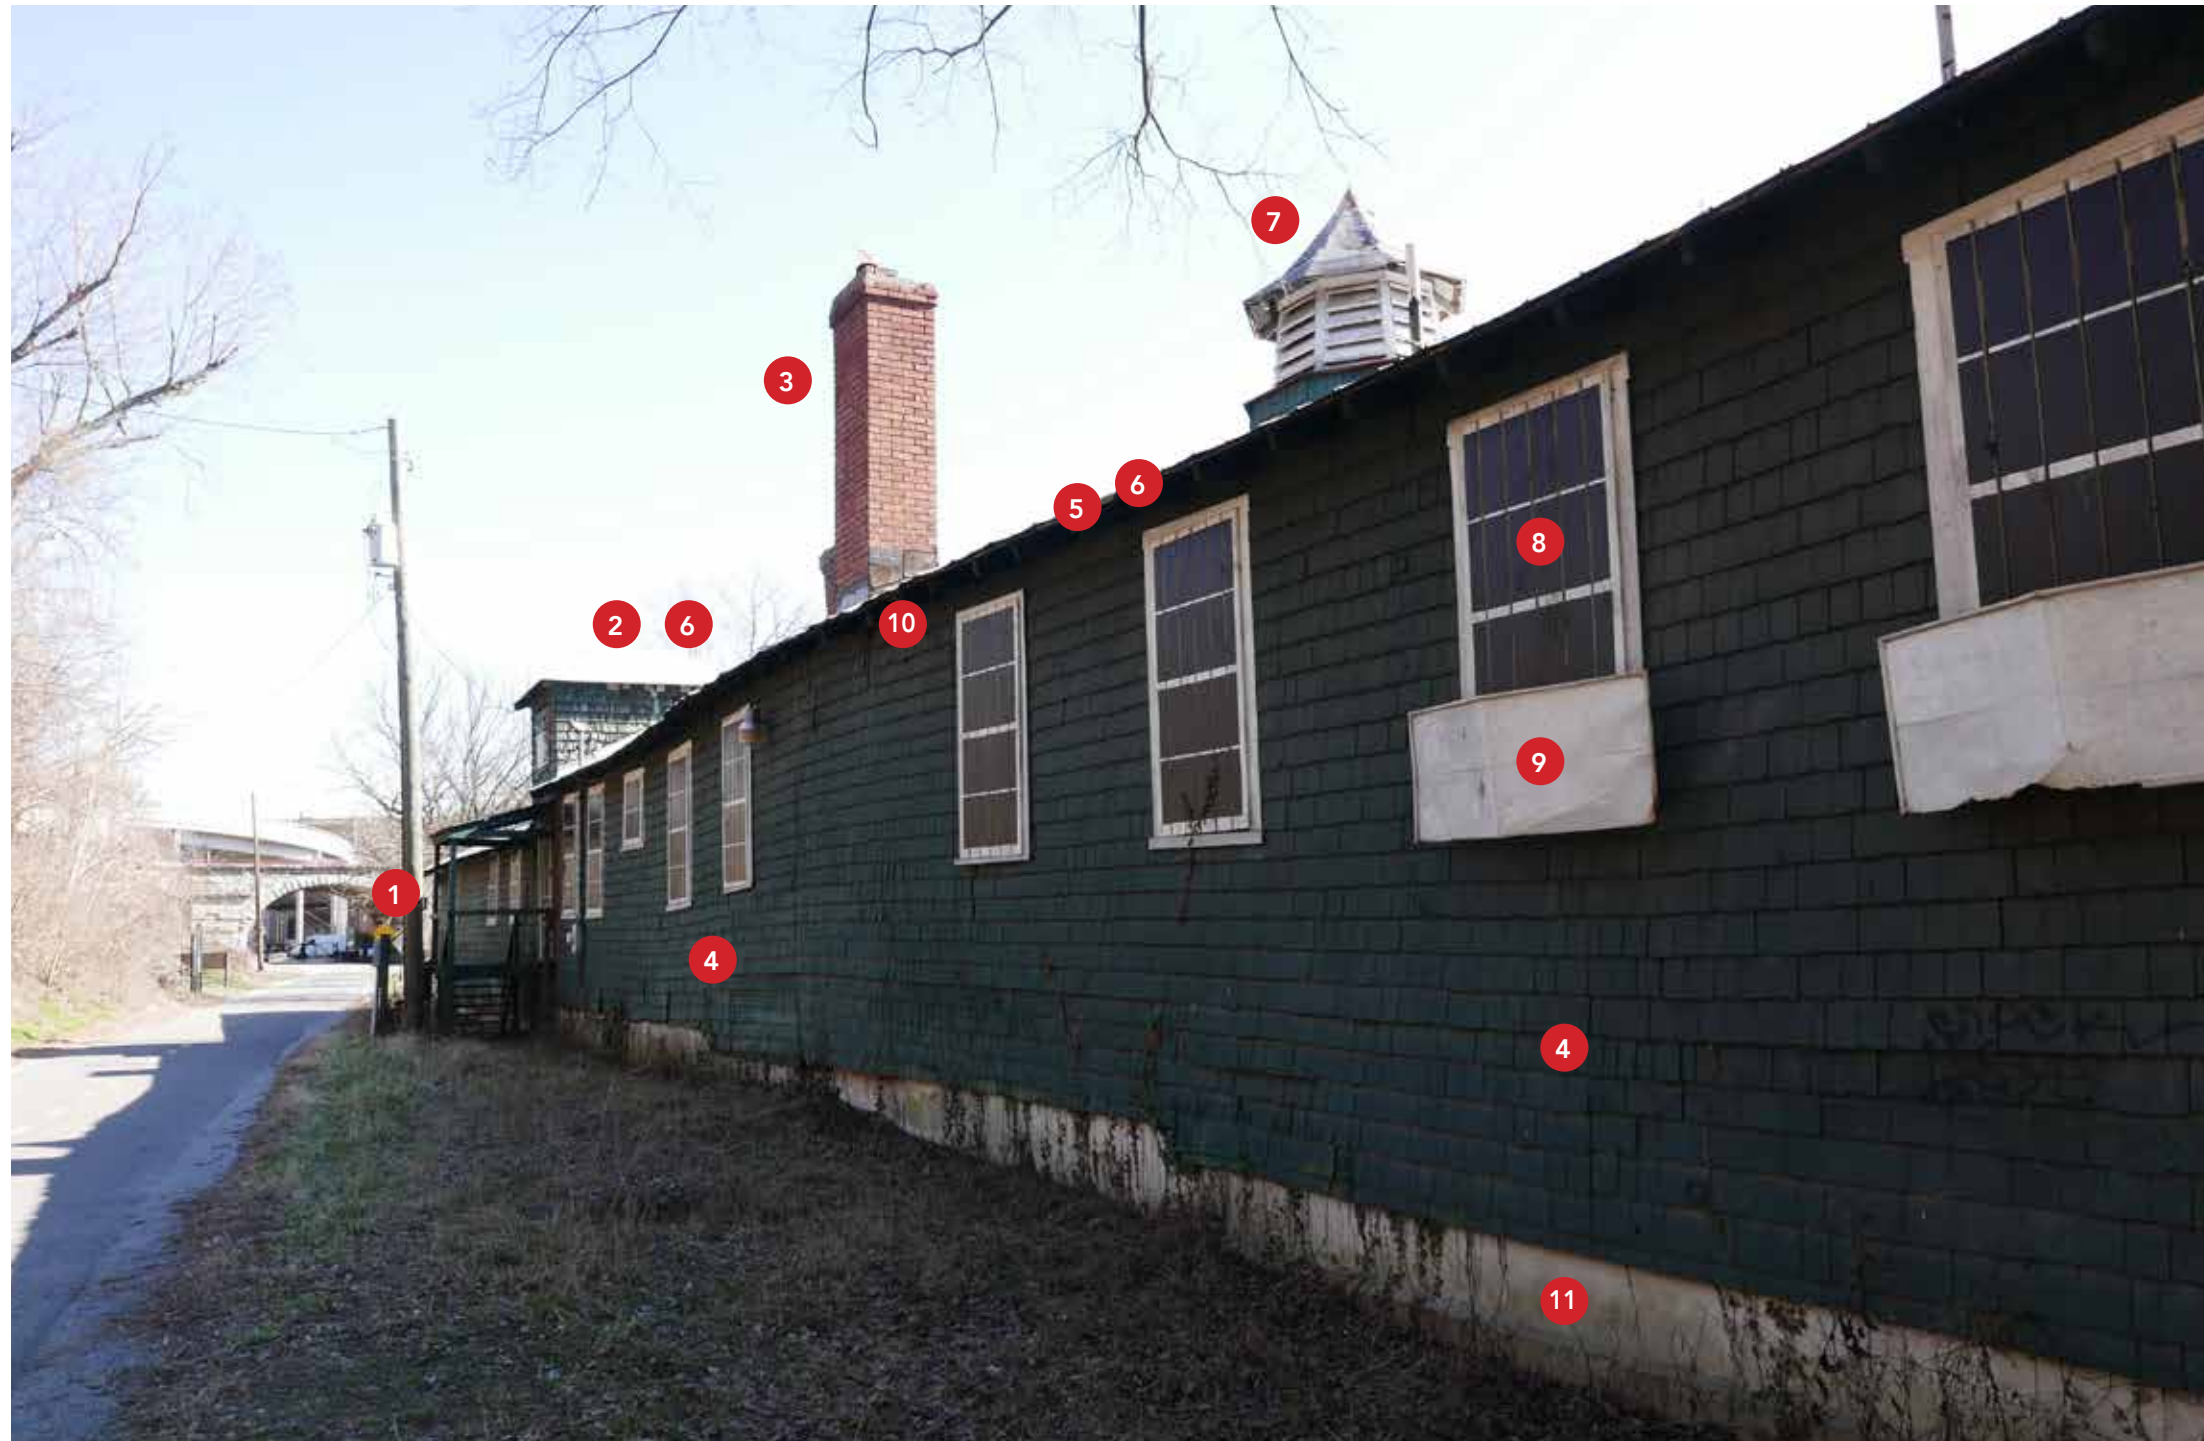
North Elevation - Observed Conditions and Repair Scope

The north elevation of the boat house is generally in poor condition. Unstable condition requiring major repair, replacement and refinish were observed. The roofing which is not historic to the 1903 condition is in need of complete replacement. The exterior wood shingles and wood soffits and trims are deteriorated in places needing repair and or replacement. The exterior windows have been boarded over to protect historic fabric and appear to be in restorable condition.

1. Deteriorated wood stair and porch structure to be repaired
2. Repair deteriorated wood framed light original upper level entry
3. Repair and repoint original brick chimney
4. Severely deteriorated wood shingles to be replaced
5. Install period correct gutters and downspouts
6. Replace deteriorated corrugated metal roofing and flashings
7. Restore deteriorated venting cupola
8. Remove overlay door and window guards and restore historic doors and windows
9. Remove metal window guards
10. Repair hole in exterior wall around chimney
11. Repair and waterproof existing masonry and concrete foundation wall

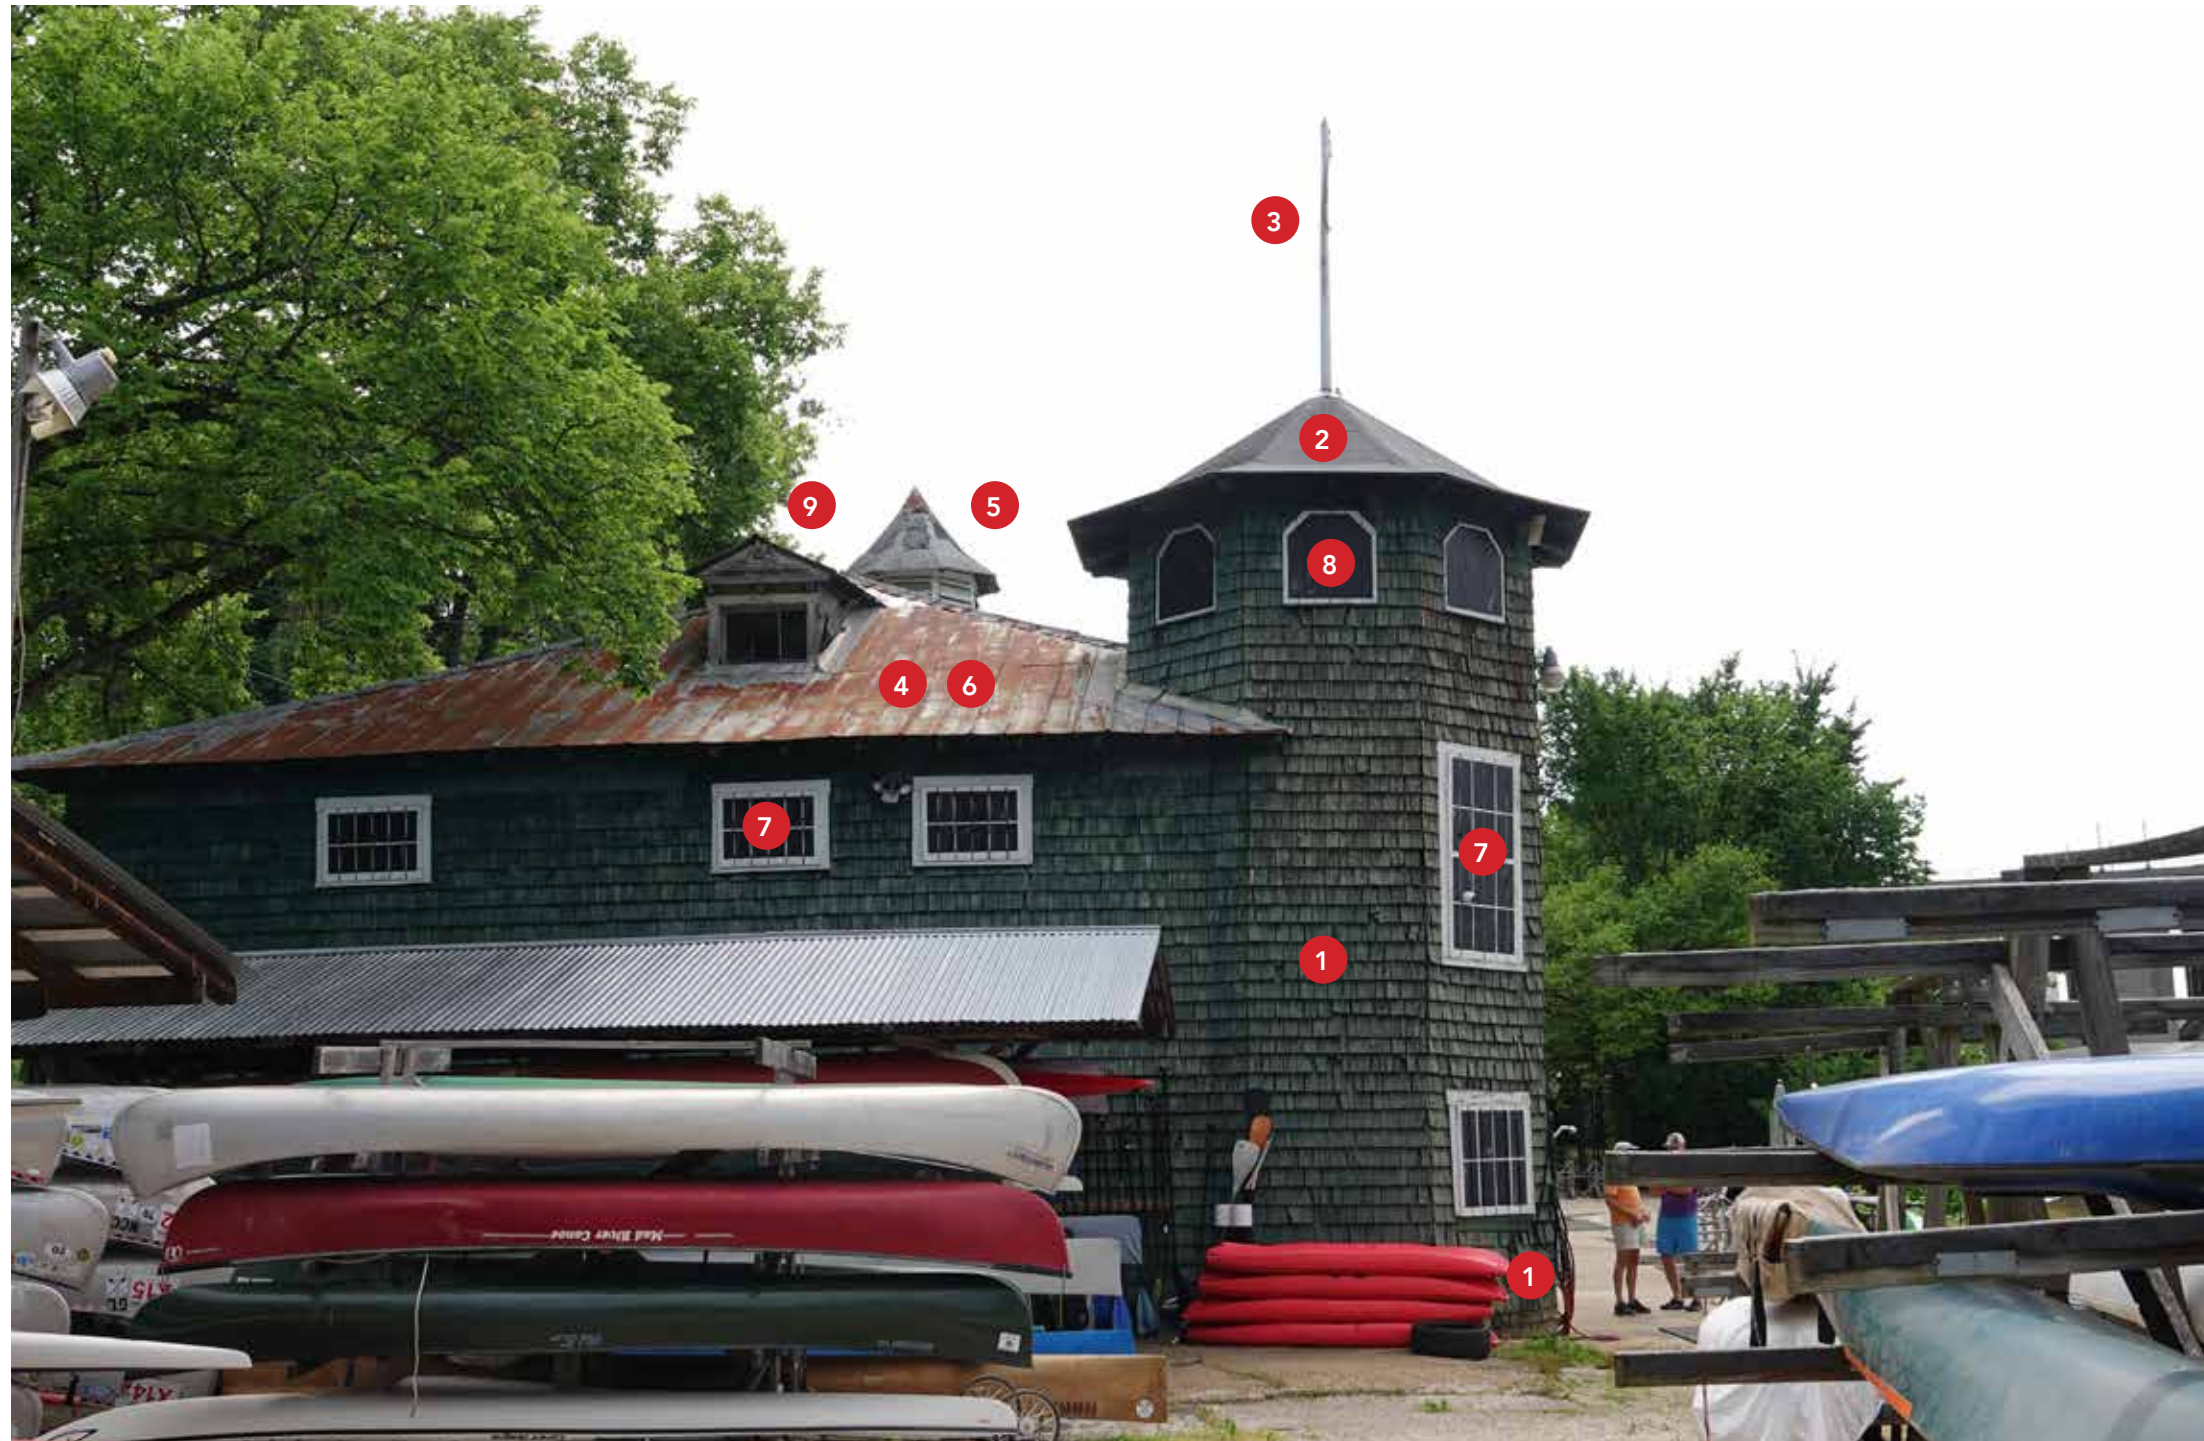
West Elevation - Observed Conditions and Repair Scope

The north elevation of the boat house is generally in poor condition. Unstable conditions requiring major repair, replacement and refinish were observed. The roofing which is not historic to the 1903 condition is in need of complete replacement. The exterior wood shingles and wood soffits and trims are deteriorated in places needing repair and or replacement. The exterior windows have been boarded over to protect historic fabric and appear to be in restorable condition. There are openings in the exterior wall at the bottom of the wall in several locations

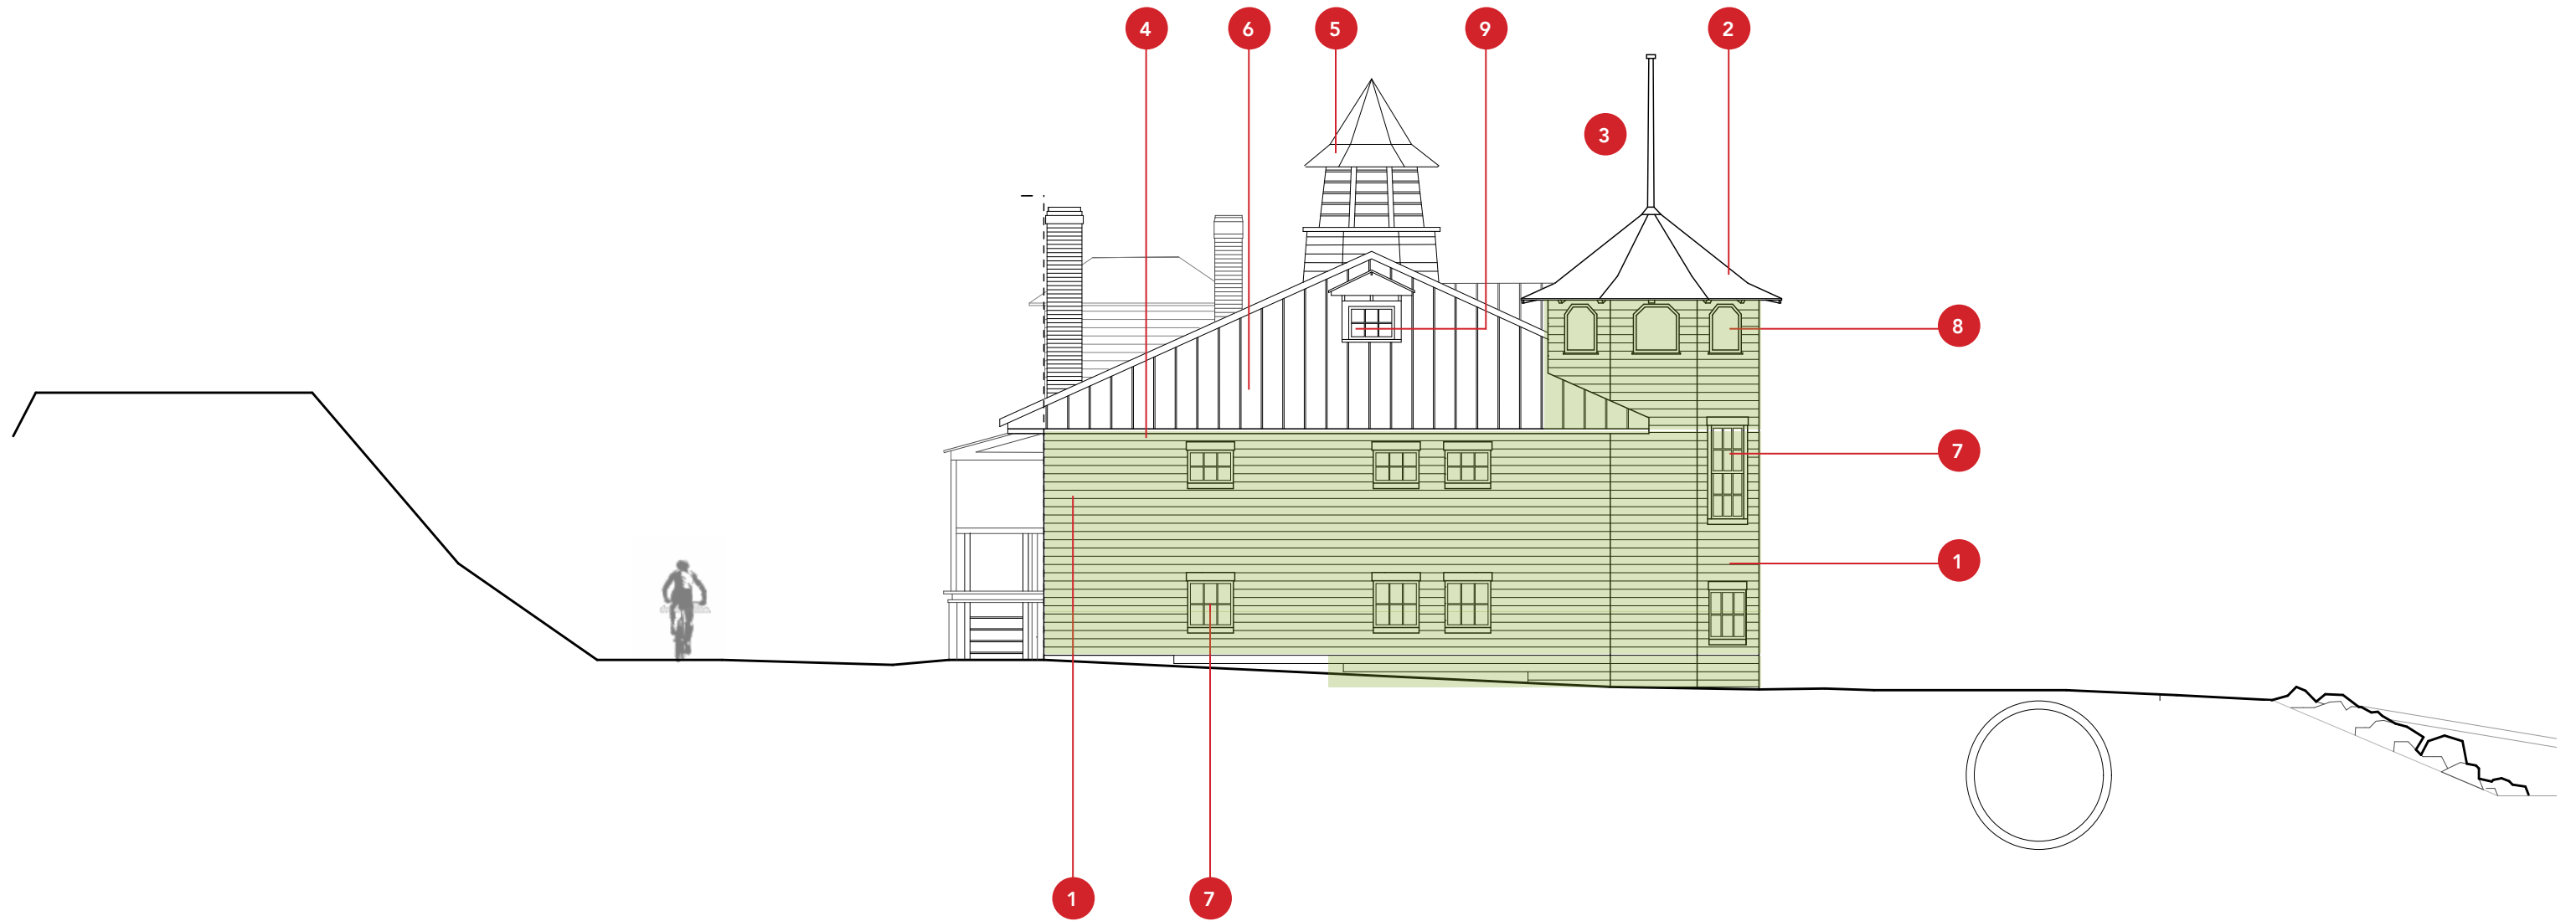
West Elevation - Observed Conditions and Repair Scope

Approximate area of deteriorated shingles to be removed and replaced
