# THE WASHINGTON CANOE CLUB - Interior and Exterior Modifications and Repairs

3700 Water Street NW Washington, DC

Old Georgetown Board US Commission of Fine Arts • Concept Design Submission Volume 1

October 17, 2024

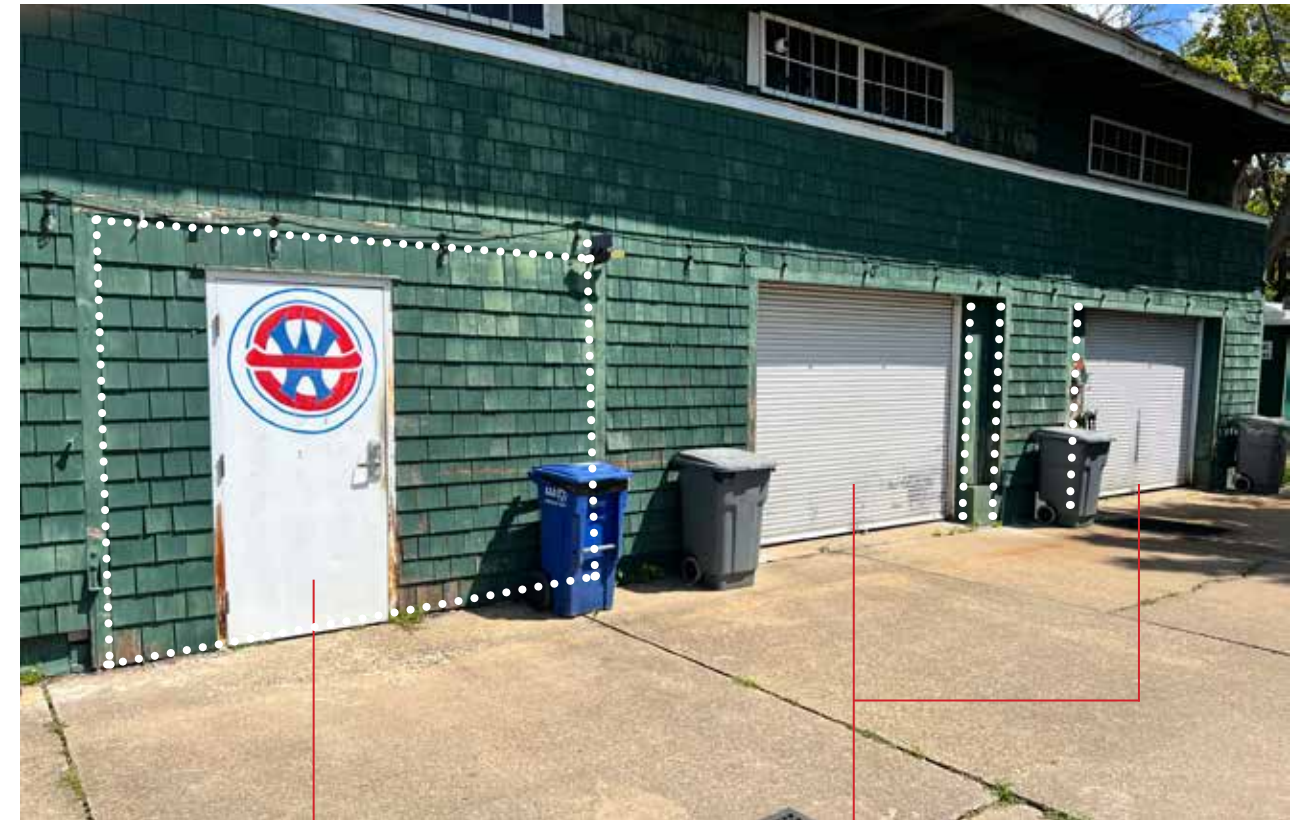
**12** Remove wood wall infill and door to reestablish original opening.

**13** Remove metal roll up garage door and wood wall infill to reestablish original opening at two doors.

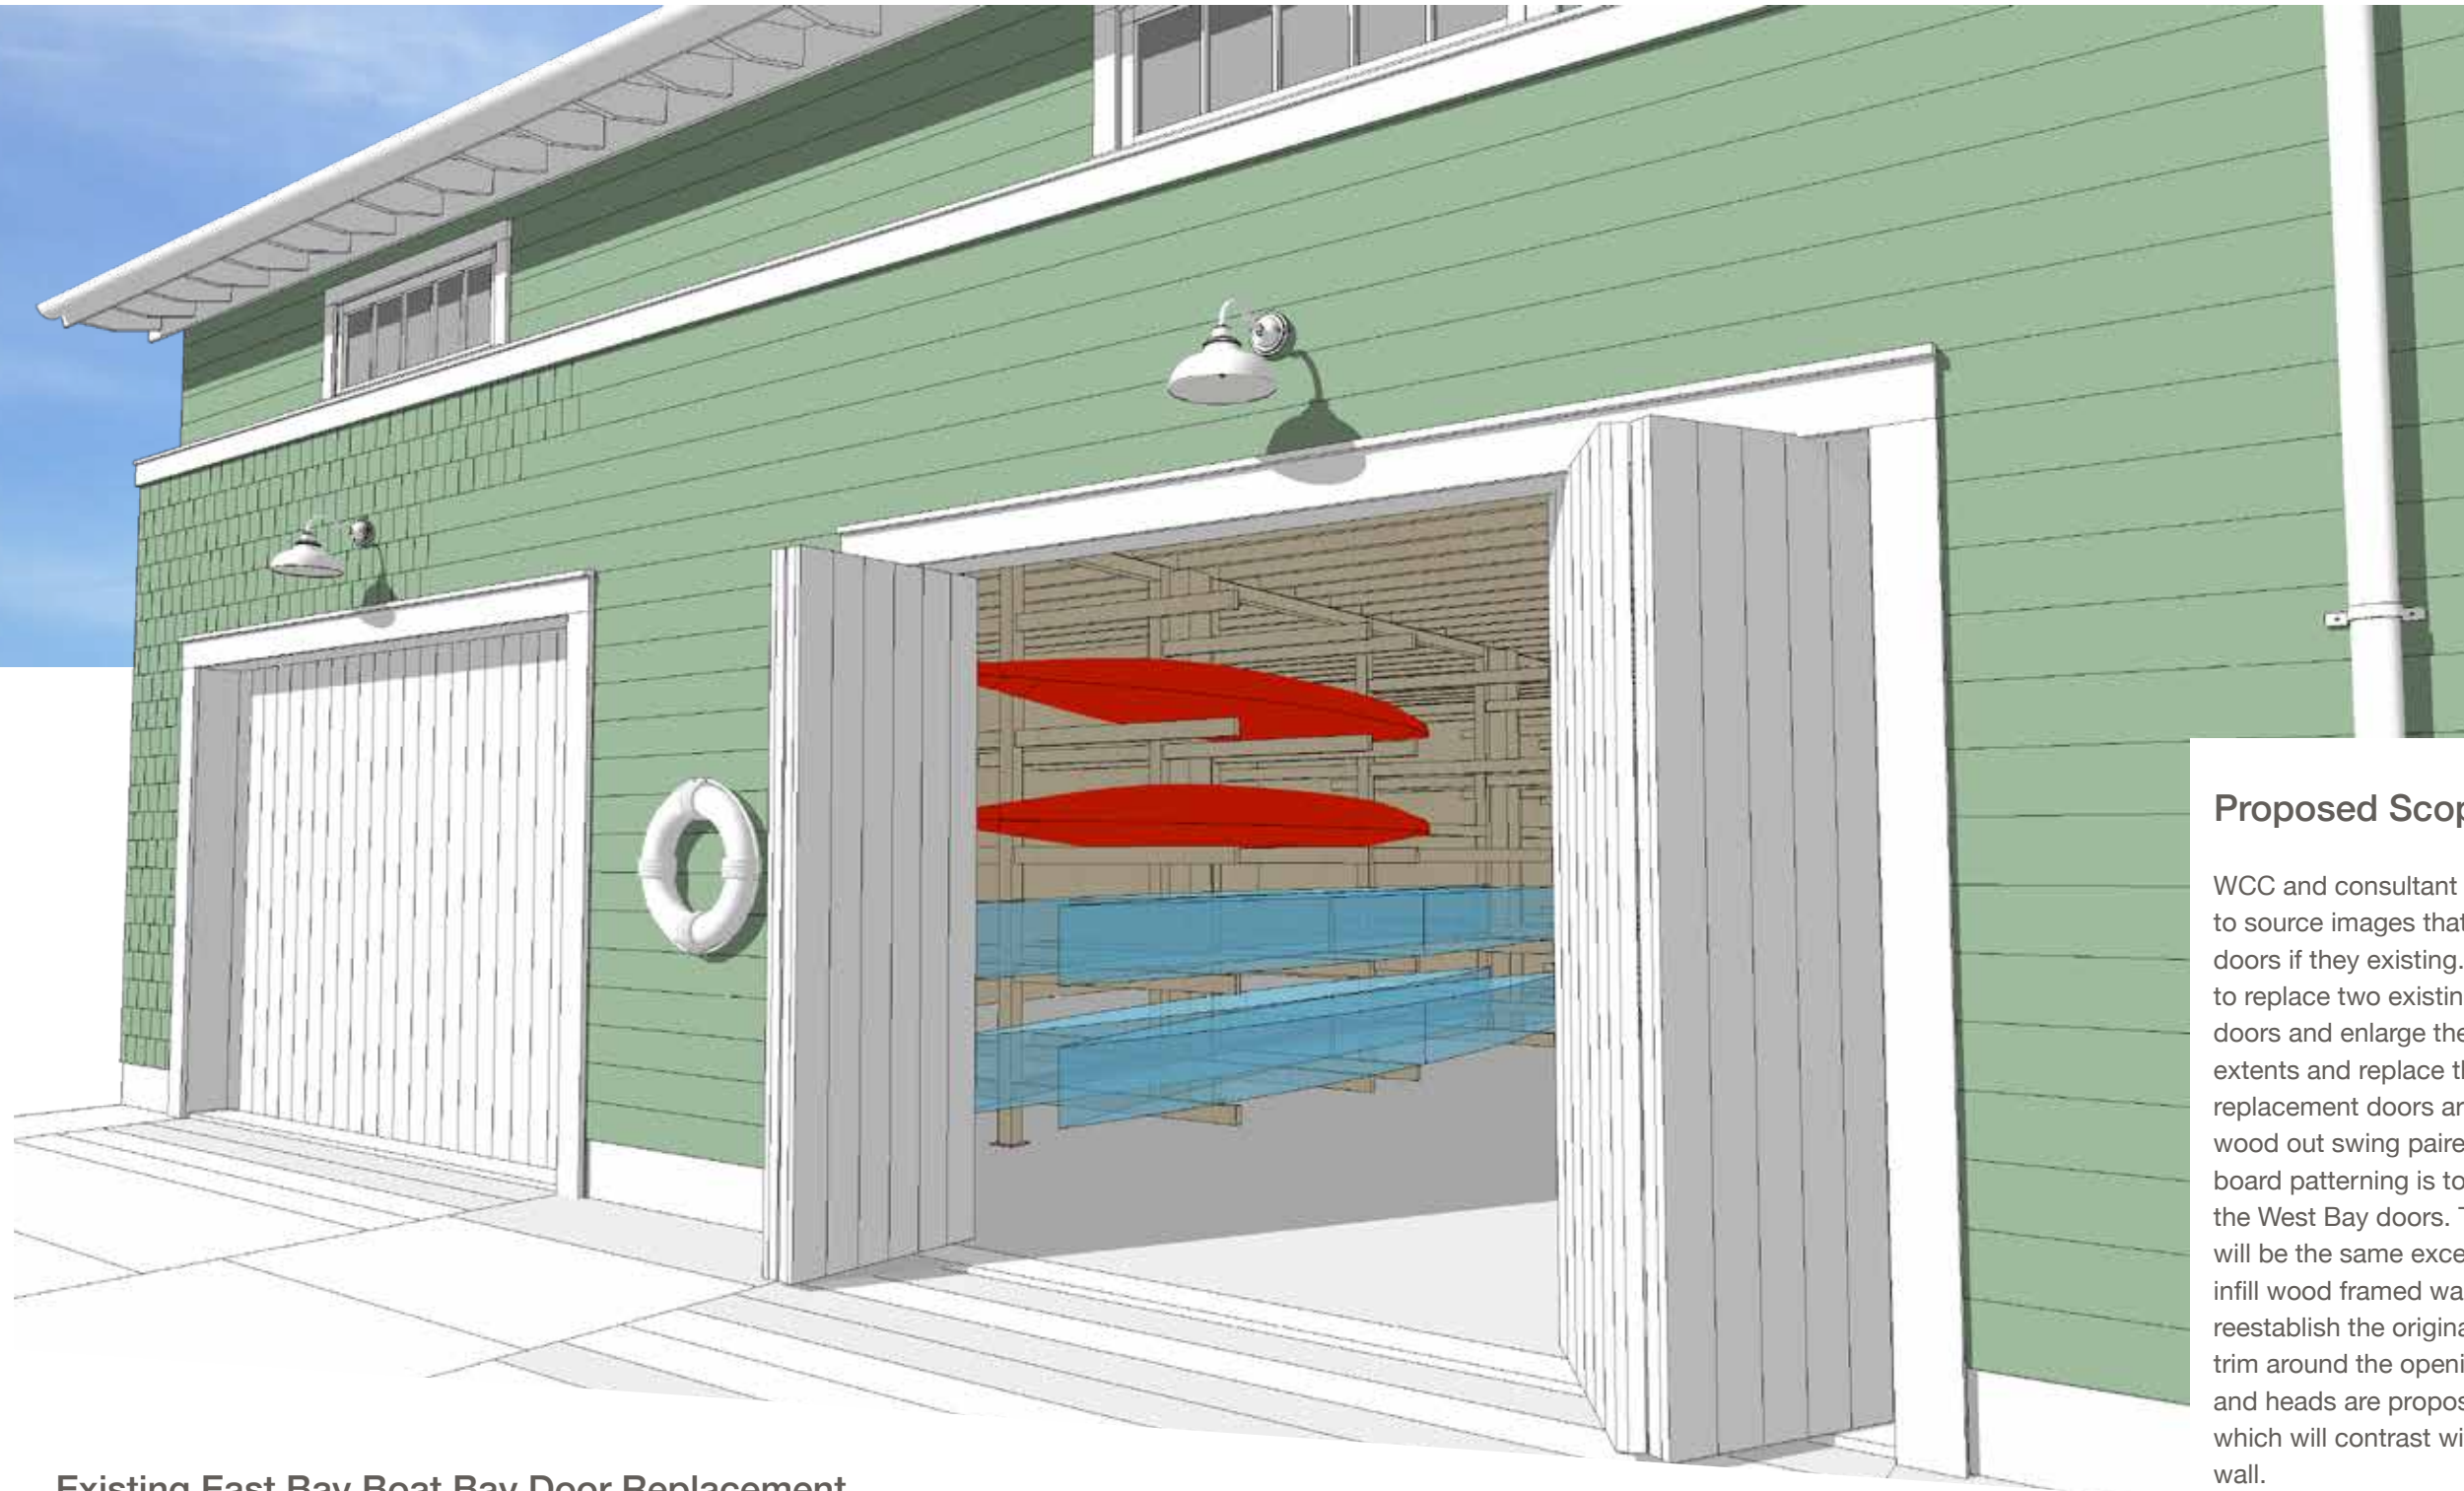
Existing East Bay Boat Bay Door Replacement

WCC and consultant team have not been able to source images that show the original bay doors if they existing. The project proposes to replace two existing roll up metal garage doors and enlarge the opening to its original extents and replace the garage doors. The replacement doors are envisioned as painted wood out swing paired bi-fold doors. Wood board patterning is to be similar or match the West Bay doors. The furthest west door will be the same except that the existing infill wood framed wall would be removed to reestablish the original opening. The wood trim around the opening including the jamb and heads are proposed to be painted a color which will contrast with the adjacent shingled wall.

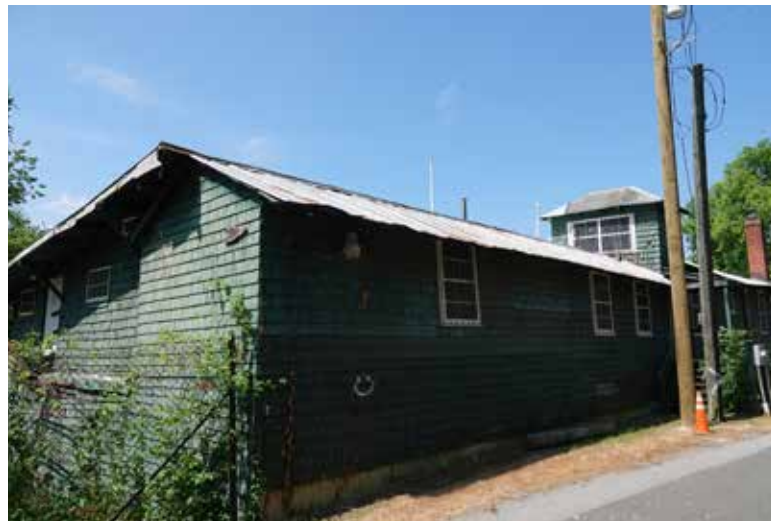
1

1. Deteriorated wood trim to be repaired, replaced and refinished
2. Remove overlay door and window guards and restore historic doors and windows
3. Severely deteriorated wood shingles to be replaced.

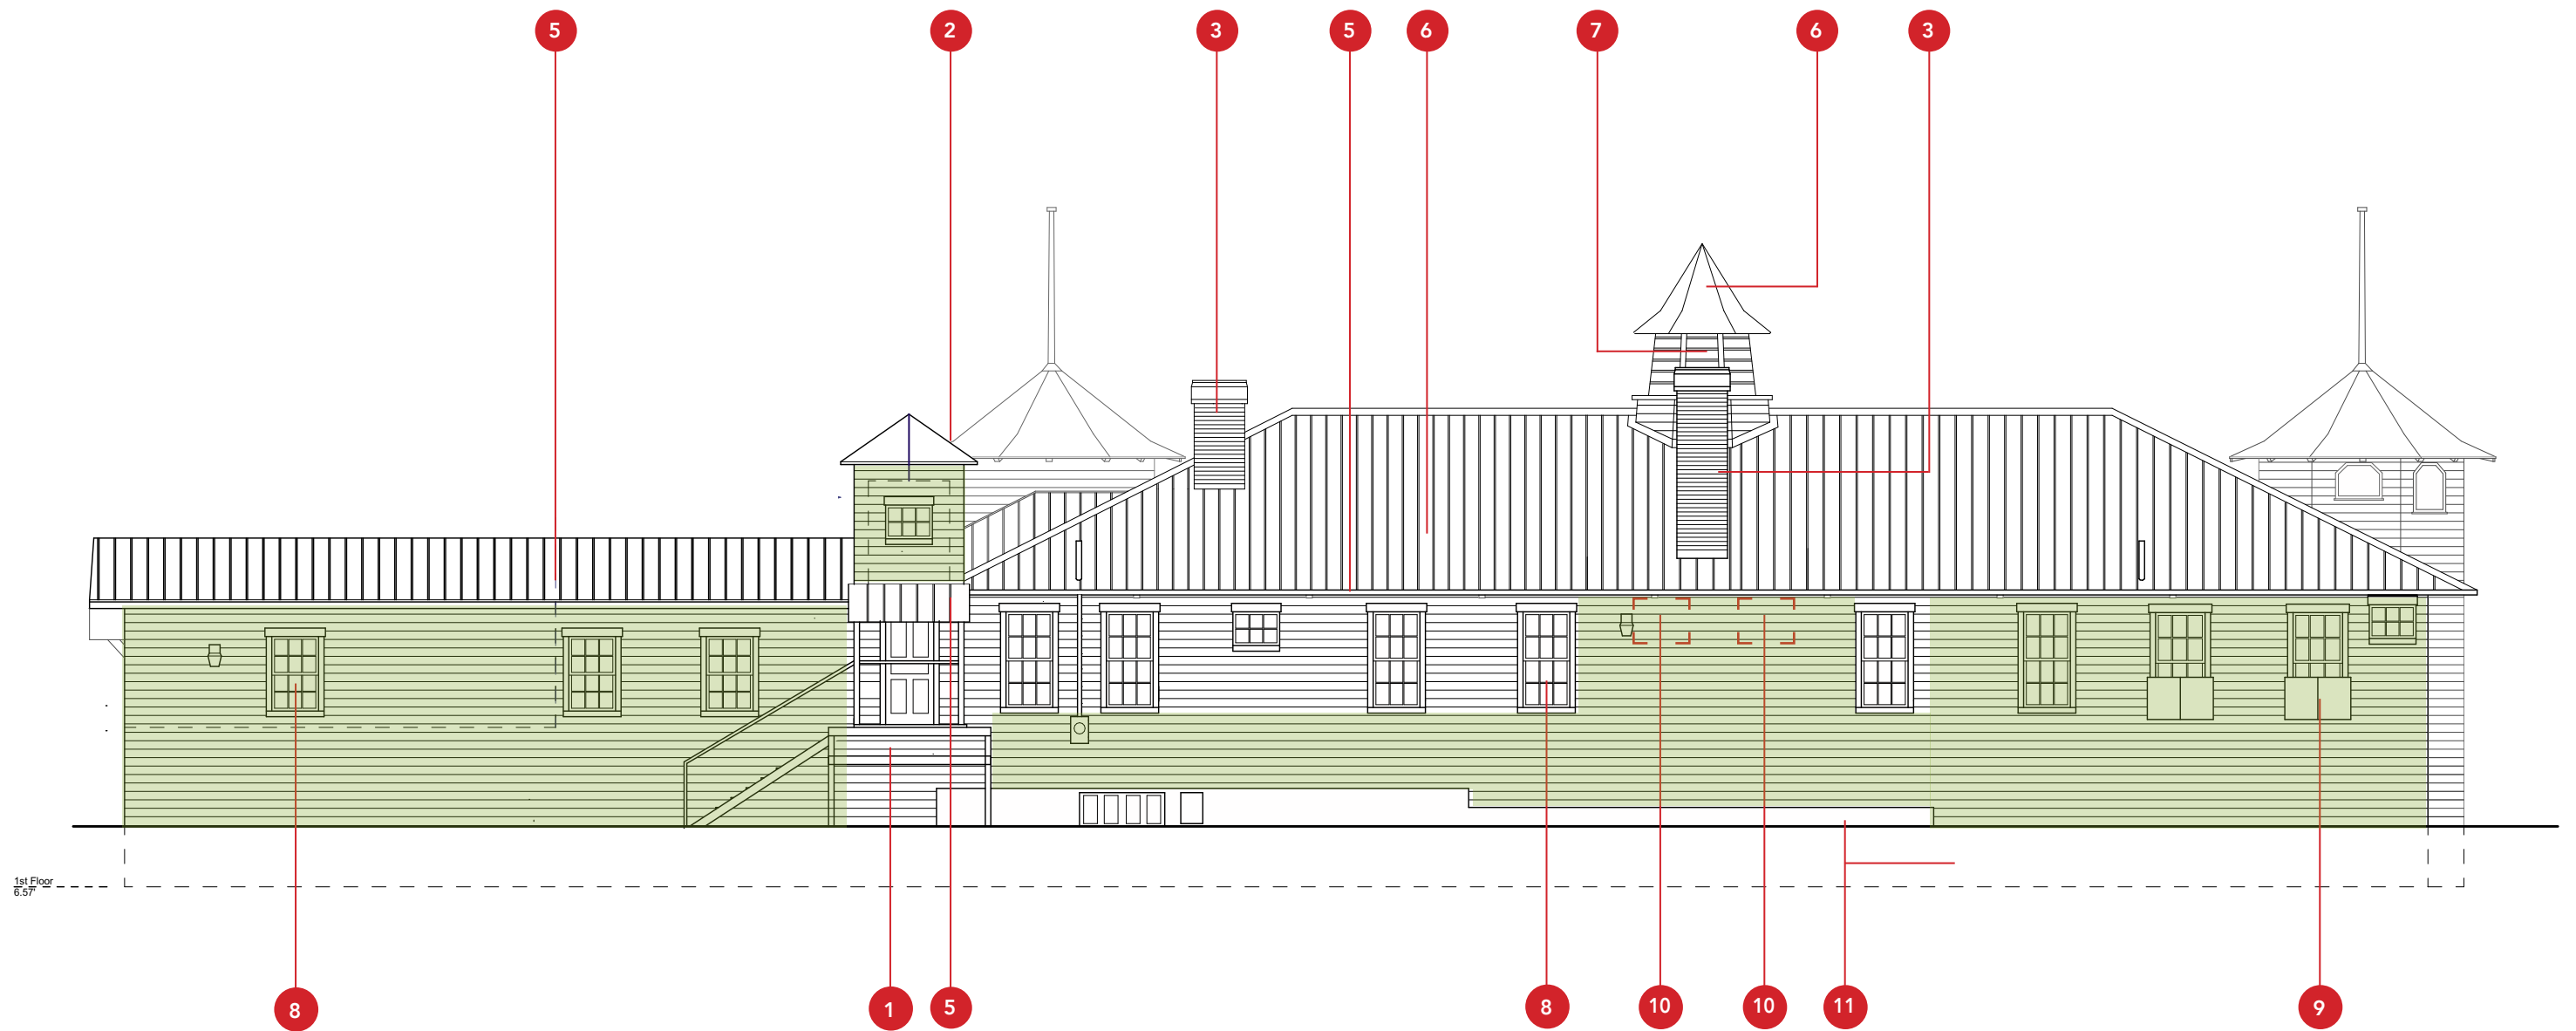
Approximate area of deteriorated shingles to be removed and replaced

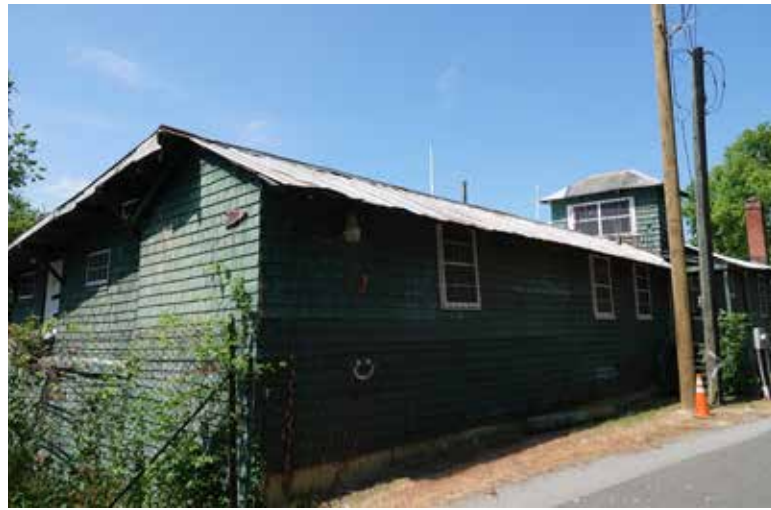
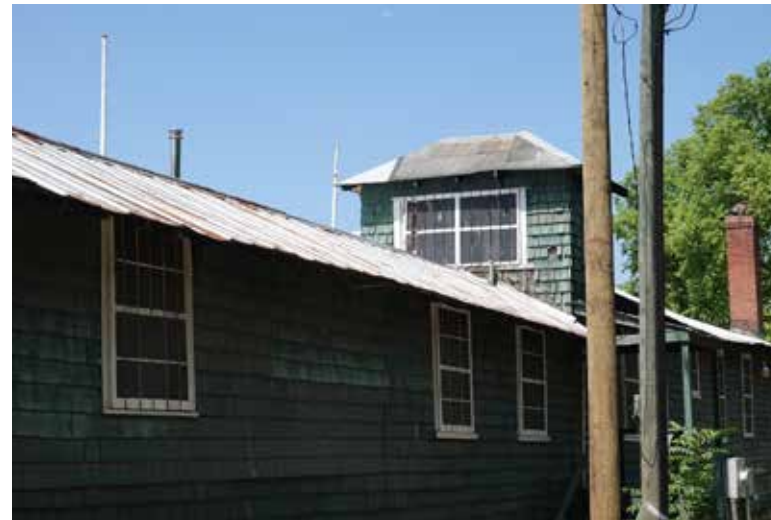
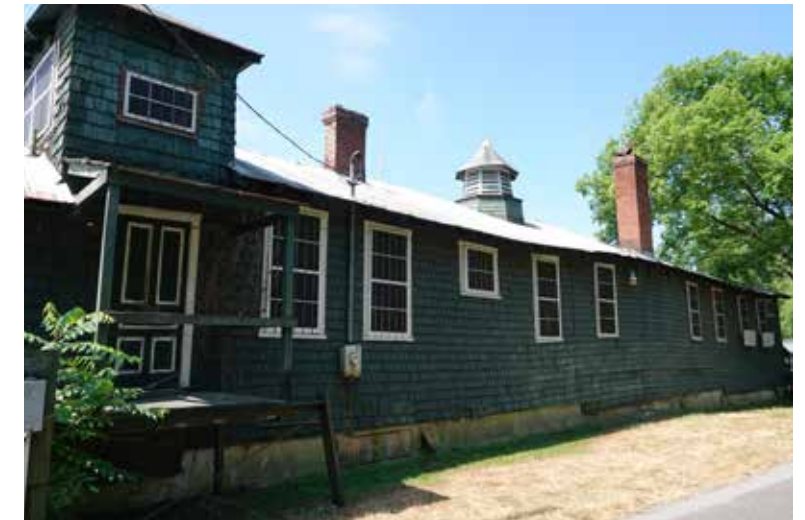
1. Deteriorated wood stair and porch structure to be repaired
2. Repair deteriorated wood framed light original upper level entry
3. Repair and repoint original brick chimney
4. Severely deteriorated wood shingles to be replaced
5. Install period correct gutters and downspouts
6. Replace deteriorated corrugated metal roofing and flashings
7. Restore deteriorated venting cupola
8. Remove overlay door and window guards and restore historic doors and windows
9. Remove metal window guards
10. Repair hole in exterior wall around chimney
11. Repair and waterproof existing masonry and concrete foundation wall

2  
6

8

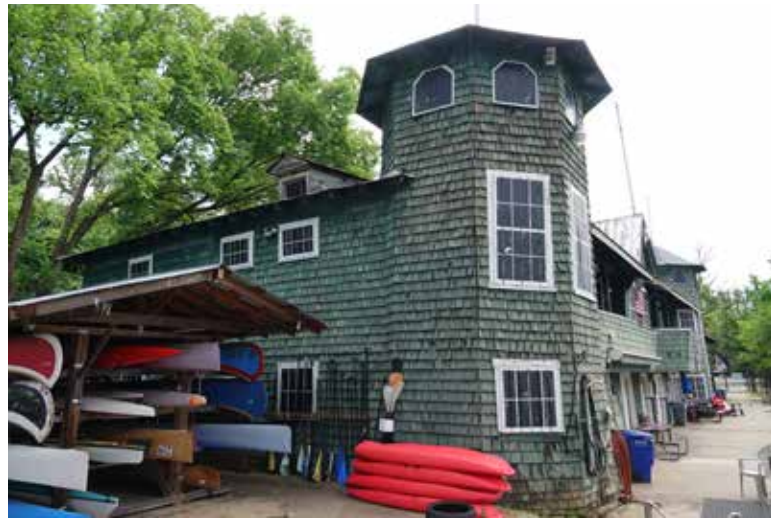
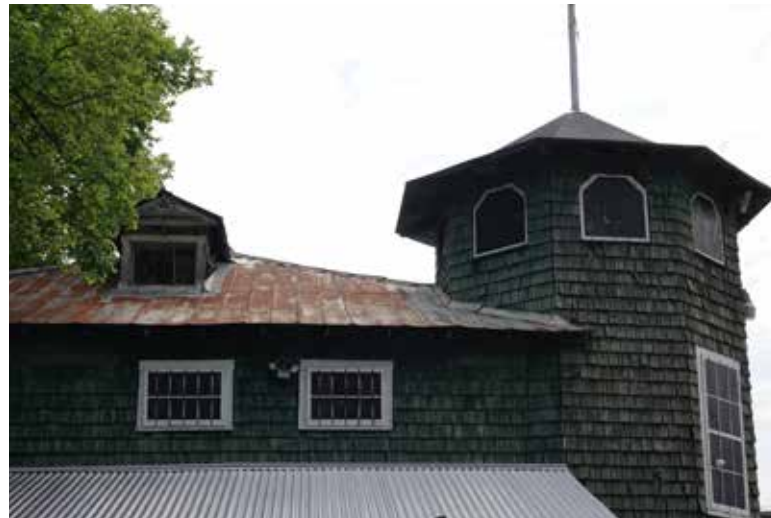
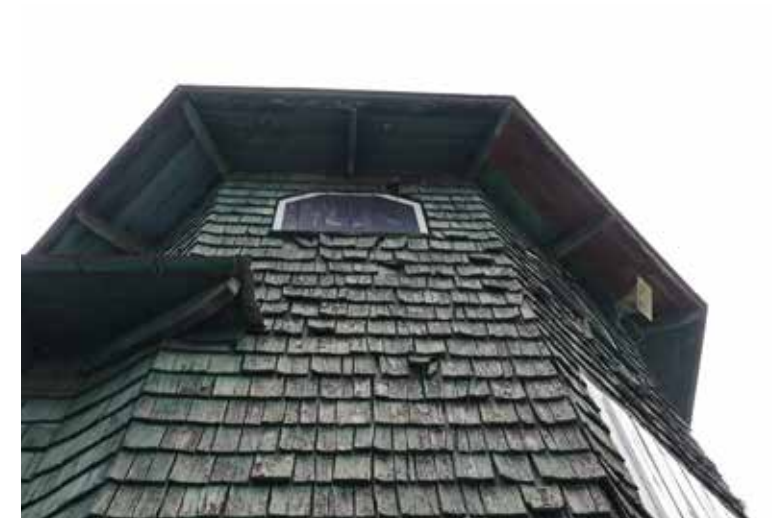
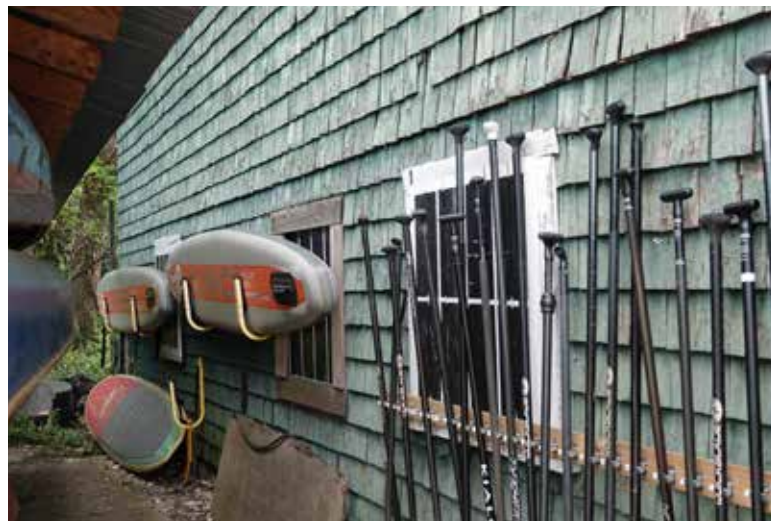
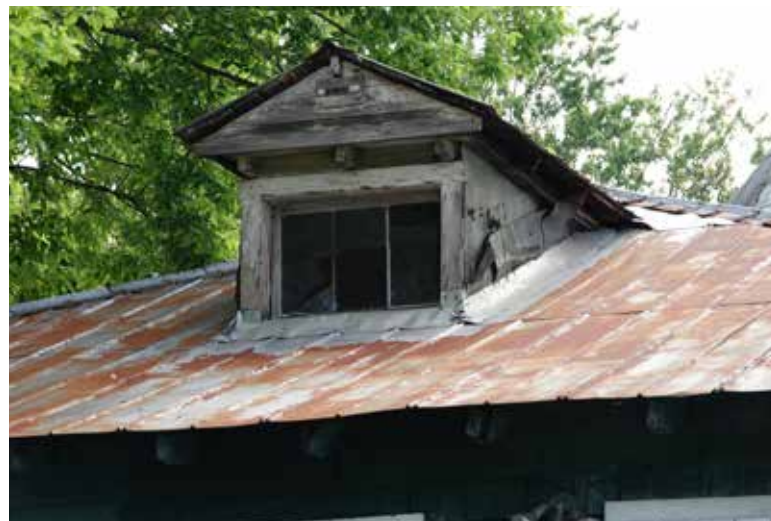
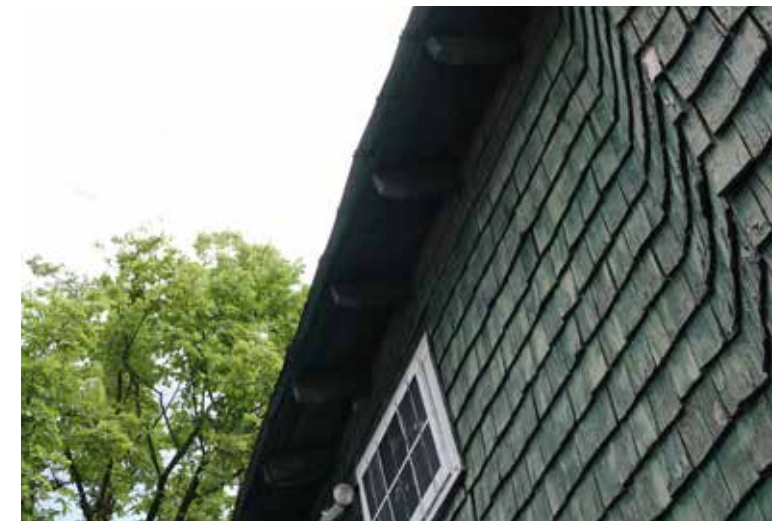
1. Severely deteriorated wood shingles to be replaced
2. Replace sheet bituminous roofing and repair flagpole
3. Install period correct gutters and downspouts as viewed in historic photos
4. Restore deteriorated venting cupola
5. Replace deteriorated corrugated metal roofing and flashings
6. Remove overlay door and window guards and restore historic doors and windows
7. Reopen close openings at turrets
8. Repair wood dormer and window. Replace roofing and flashings

4  
6

1  
8
