APPLICATION AND REFERRAL TO THE US COMMISSION OF FINE ARTS FOR OLD GEORGETOWN REVIEW

Rear Window Replacement Project 1636 33rd St, NW REVISED 8.24.22

1636 33rd STREET (REAR) SUPPLEMENTAL PHOTOS REVISED 8.24.22

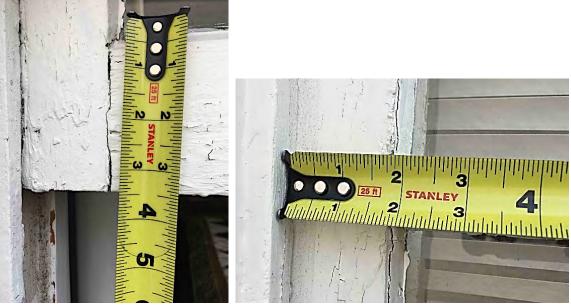
Lower Rail

Existing Lower Rail: 3-1/2 face Existing Stiles: 1-3/4" face Existing Upper Rail: 1-3/4" face Existing Meeting Rail: 1" face Existing Muntins - 7/8"

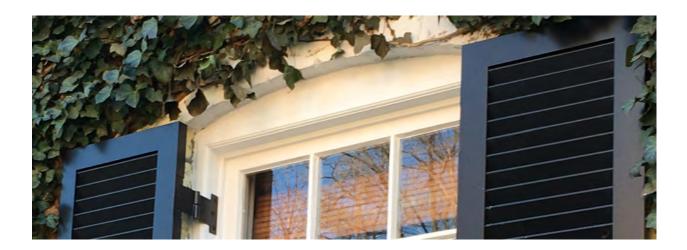
ARCHES

Flat decorative arches will be replicated on site with sapele mahogany. Here is a similar window we replicated at the OGB approved job at 1526 32nd St, NW
