# Water Street Trailhead Project

Old Georgetown Board Meeting  
January 7, 2021

# Board Recommendations and Response

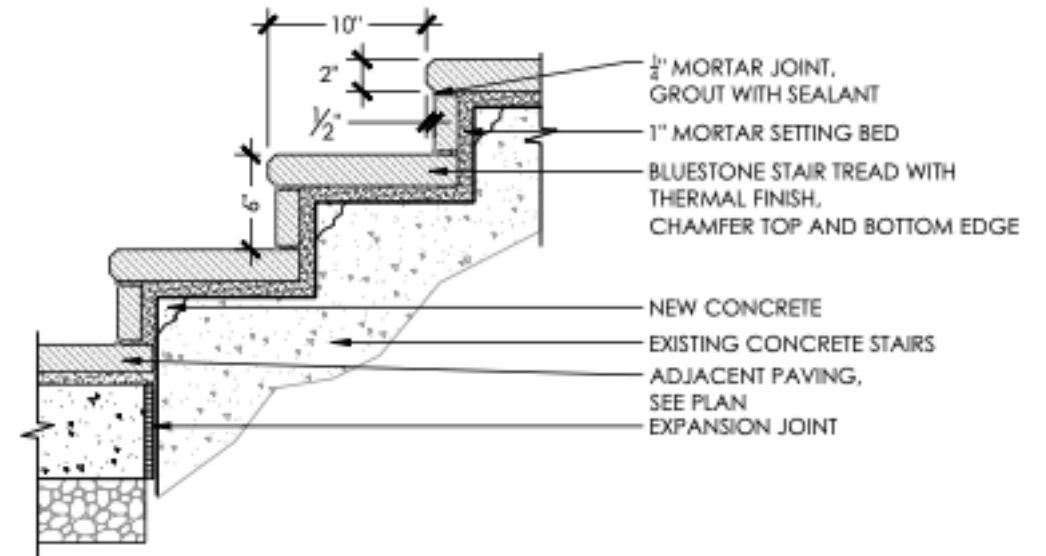
1. EXISTING CONCRETE STAIRS TO HAVE ANY LOOSE OR FRACTURED CONCRETE MATERIAL REMOVED.
2. EXISTING STEPS TO BE POWER WASHED AND DEBRIS FREE PRIOR TO REPAIR AND INSTALLATION OF CLADDING.

Clad stairs with a 2” bluestone with a 1” mortar setting bed, using hand-held power tools to break away loose existing concrete material and weak areas in stairs that may break away in the near future. This is the BID’s preferred option.

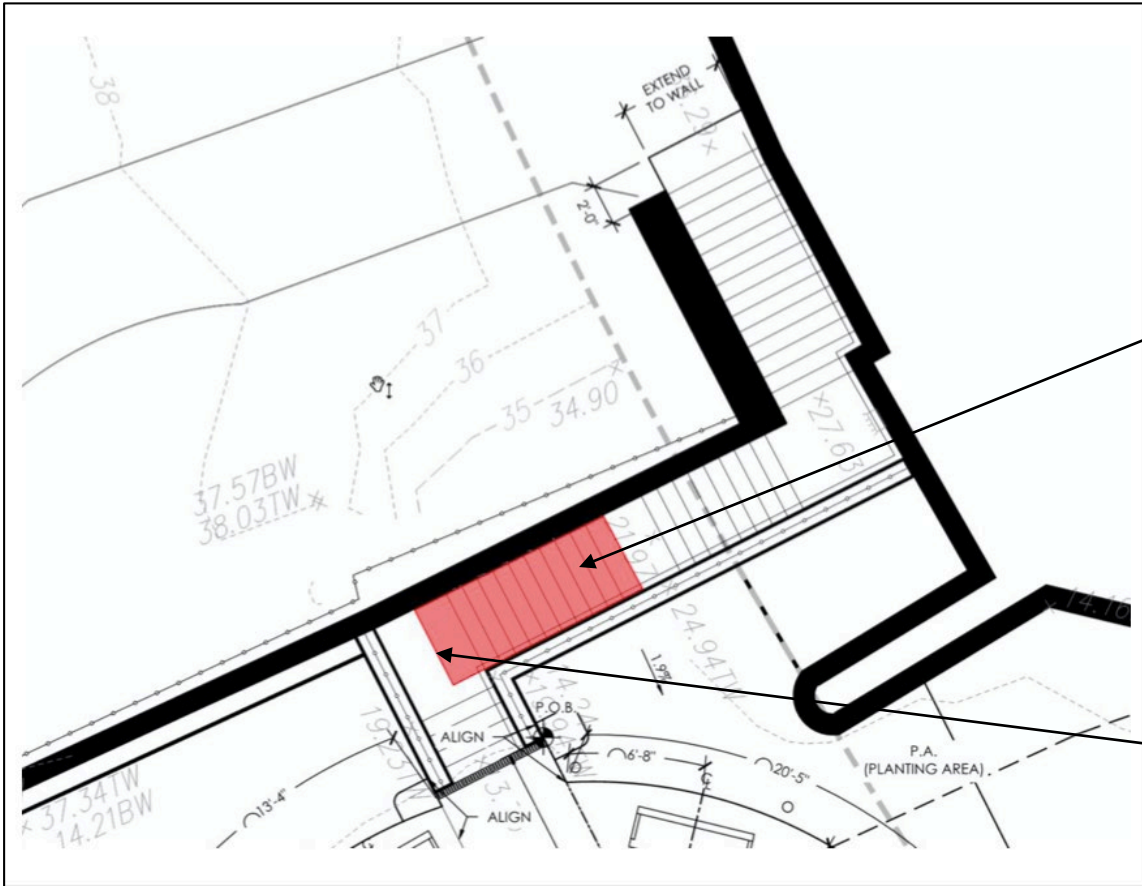
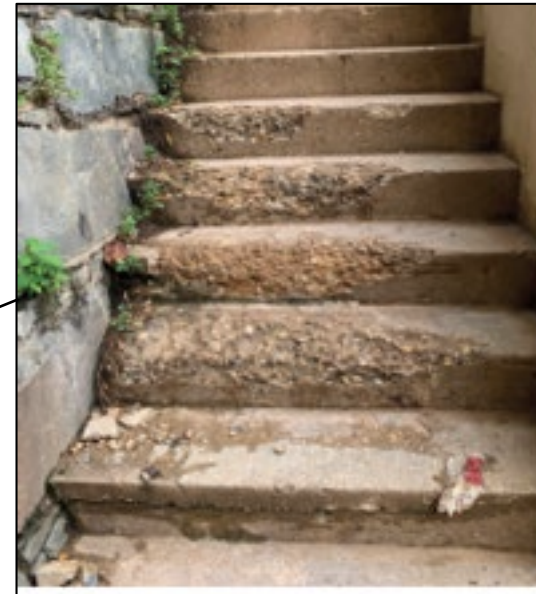
## Partial concrete replacement option

Replace only the most damaged concrete section.

Damaged section of stairs

Repair only the most damaged stairs in the middle run, using a small mounted machine to cleave the stairs into large chunks. Demolish stairs to the gravel base or to a depth of concrete that new stairs can be pinned into the existing concrete base and adjacent wall. Pour new concrete stairs in that location.

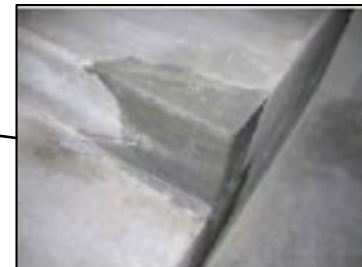
Condition at joint between old and new concrete
