Netherlands American Cemetery Visitor Center

CFA meeting Overflow Parking & Restroom Facility
2023.04.06

KAAN Architecten

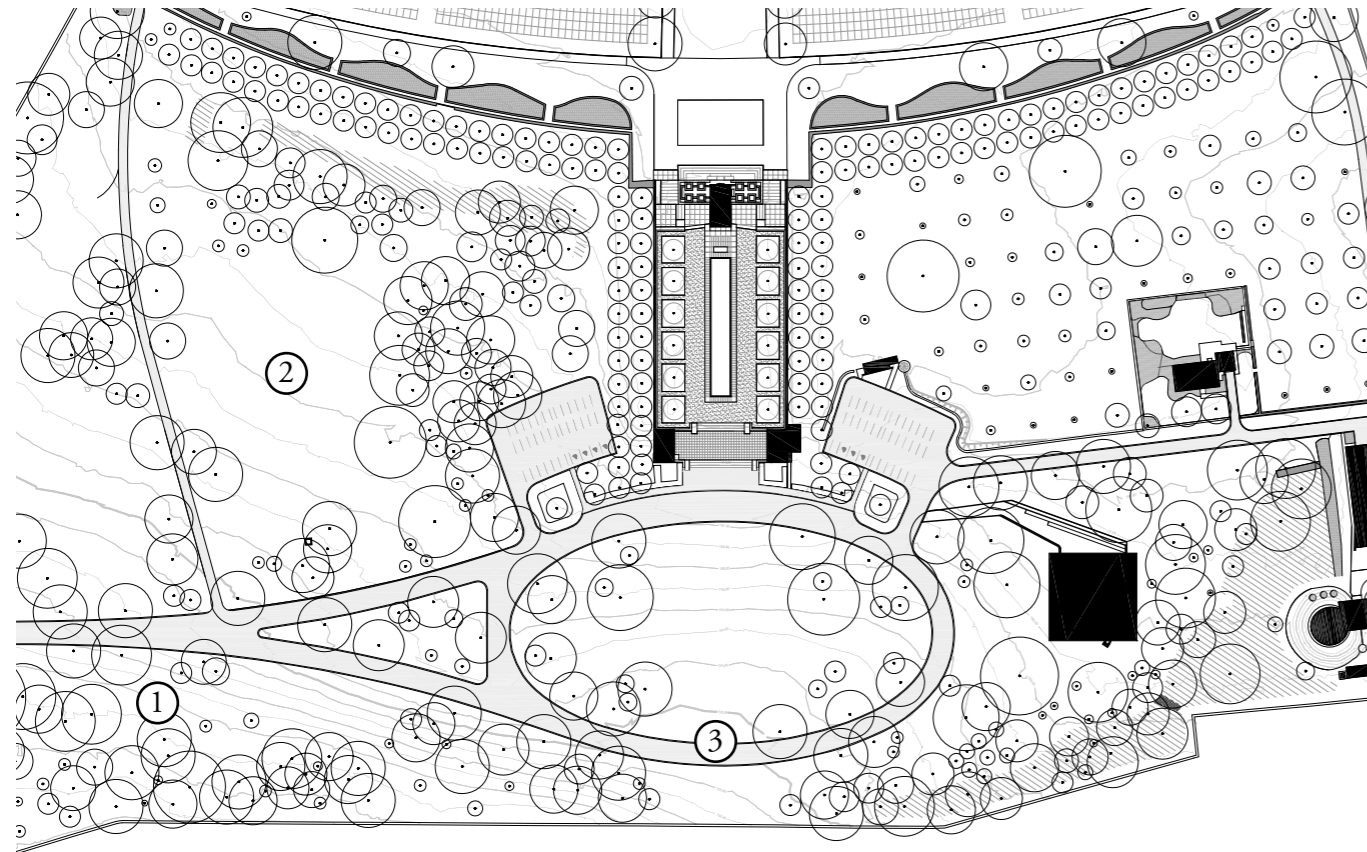
The existing overflow parking (OP) is comprised of an unformalized system of open spaces around the site. In this three main areas of overflow can be seen – on the roads, at the entrance orchard and on the open field. In total an estimated amount of 165 spaces are available. These facilities for overflow parking are used approximately 100 days each year, predominantly in the summer months.

1. OP orchard
2. OP lawn
3. OP ellipse

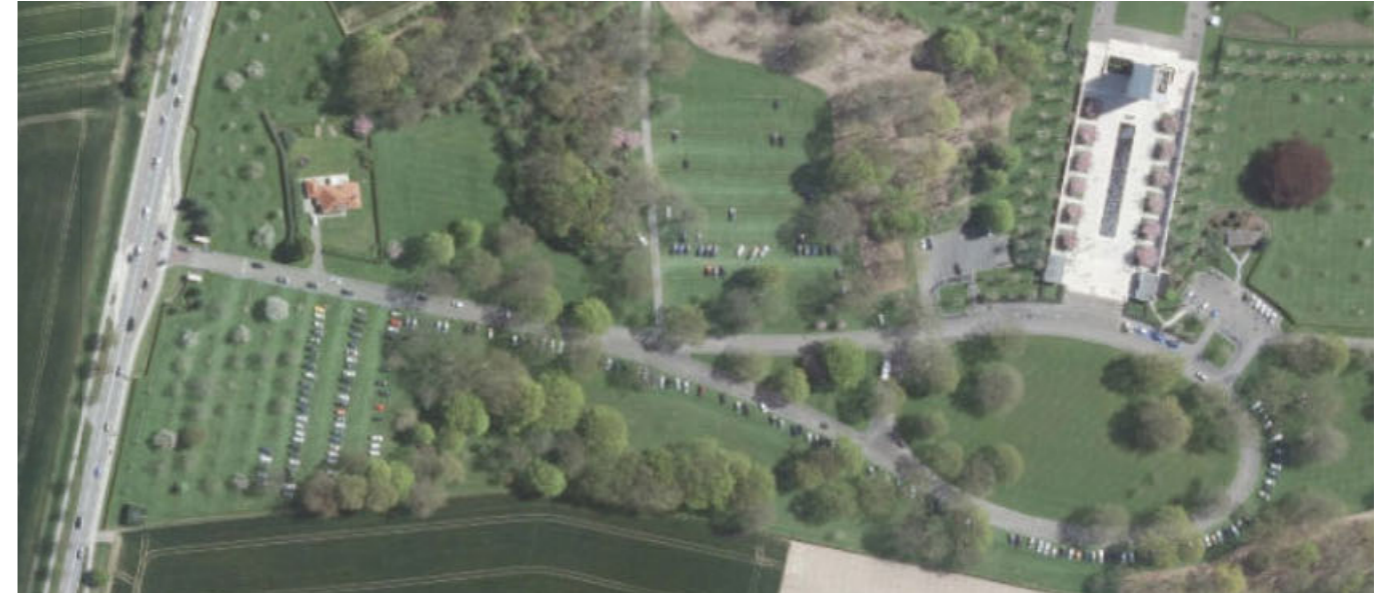
Situation of overflow parking during special event in 2016

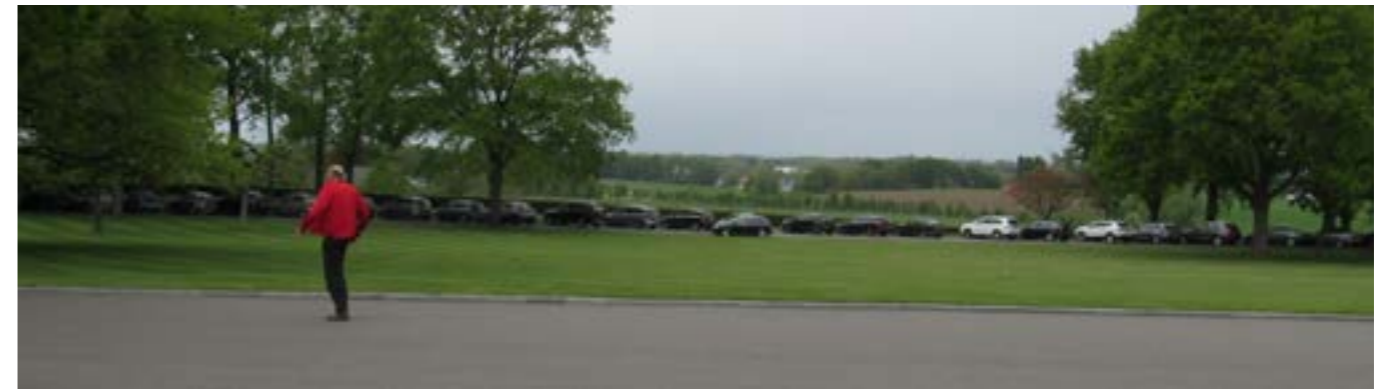
Overflow parking on orchard during Memorial Day 2019

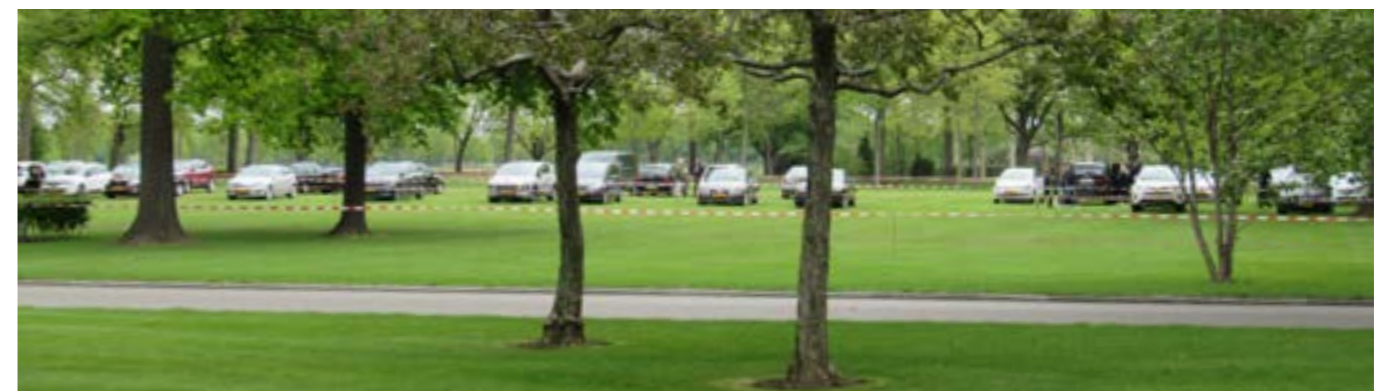
Overflow parking on lawns during Memorial Day 2019

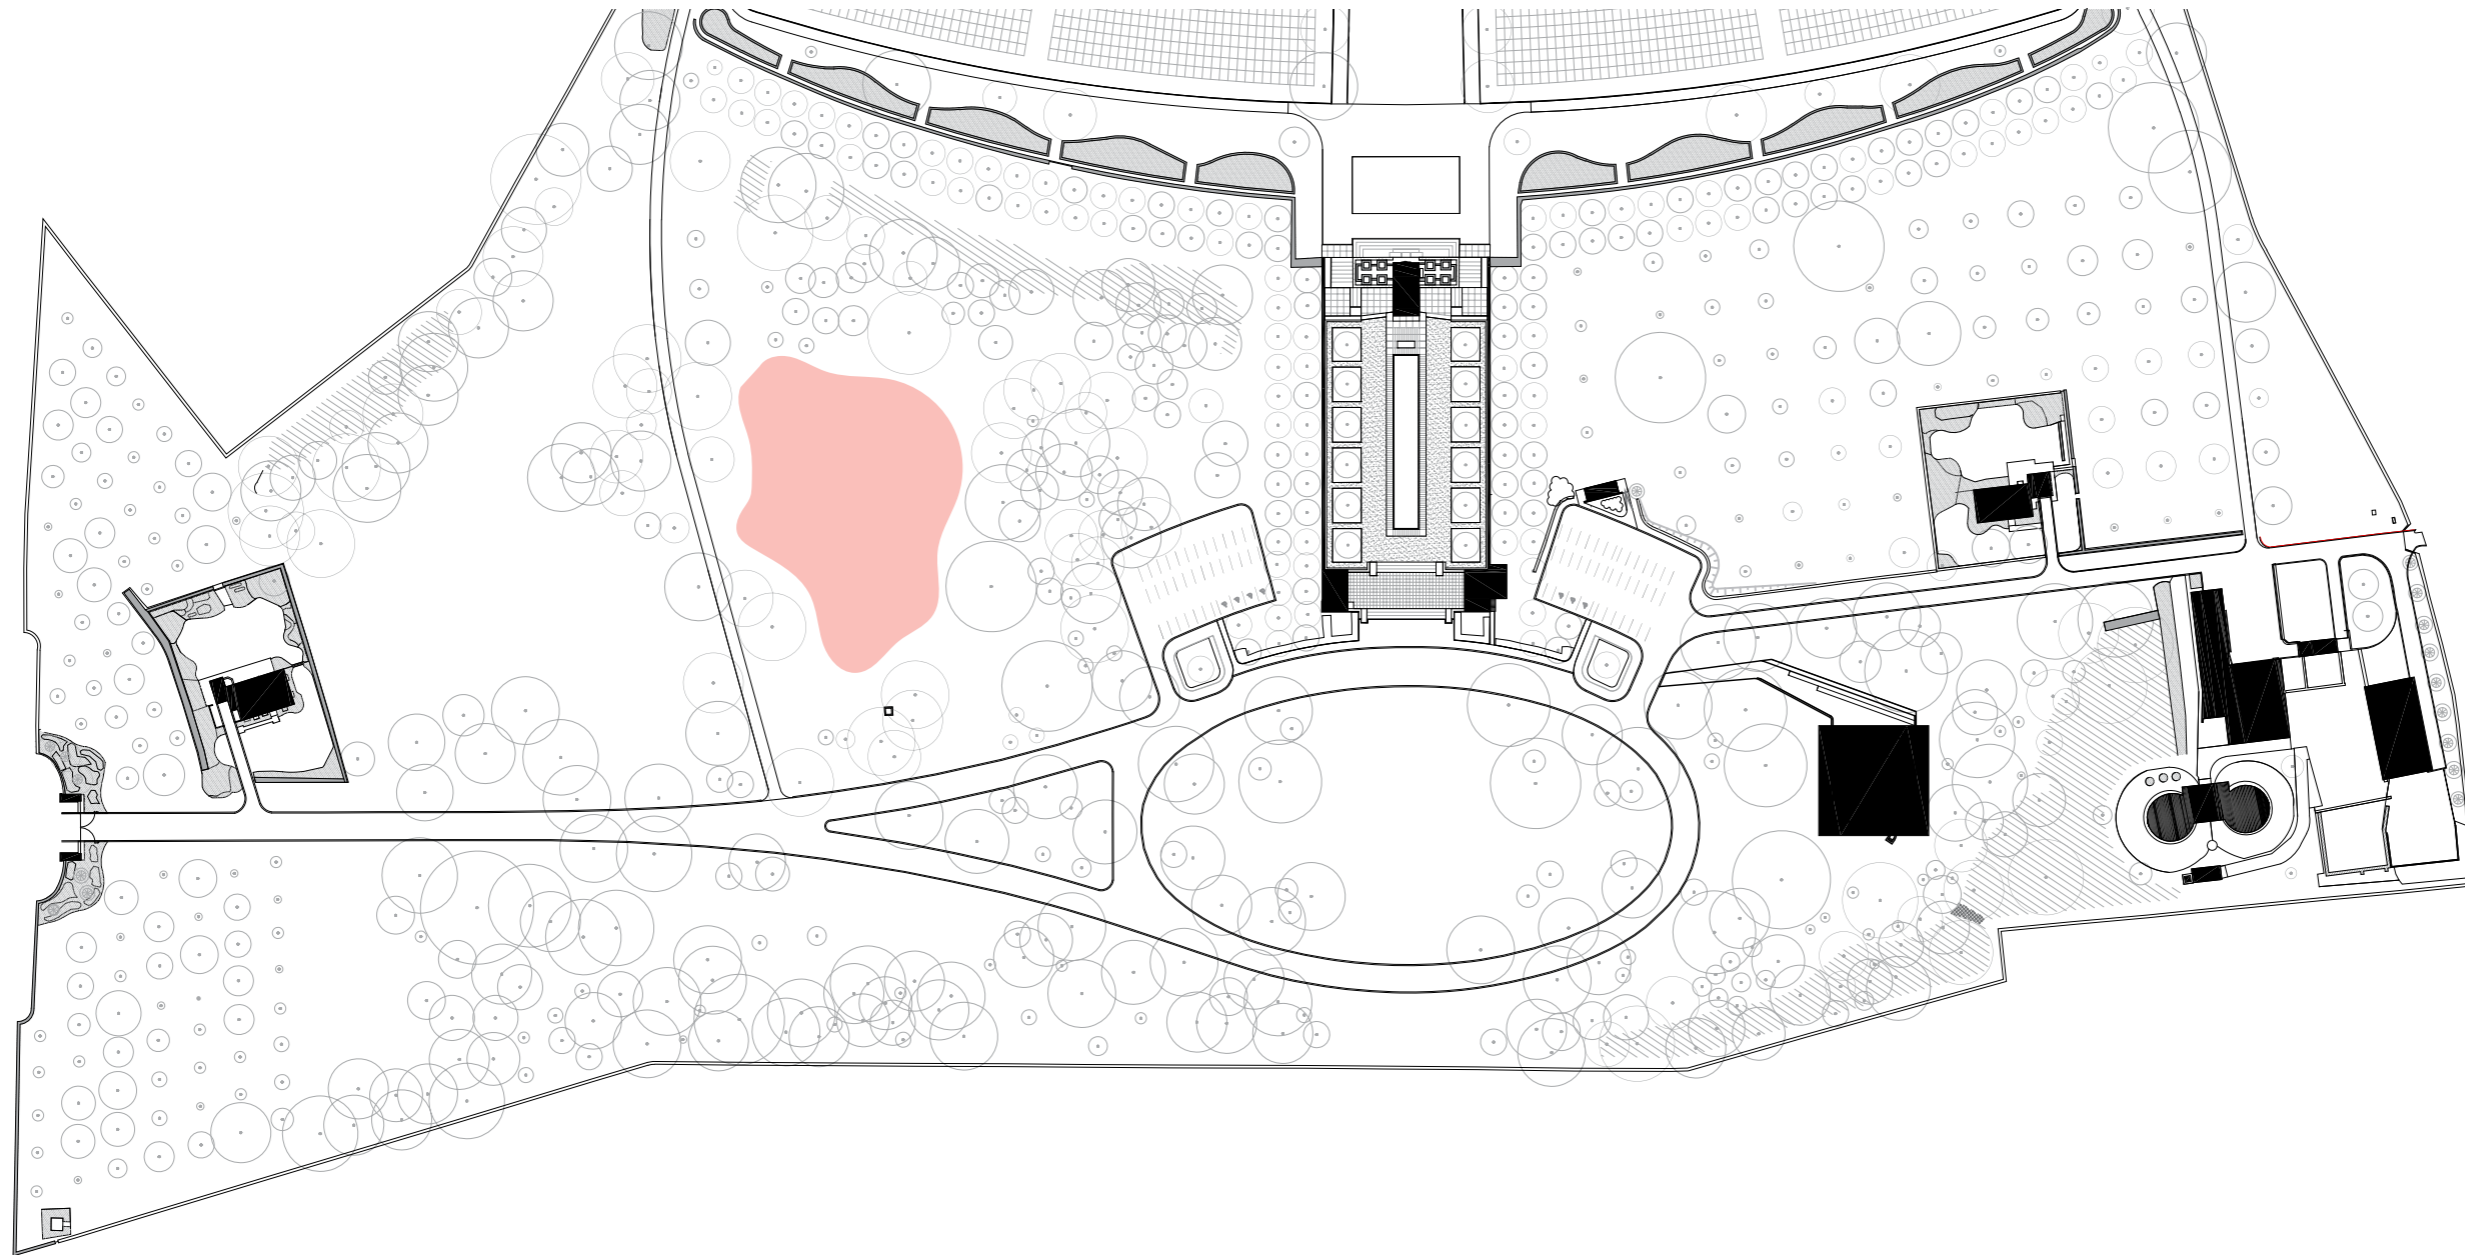
The meadow south of the superintendent's residence and north of the north parking lot is currently used at peak visitation times (such as special events) for overflow parking. Formalizing the site with a reinforced grass surface is the preferred alternative.

The site will be formalized with a reinforced grass surface suitable for vehicular movements without impacting the permanent appearance of the meadow. Parking spaces and driveways can be demarcated using stainless steel insets for grass tiles, which can be removed during low season.

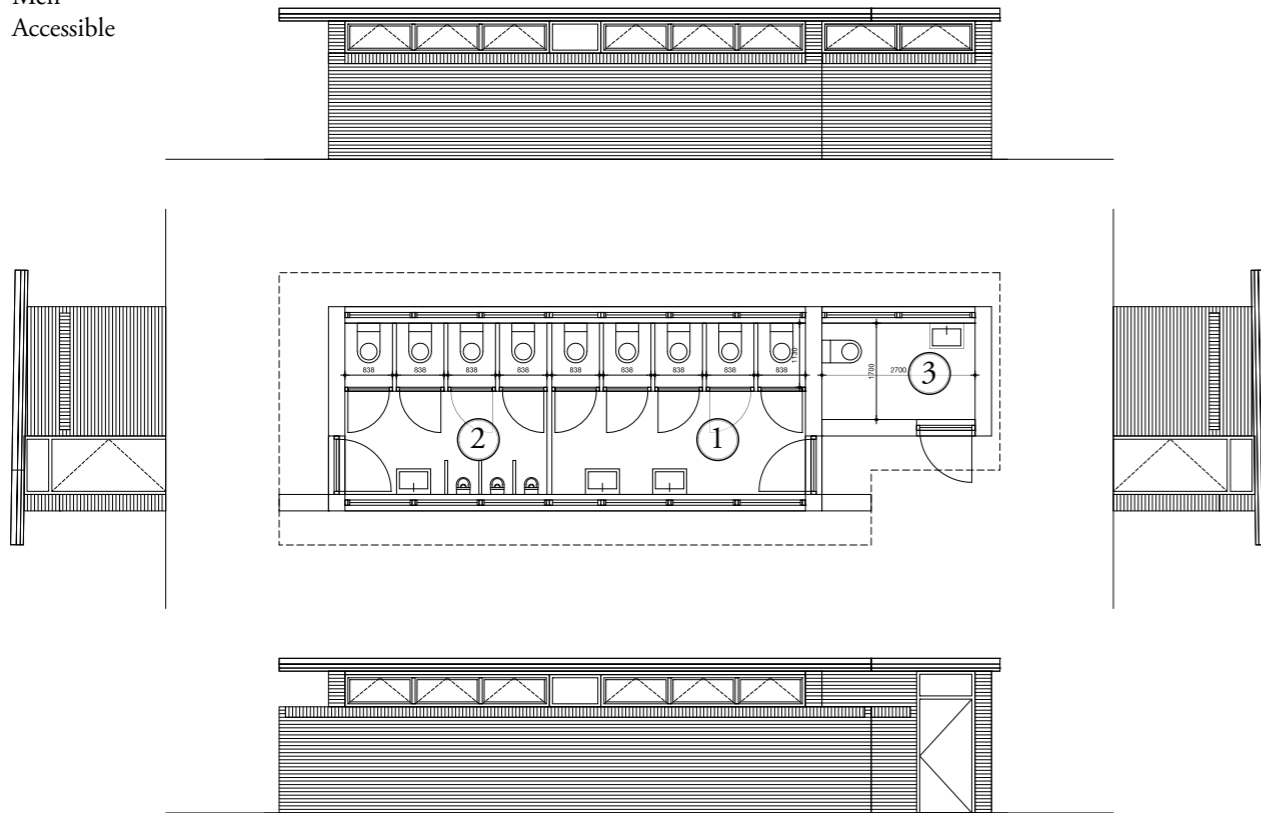
⊙
Plan and facade existing restroom, not to scale

Before the construction of the Monument was finished, the first additions to the original design were made. Added to the original layout of the cemetery was a sanitary building designed by Architectenbureau A.J.N. Boosten. Located close to the south side of Court of Honor, next to the apple orchard, the toilet building hides itself behind shrubs and hedges. The materialisation of the brick façades contrast from the other monumental architectural features, which are primarily clad in English Portland stone.

- 1. Women
- 2. Men
- 3. Accessible

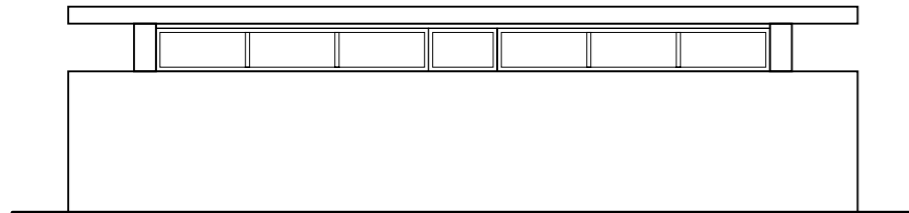
1 Renovation

expansion and renovation existing building

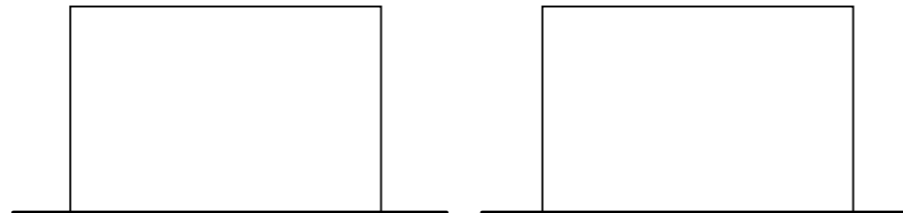
2 Split

newbuild on north and south parking

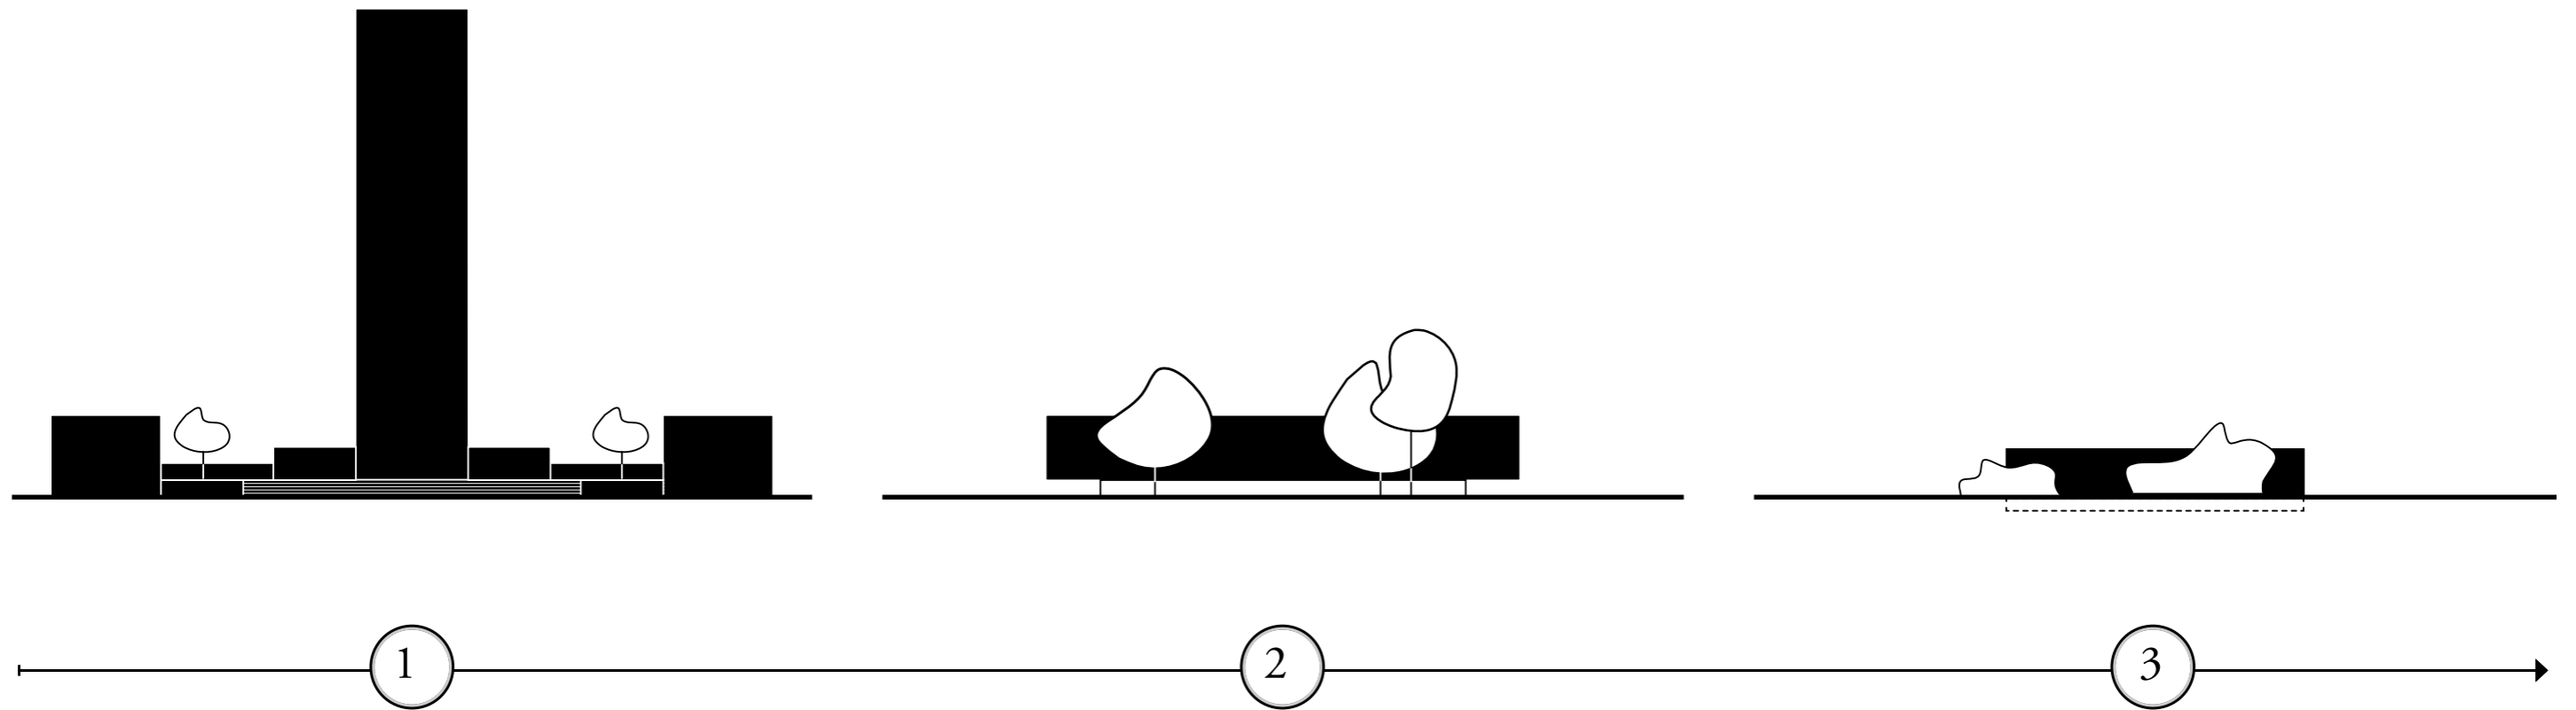
RESTROOM FACILITIES - CONCEPT DESIGN - HIERARCHY IN LANDSCAPE

MAIN ACTIVITY

- defining symmetrical axis
- landscape framing volume
 - cinematic viewsheds

SUPPORT ACTIVITY

- placed on symmetrical axis
- landscape screens volume
 - views towards site

ACCESSORY BUILDING

- not part of symmetrical axis
- landscape obscures volume
 - view towards sky

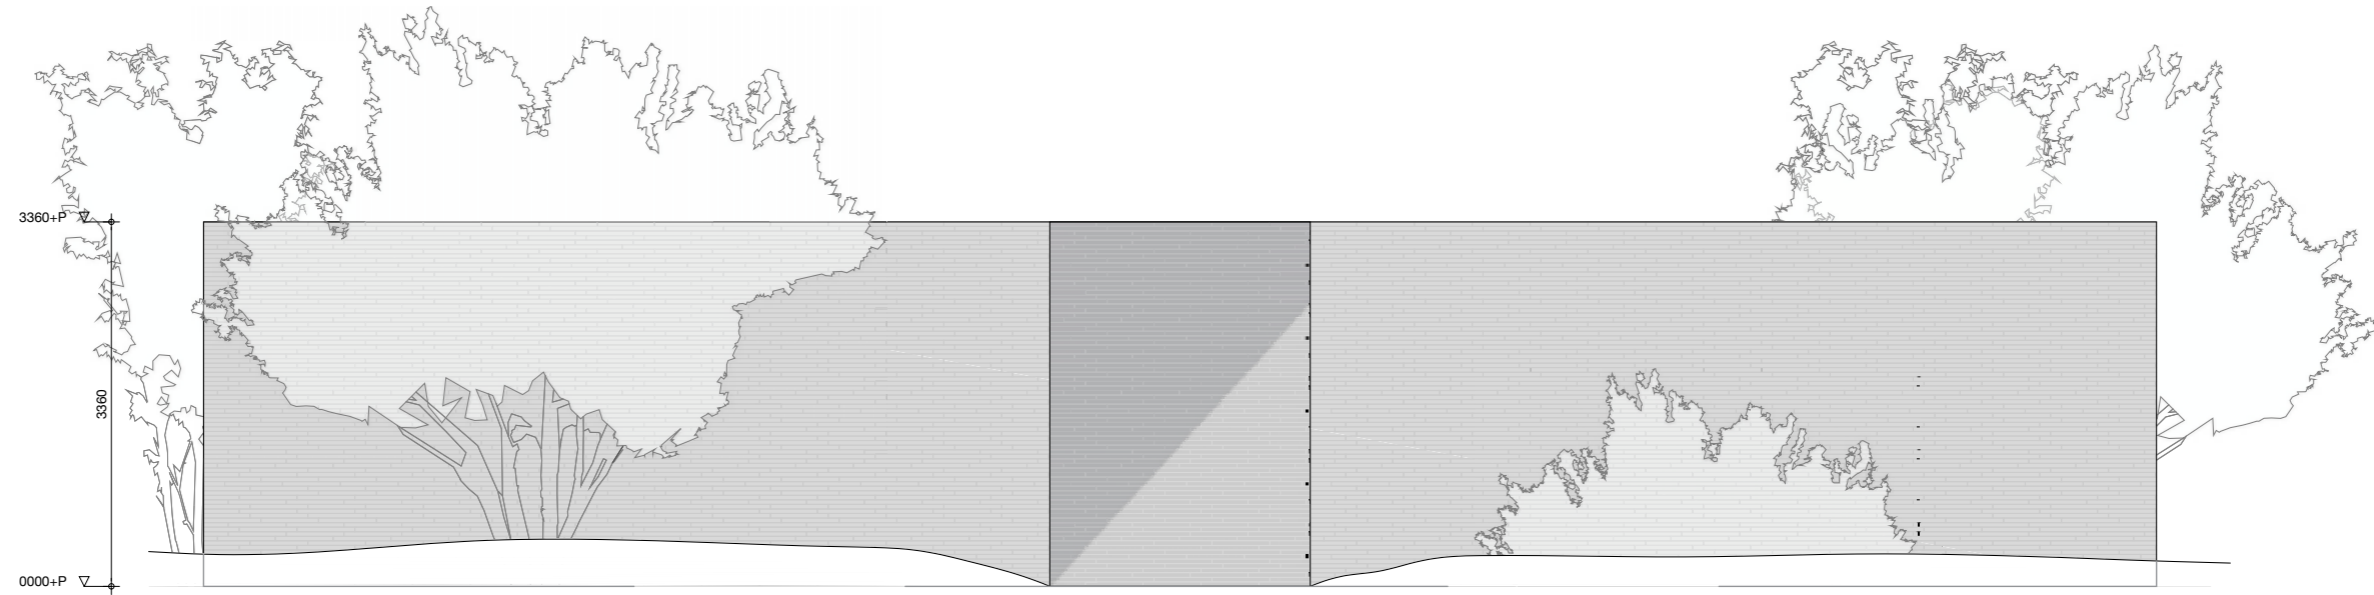
RESTROOM FACILITIES - CONCEPT DESIGN - EMBEDDING

Building volume embeds into sloping landscape

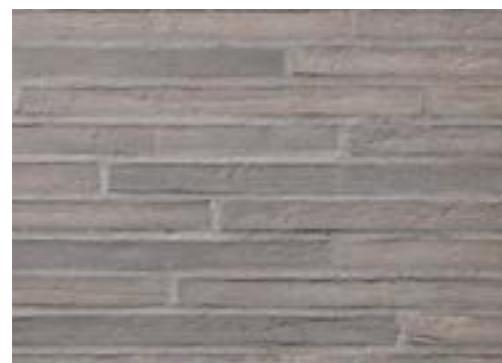
walls + floor exterior:

Brick - Petersen K54
random bond, joints grouted fully
flush with bricks

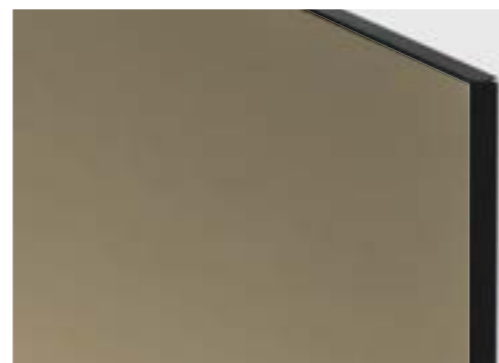
glazing and mirrors

glazing with dark bronze
coating

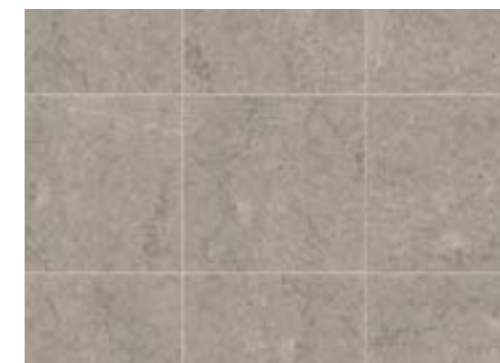
walls + floor interior:

natural stone tiles, in a color
matching selected brick,
400x400mm tiles

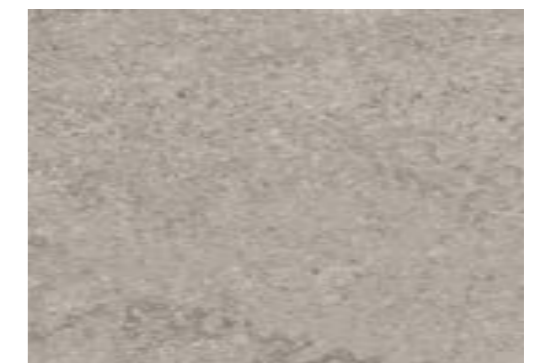
washbasin

solid object of natural stone as
tiling

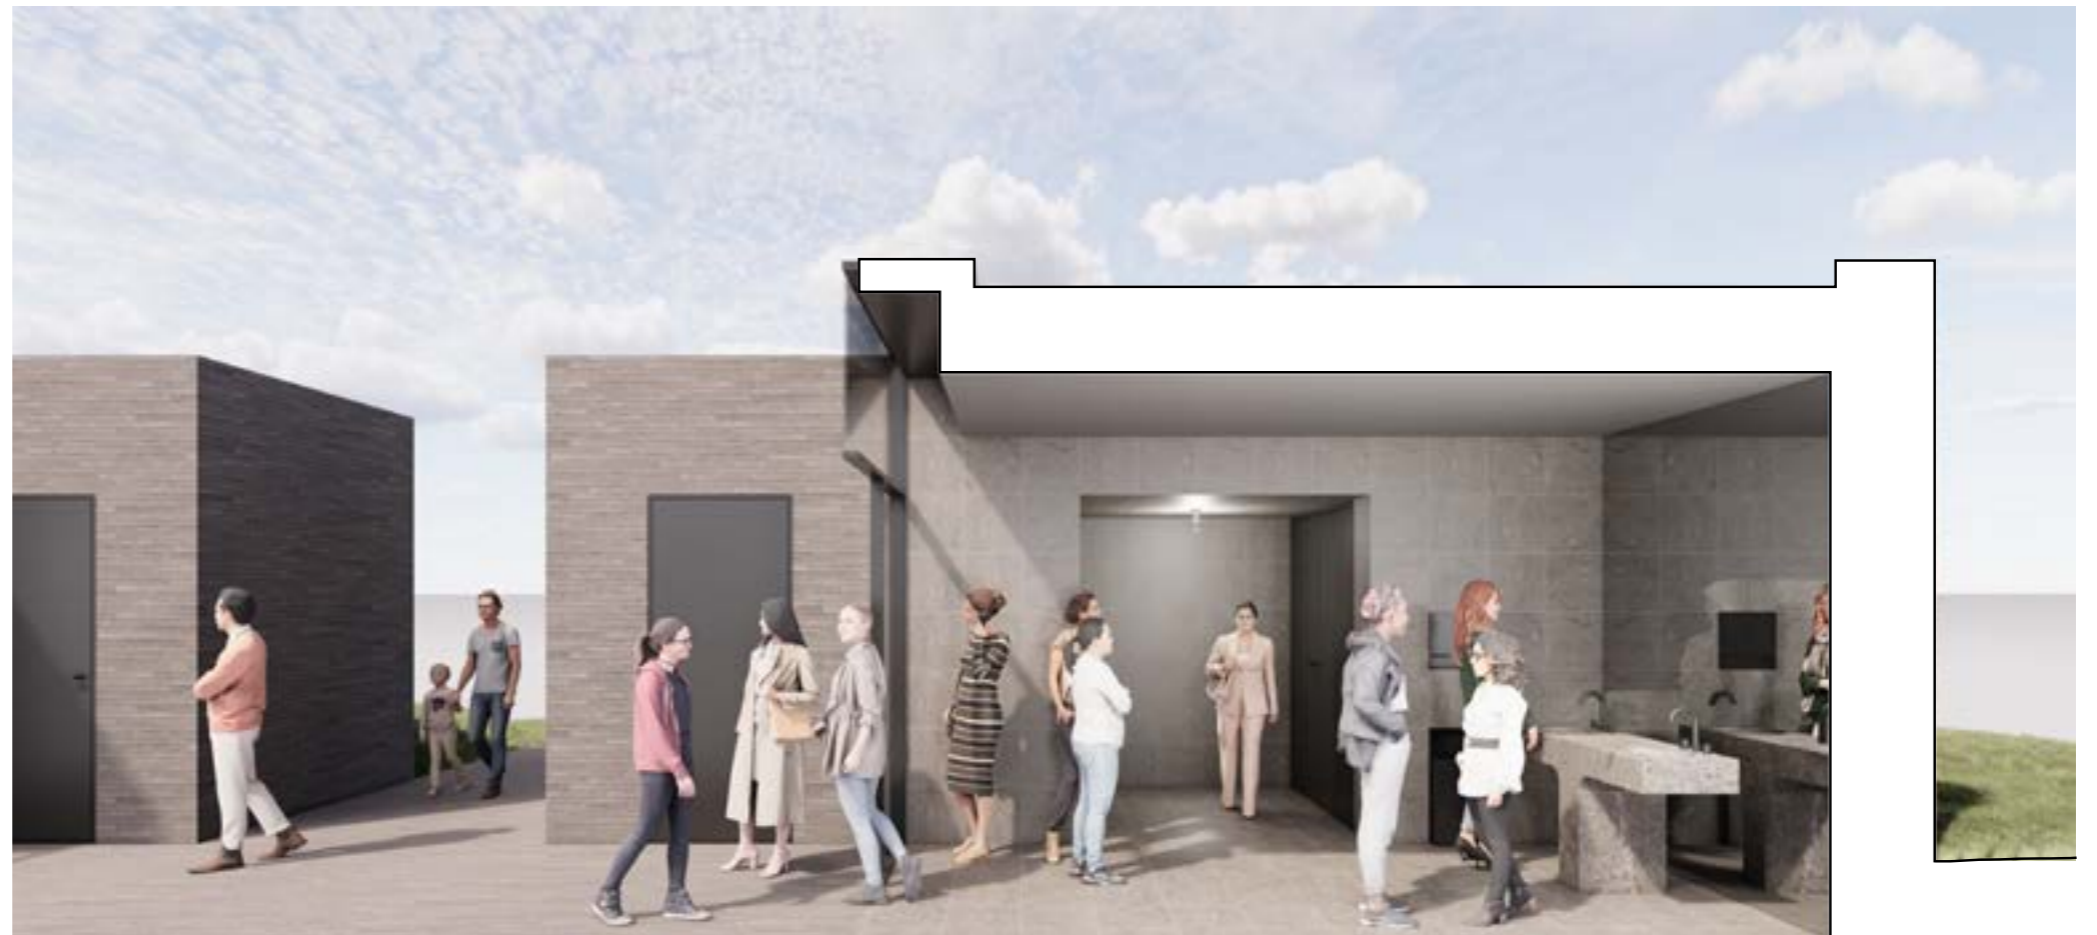
RESTROOM FACILITIES - CONCEPT DESIGN - CAPACITY

entrance / covered waiting space
 $4 \times 10\text{m}^2 = 40\text{m}^2$ total
full bus 56 persons = 1.4 p/m^2

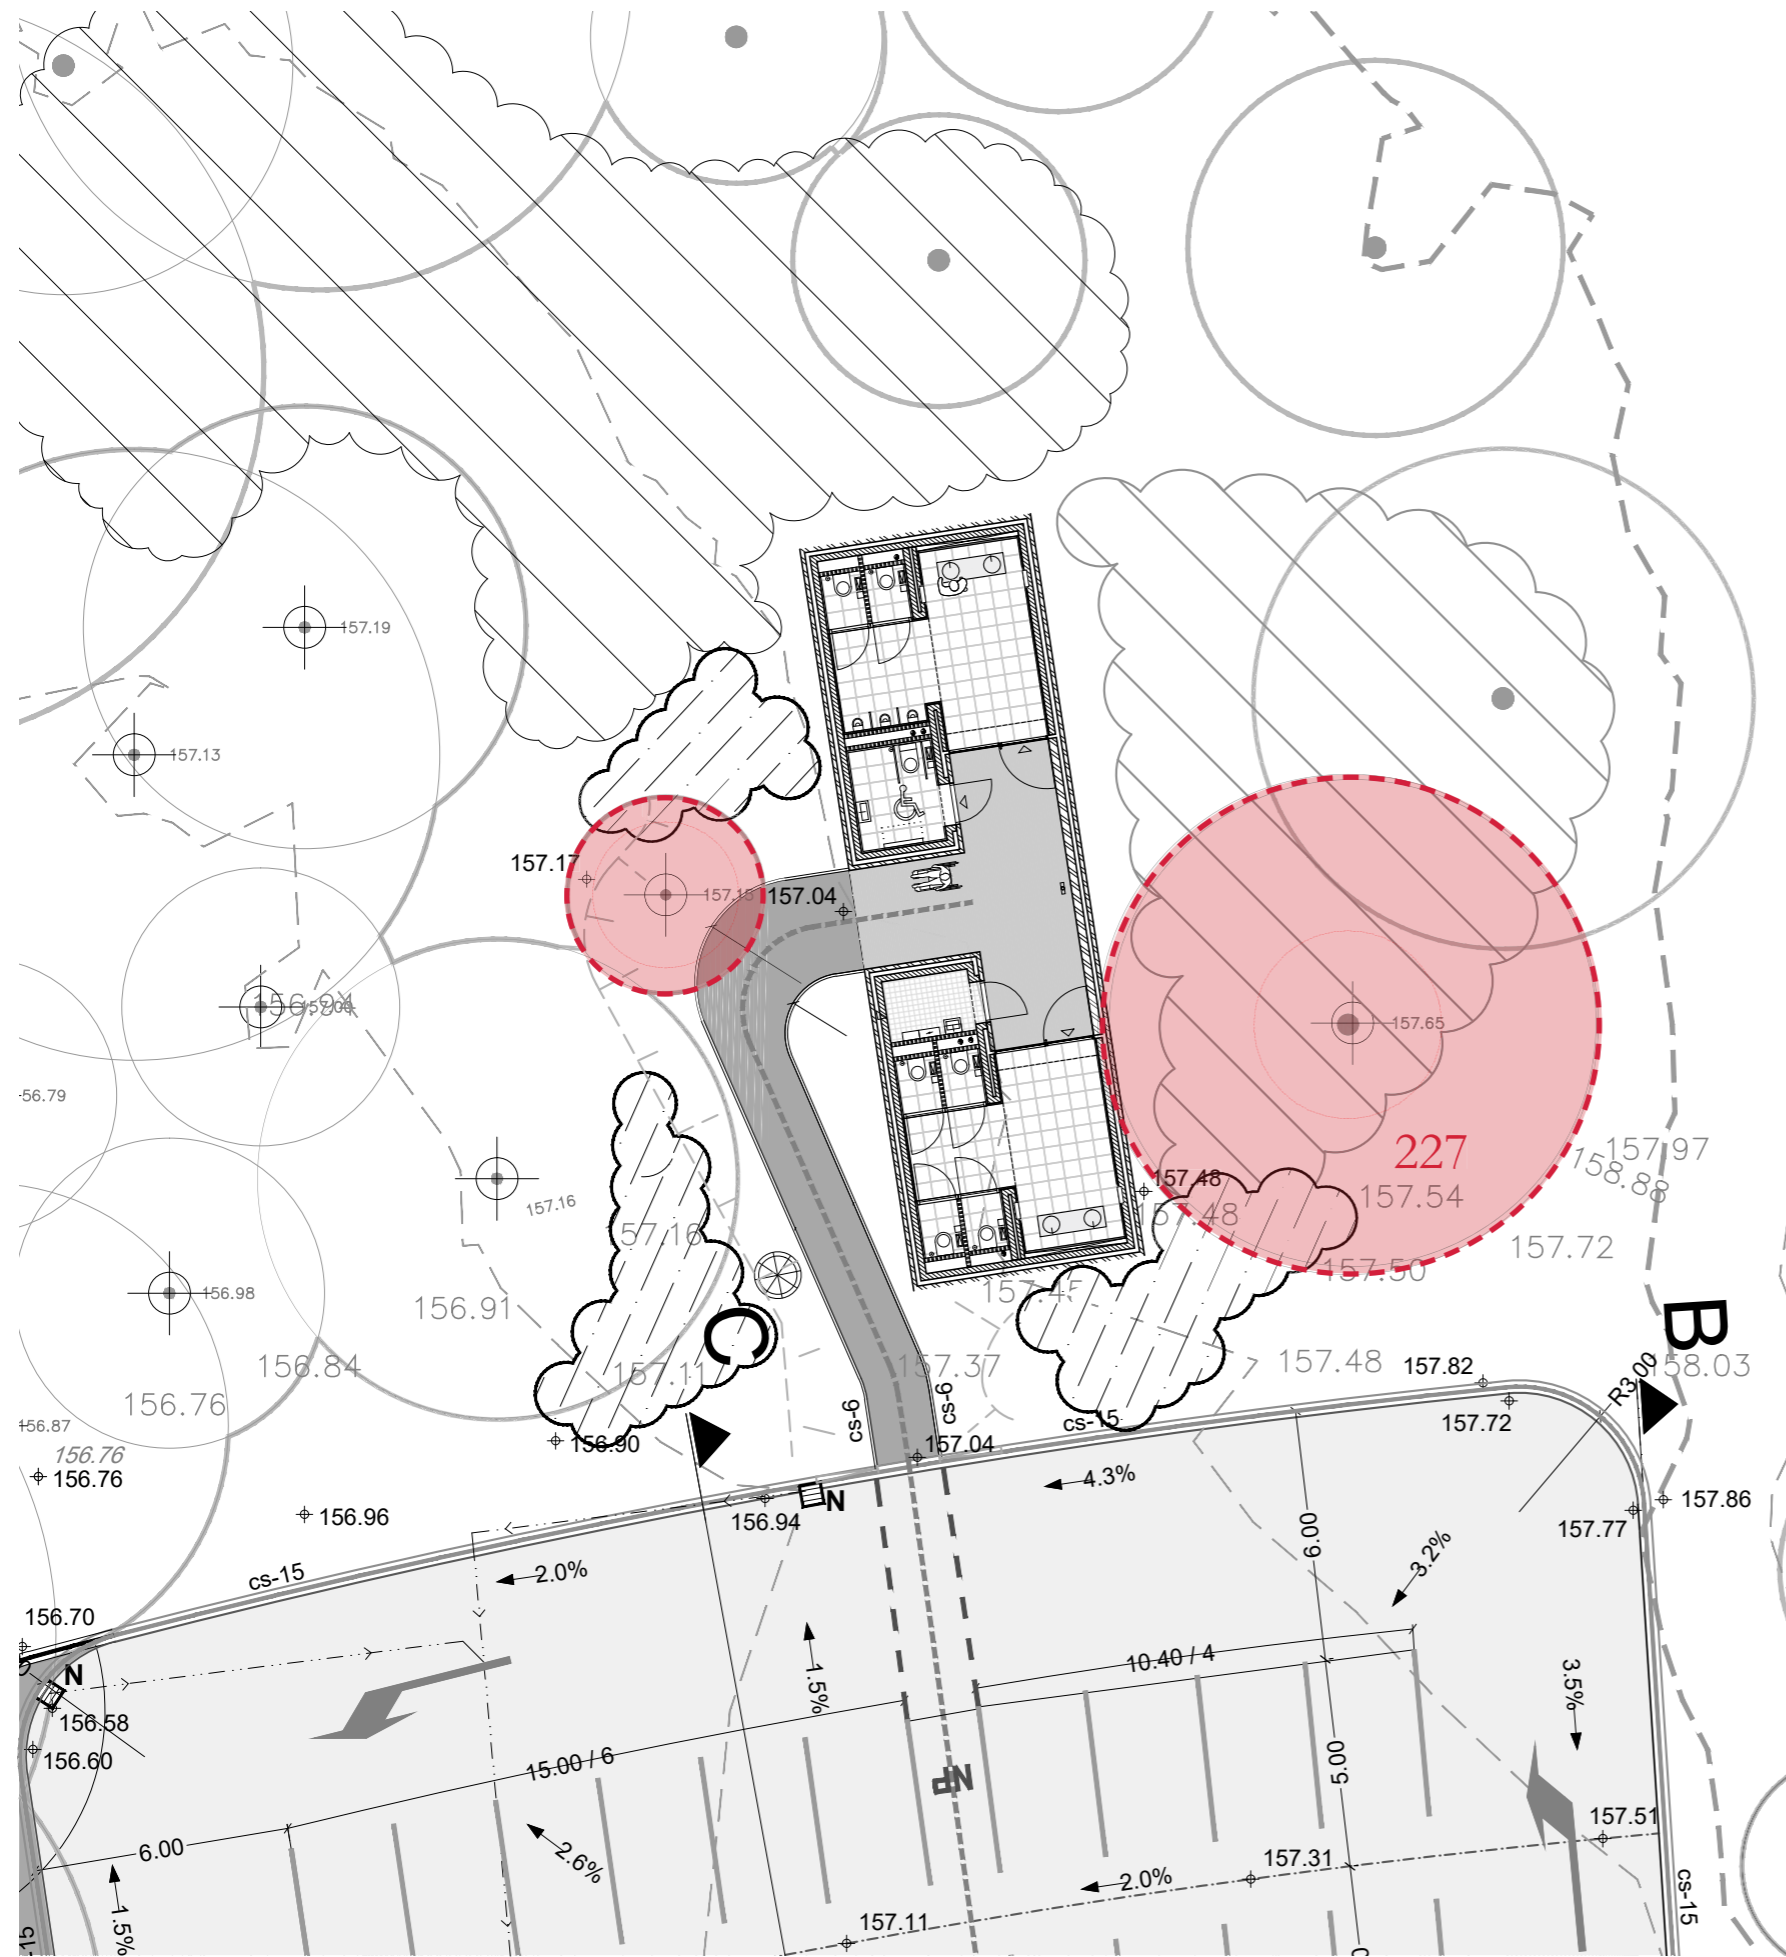
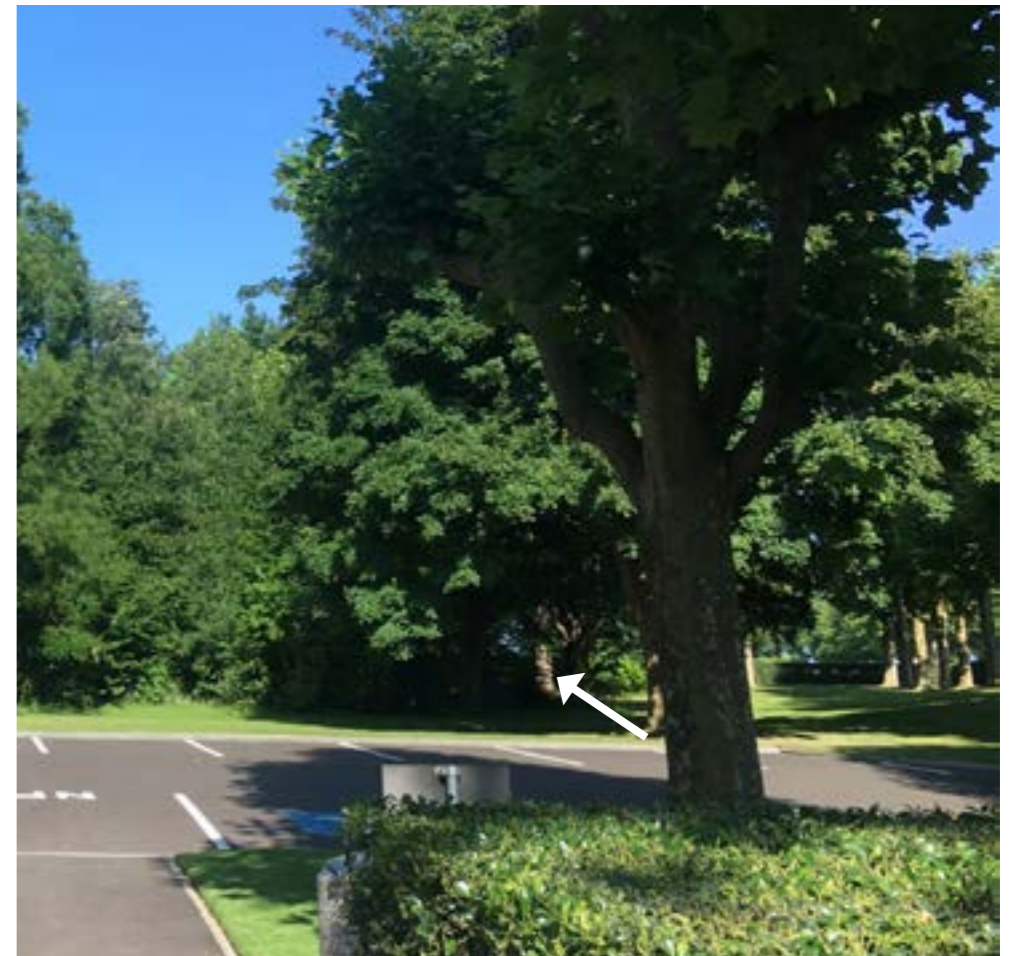
IMPACT VEGETATION

Nr.	Species	Crown (m)	Cause
227	Acer campestre	12	Restroom North

tree crown projections
-

cutting tree
-

critical root zone / potential damage
-

crown projection / potential damage
