Netherlands American Cemetery Visitor Center

CFA meeting Overflow Parking & Restroom Facility
2023.04.06

KAAN Architecten

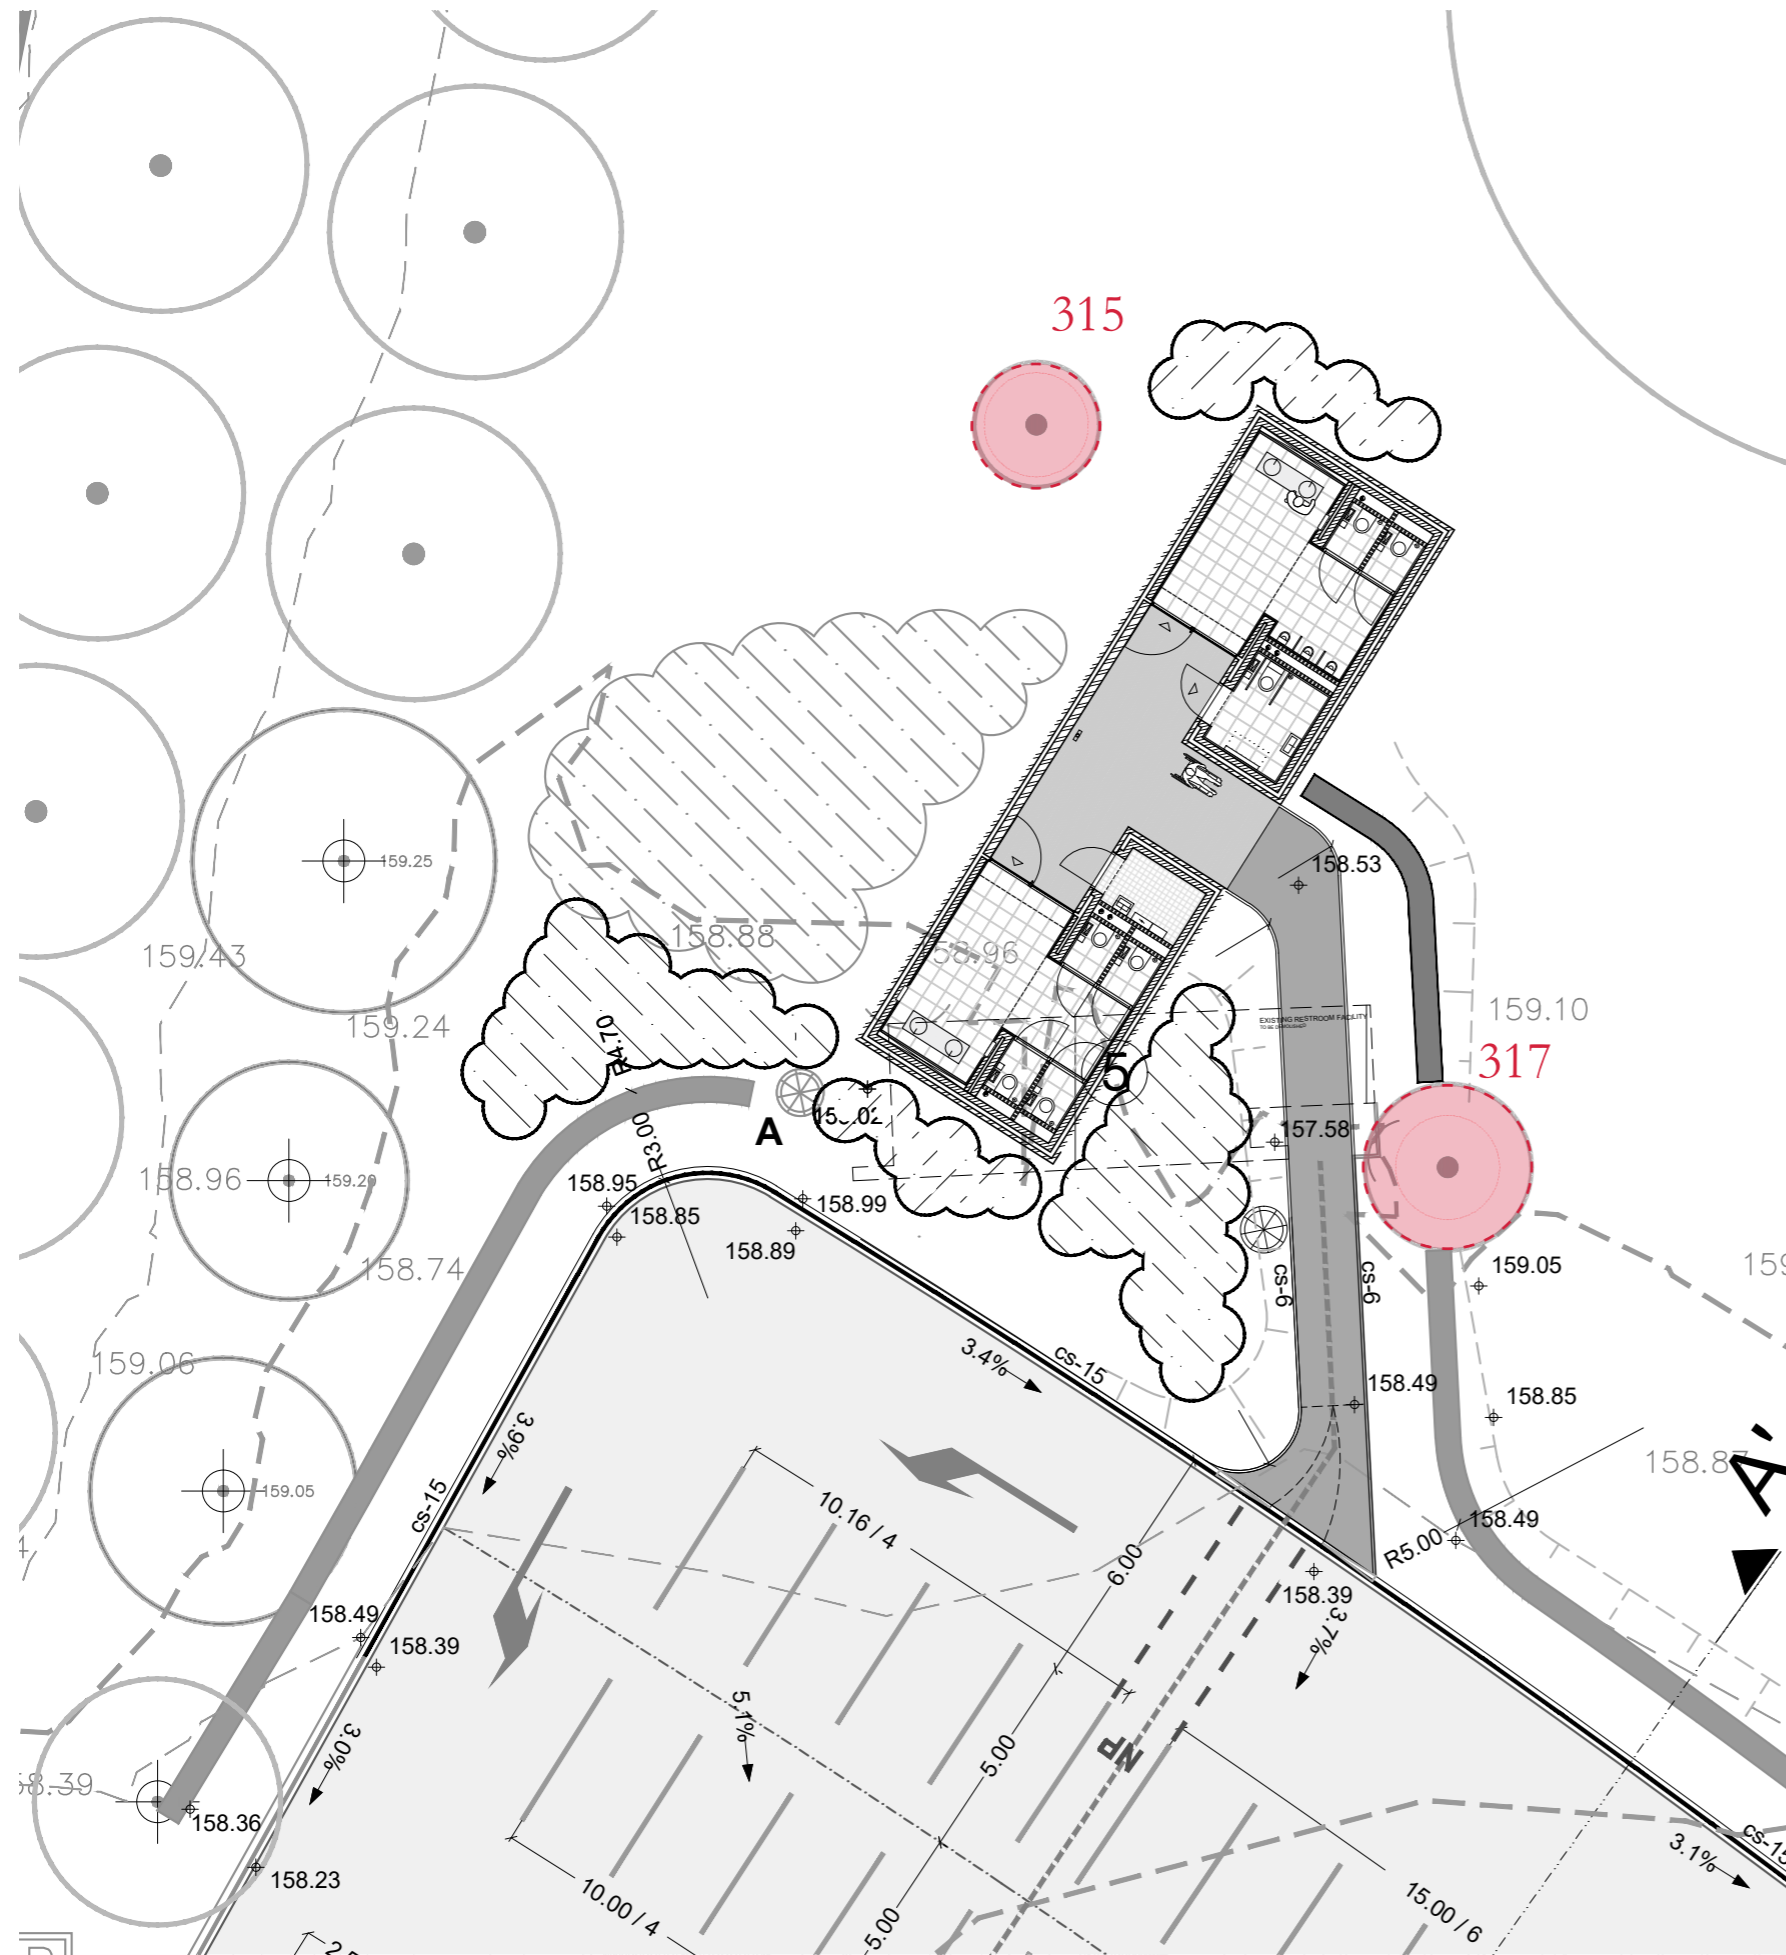
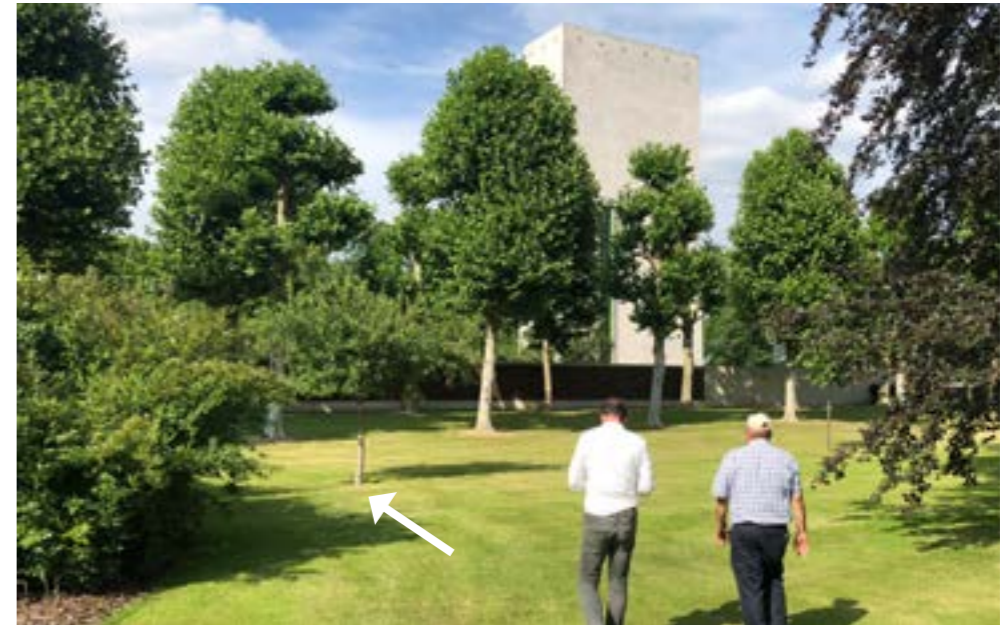
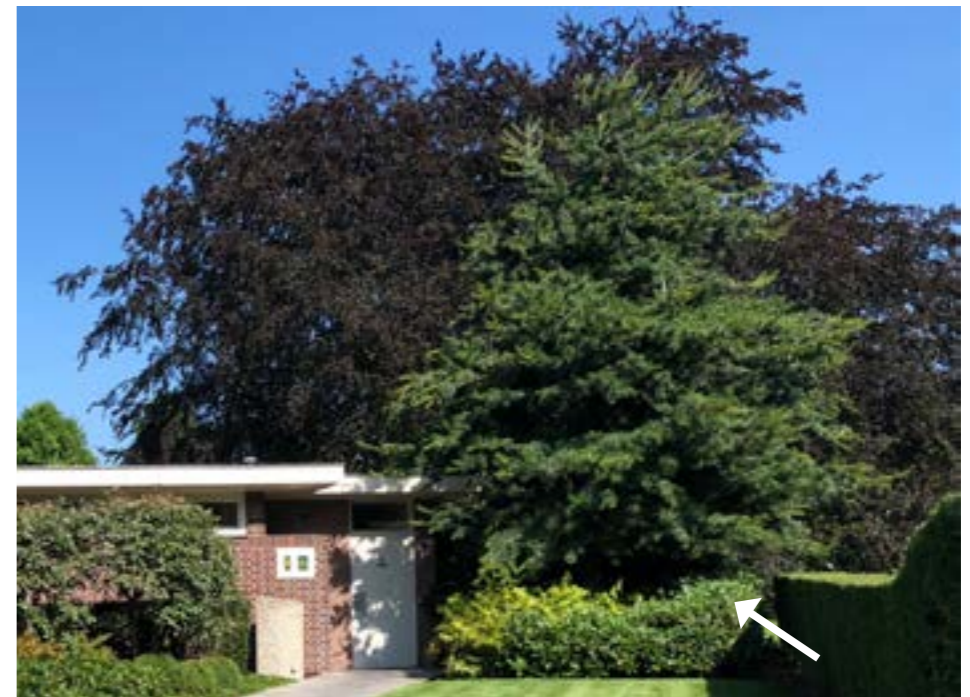
IMPACT VEGETATION

Nr.	Species	Crown (m)	Cause
315	Malus domestica	3,5	Restroom South
317	Pinus parviflora	7	Restroom South

- tree crown projections
- ✗ cutting tree
- critical root zone / potential damage
- crown projection / potential damage

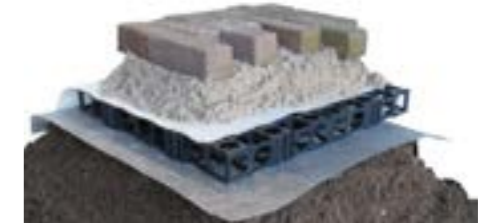
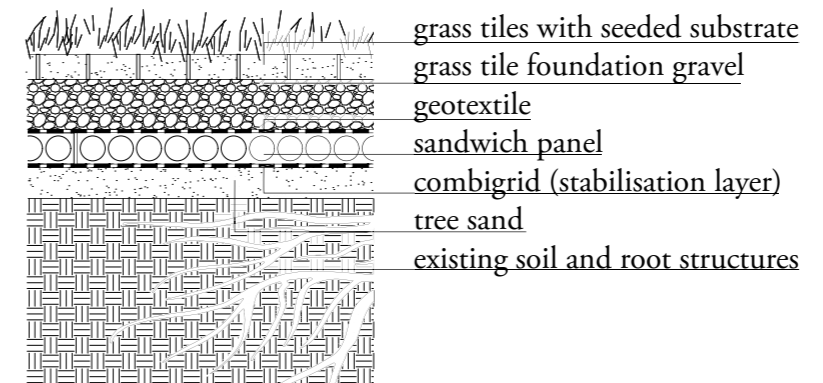
Sample package buildup - around critical root zones

Protection of critical root zones

Around the borders of the overflow parking, care must be taken to protect the root systems of adjacent trees from potential damage. One system that can be applied to prevent damage to trees due to compacting of soil and pressure on roots is a sandwich panel construction in a package as described below, to distribute the loads caused by parked and moving vehicles. This ensures that root structures are protected, while guaranteeing a sufficient aeration and permeability of the soil.

layer thicknesses will follow from ground survey
