APPLICATION AND REFERRAL TO THE US COMMISSION OF FINE ARTS FOR OLD GEORGETOWN REVIEW

THE OWNERS OF THE PROPERTY HAVE ASKED BYA / BARNESYANZE ARCHITECTS TO ORGANIZE THIS RENOVATION EFFORT. THE INTENT ON THE WHOLE IS TO STABILIZE THE FIVE STRUCTURES WHERE NEEDED AND PRESERVE THE HISTORIC FABRIC FOR THE NEXT GENERATIONS, WHILE MAKING SMALL CORRECTIONS TO WHAT APPEAR TO BE UNFORTUNATE CHANGES THAT HAVE BEEN MADE OVER TIME. IN THE CASE OF THE GUARD HOUSE, DETERIORATION IS ADVANCED, THE ROOF, WINDOWS AND DOORS WILL NEED TO BE REPLACED, AND WE ARE PROPOSING THAT THE EXTERIOR DESIGN BE HARMONIZED IN THE PROCESS WITH THE OLDER STRUCTURES ON THE SITE.

> GENERAL DATA SHEET FLOOR PLANS EXTERIOR ELEVATIONS

drawing: GENERAL DATA SHEET Oak Live

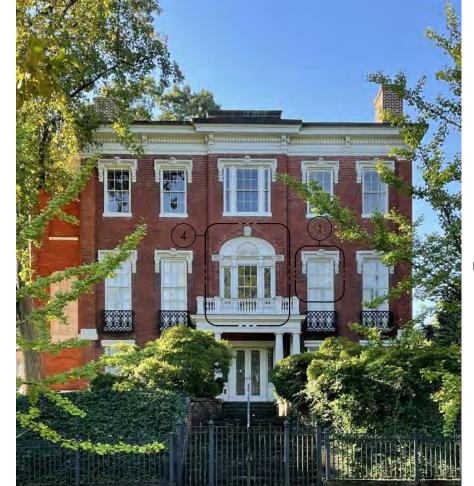
ELEVATION DETAIL - EXISTING GEORGIAN WINDOW

THE TEAM HAS EXPLORED OTHER CONNECTIONS FROM THE HOUSE INTERIOR TO THE BACK PORCH AND DETERMINED THAT THE TALL SIX-OVER-NINE SASH WINDOWS ALONG THE BACK, AND FRONT, OF THE MAIN LEVEL POCKET UP INTO THE WALL, ALLOWING DIRECT ACCESS FROM THE LIVING ROOM TO THE PORCH. THIS APPEARS TO BE AN EXISTING CONDITION THAT HAPPILY IS IN WORKING ORDER TODAY. THIS ALLOWS PASSAGE FROM THE MAIN LIVING AREAS ON THE MAIN FLOOR TO THE BACK PORCH. THE ONLY EXTERIOR CHANGE PROPOSED IN THIS SUBMISSION IS TO RESTORE THE SINGLE OPENING FROM THE DINING ROOM ON THE OTHER SIDE OF THE HOUSE BACK TO THIS SAME WINDOW. IT IS CURRENTLY A DOOR AND TRANSOM OF MORE RECENT ORIGIN.

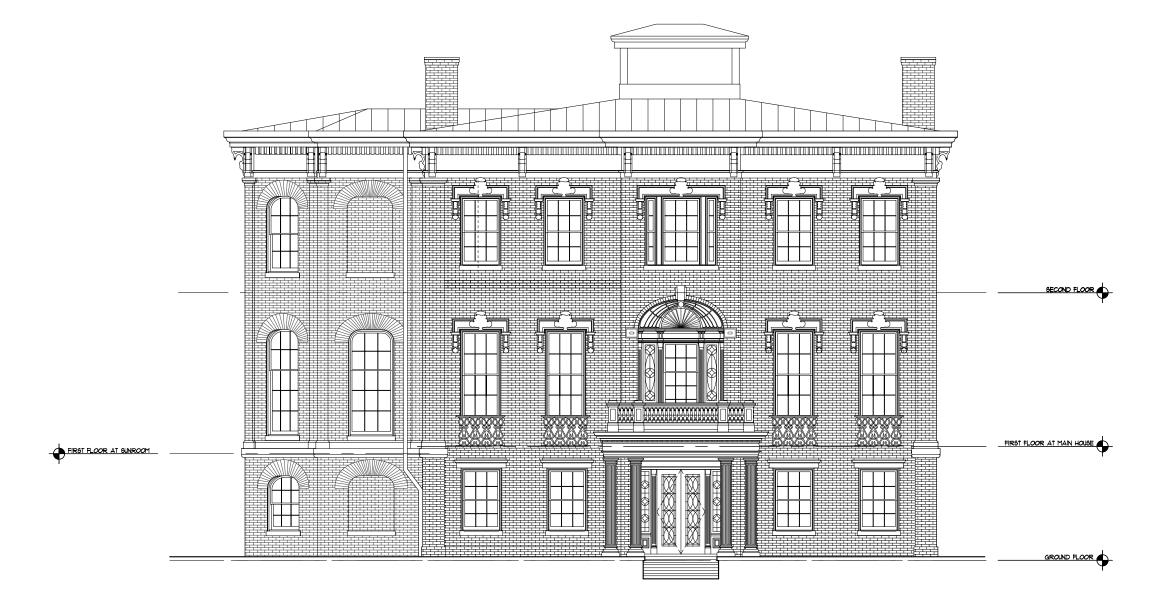
DCRA STAMP: NO PROPOSED CHANGES BUILDING LOCATION KEY: (NTS) R STREET NW GRAPHIC SCALE: 2156 Live Oak Trust
3238 R Street NW
Washington, DC 20007 DRAWING: EAST EXTERIOR EXISTING ELEVATION FIRST FLOOR BUILDING NAME: MAIN HOUSE GROUND FLOOR

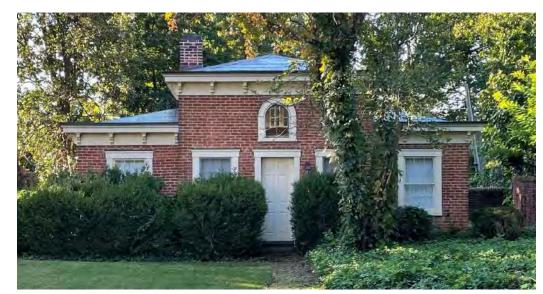
NORTH ELEVATION

REFERENCE PHOTOS: EXISTING EXTERIOR ELEVATIONS TO REMAIN

THE STRUCTURE IS LOCATED BEHIND THE MAIN HOUSE ON THE BROW OF THE HILL WHERE IT BEGINS TO SLOPE DOWN FROM THE RELATIVELY FLAT REAR LAWN. IT IS IN RELATIVELY GOOD CONDITION, AND WE ARE NOT PROPOSING ANY CHANGES TO THE EXTERIOR. THERE ARE A FEW PLACES THAT MAY REQUIRE MASONRY REPAIR, AND THE BACK PORCH MAY NEED SOME STRUCTURAL STABILIZATION, AS THERE IS SOME MOVEMENT IN THE PATIO FLOOR AND ONE CORNER OF THE PORCH. MINOR ROOF REPAIRS MAY BE NEEDED. THIS SUBMISSION DOES NOT PROPOSE CHANGES TO THIS BUILDING.
